RESTORING RAISED BOG IN IRELAND
Project Reference: LIFE04 NAT/IE/000121

A REPORT ON THE RESTORATION OF PROJECT SITE No. 1

LOUGH LURGEEN BOG & GLENAMADDY TURLOUGH, CO. GALWAY

**Compiled by: John Derwin,
Project Ecologist,
September 2008**

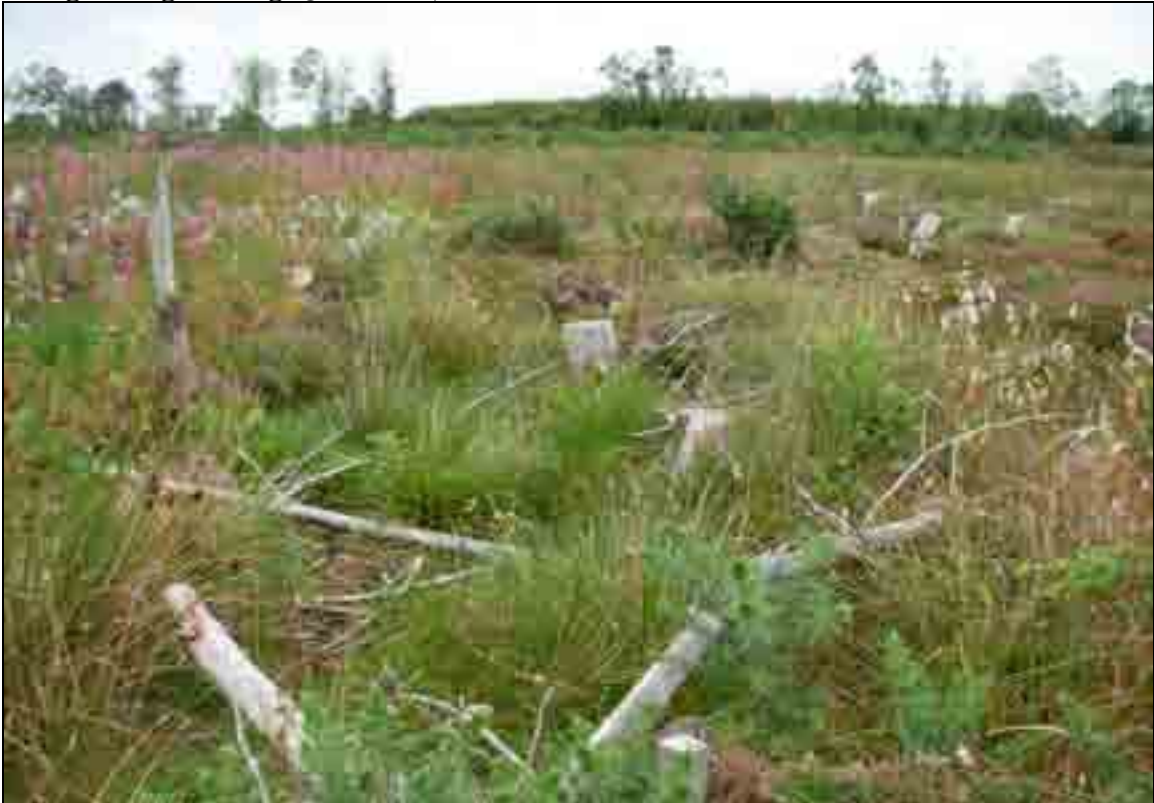
Lough Lurgen Bog Quadrat 2, 2008

Quadrat 2: This quadrat is located on the northern margin of Lough Lurgeen Bog and occurred within recently clear-felled conifer plantation on high bog with vegetation containing Ling Heather, Hare's-tail Cotton-grass, with *Hypnum* moss and numerous *Sphagnum* species. With the blocking of drains, Ling Heather and Hare's-tail cotton-grass cover increased. Over time *Sphagnum* cover will increase and this wet bog margin will develop raised bog habitat.

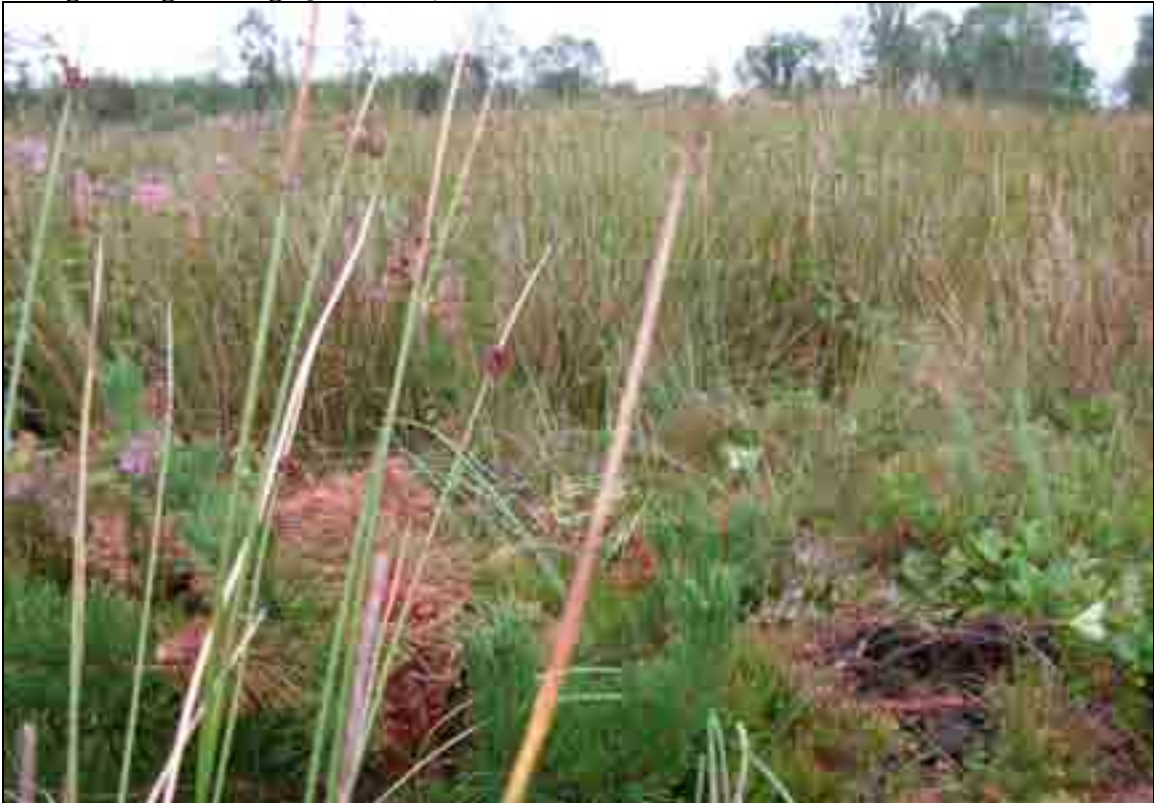
Lough Lurgen Bog Quadrat 3, 2008

Quadrat 3: This quadrat is located on the northern margin of Lough Lurgeen Bog and occurred within recently clear-felled conifer plantation on cutover bog with vegetation dominated by Soft Rush, Willow-herb, Ling Heather, *Hypnum* moss and numerous *Sphagnum* species. With the blocking of drains, Soft Rush still dominates this mineral peat margin with Ling Heather and *Sphagnum* moss. Over time this margin will develop lagg zone habitat of the raised bog margin.

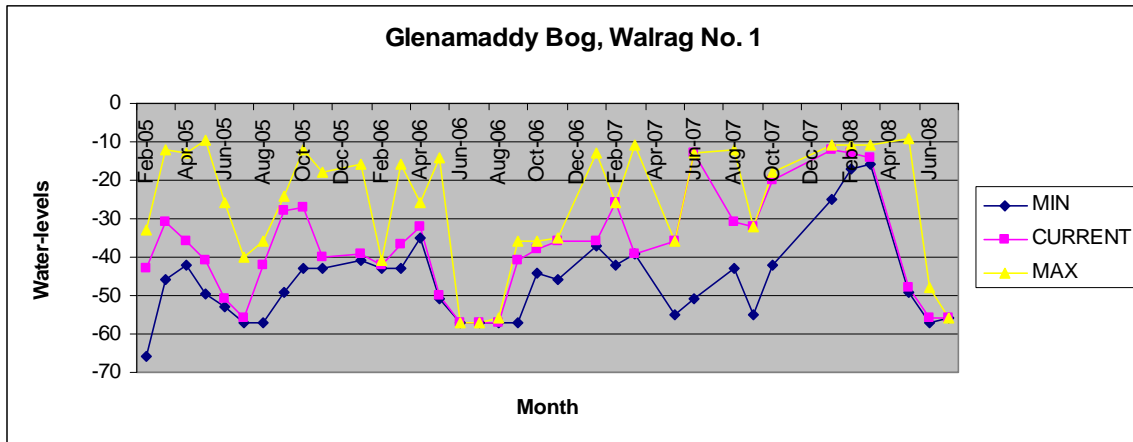
Glenamaddy Bog Walrag 1: Clearfell on High Bog Margin. (Water-levels remain below 20cm of bog surface post restoration*, due to proximity of mineral soil. Water-levels decline further in summer months)

Clearfell (2004) May 2005 May 2006 *Drain-blocking May 2007 May 2008

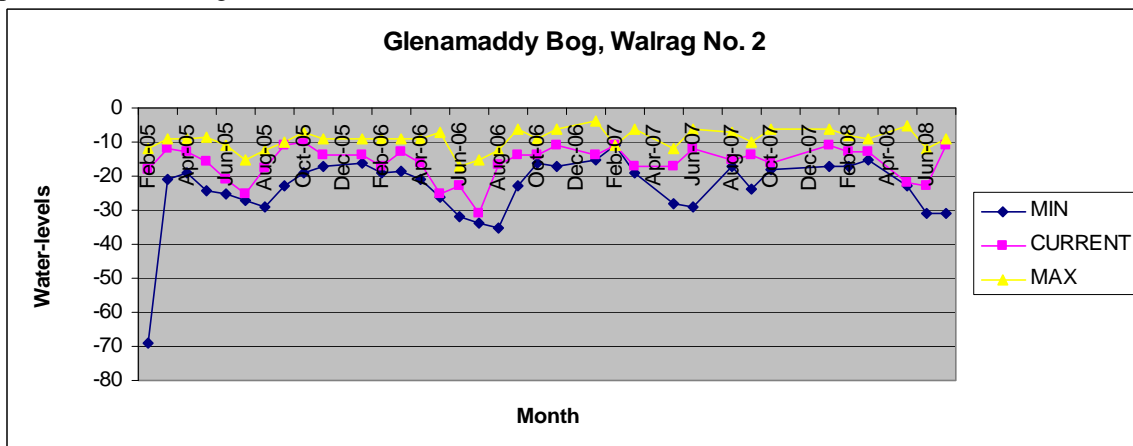
Glenamaddy Bog Walrag 2: Clearfell on High Bog. (Water-levels remain within 20cm of bog surface post restoration*, slight decline in summer months)

Clearfell (2004) May 2005 May 2006 *Drain-blocking May 2007 May 2008

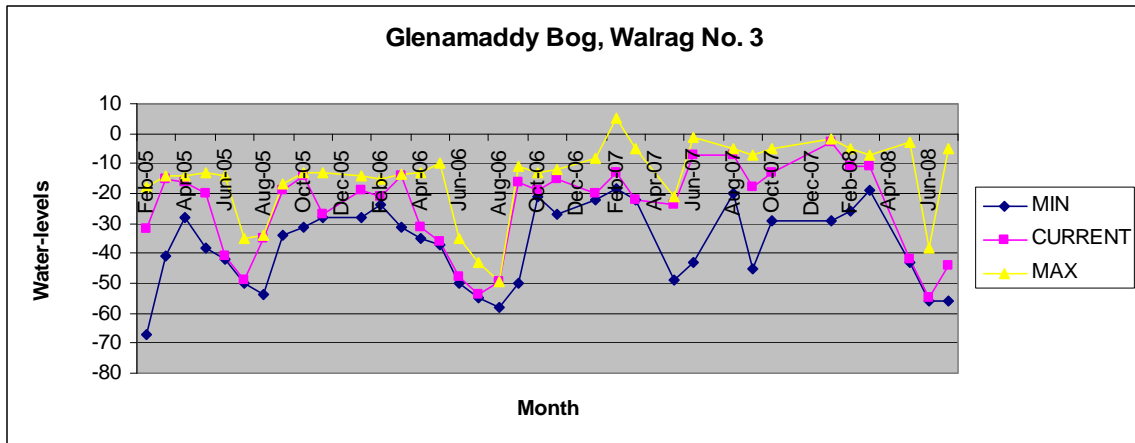
Glenamaddy Bog Walrag 3: Clearfell on High Bog Margin. (Water-levels remain between 20 -30cm of bog surface post restoration*, with further decline in summer months)

Clearfell (2004) May 2005 May 2006 *Drain-blocking May 2007 May 2008

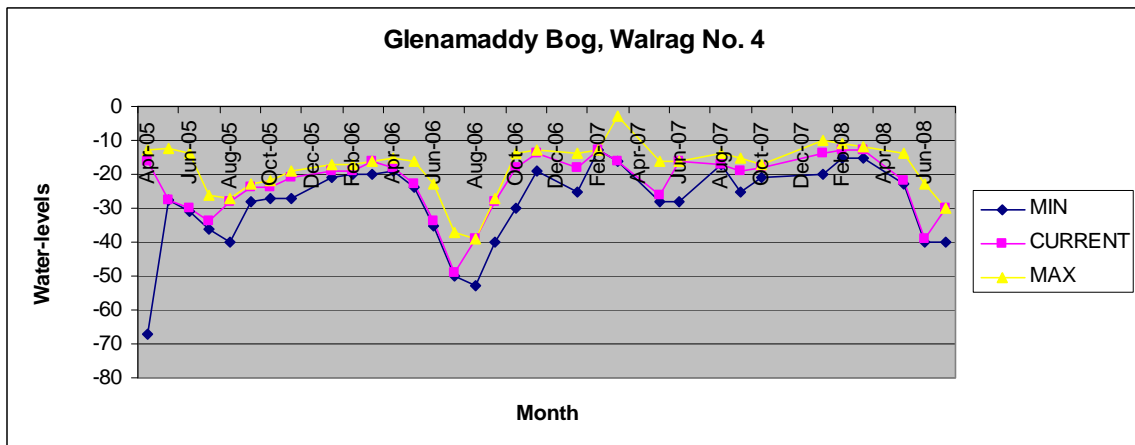
Glenamaddy Bog Walrag 4: Clearfell on Cutover Bog. (Water-levels remain around 20cm of bog surface post restoration*, with further decline in summer months, due to proximity of mineral soil)

Clearfell (2004) May 2005 May 2006 *Drain-blocking May 2007 May 2008

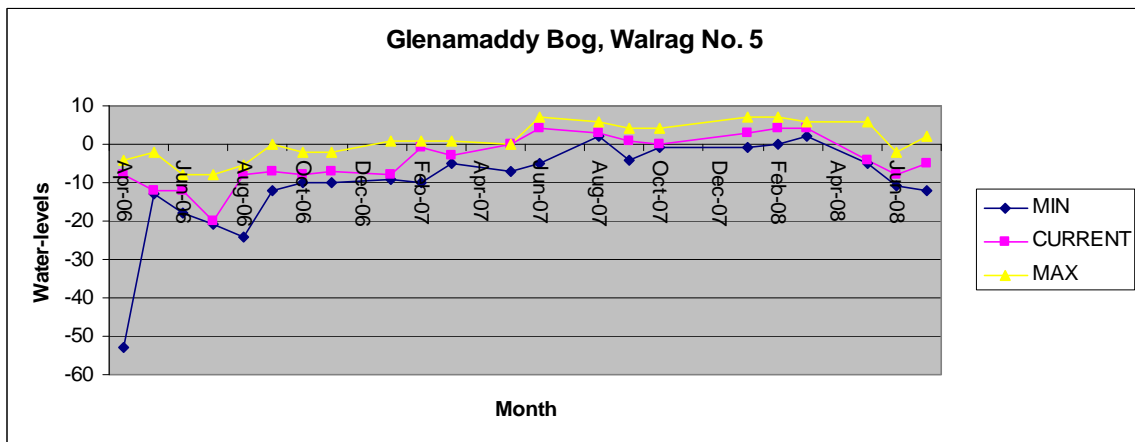
Glenamaddy Bog Walrag 5: Clearfell on Cutover Bog. (Water-levels remain within 10cm of bog surface post restoration*, with slight decline in summer months)

Clearfell (2004) May 2005 May 2006 *Drain-blocking May 2007 May 2008

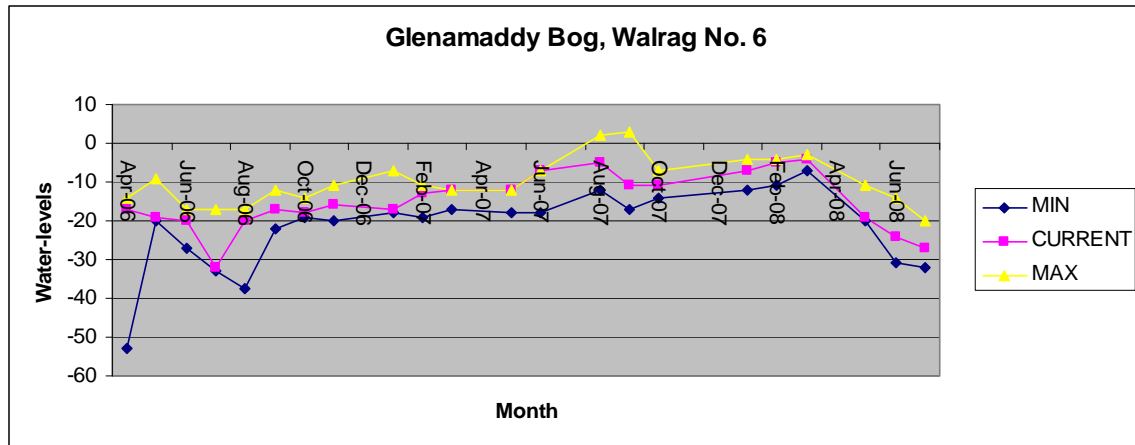
Glenamaddy Bog Walrag 6: Clearfell on Cutover Bog. (Water-levels within 20cm of bog surface post restoration*. Decline in summer months, due to proximity of mineral soil)
