RESTORING RAISED BOG IN IRELAND
Project Reference: LIFE04 NAT/IE/000121

A REPORT ON THE RESTORATION OF PROJECT SITE No. 10

ARDAGULLION BOG, Co. LONGFORD

**Compiled by: John Derwin,
Project Ecologist,
September 2008**

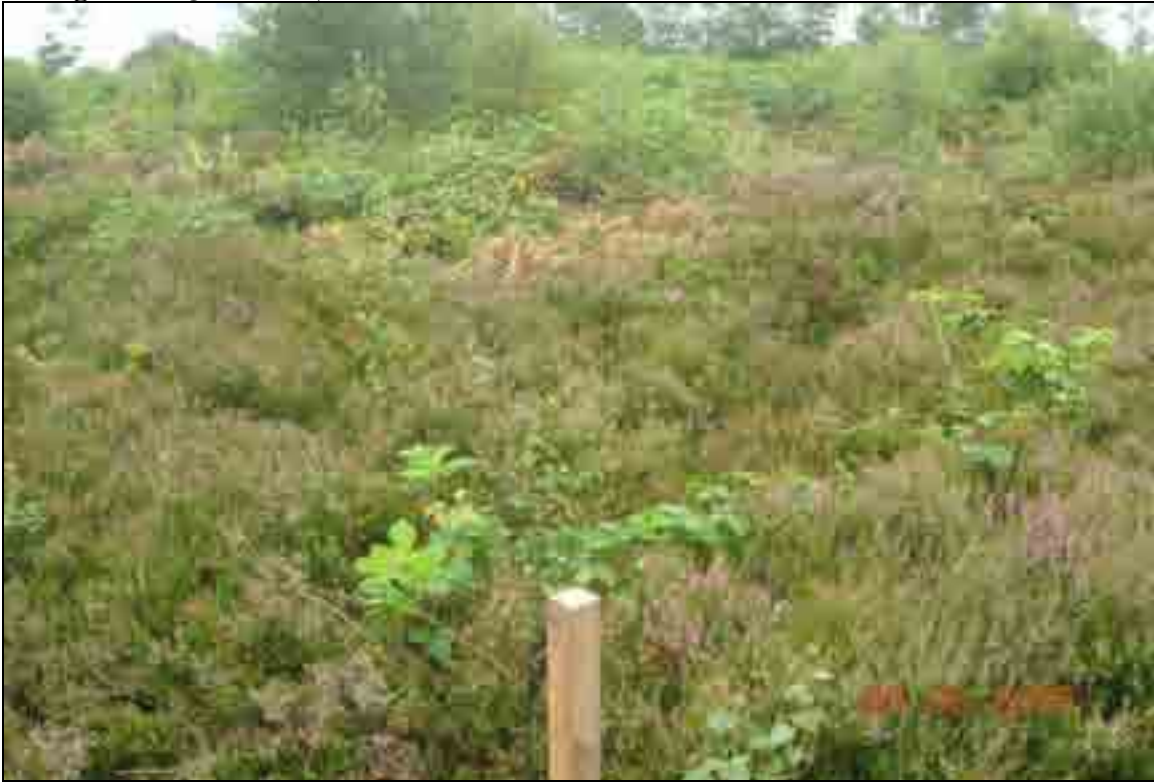
Ardagullion Quadrat 1, 2005

Quadrat 1: This quadrat is located on the north-east margin of Ardagullion and occurred within young conifer plantation with a ground cover containing Ling Heather, Bramble and *Hypnum* moss. This margin adjoined active peat-cutting and so drain-blocking was restricted. With the felling to waste of the conifers, it can be seen that Downy Birch and Ling Heather cover increased. Over time, this dry bog margin will develop into wet birch woodland.

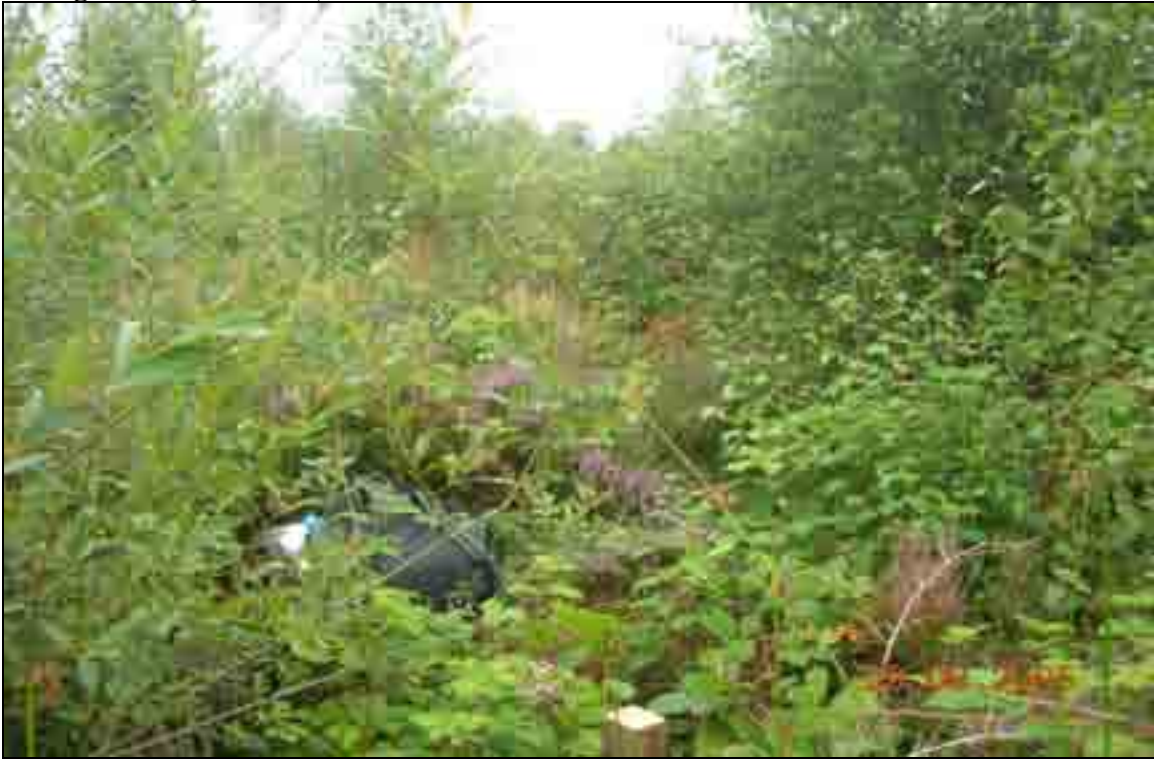
Ardagullion Quadrat 2, 2005

Quadrat 2: This quadrat is located on the south-east margin of Ardagullion and occurred within young conifer plantation with a ground cover containing Ling Heather, Bramble and *Hypnum* moss. This margin adjoined active peat-cutting and so drain- blocking was restricted. With the felling to waste of the conifers, it can be seen that Downy Birch, Bramble and Ling Heather cover increased. Over time, this dry bog margin will develop into wet birch woodland.

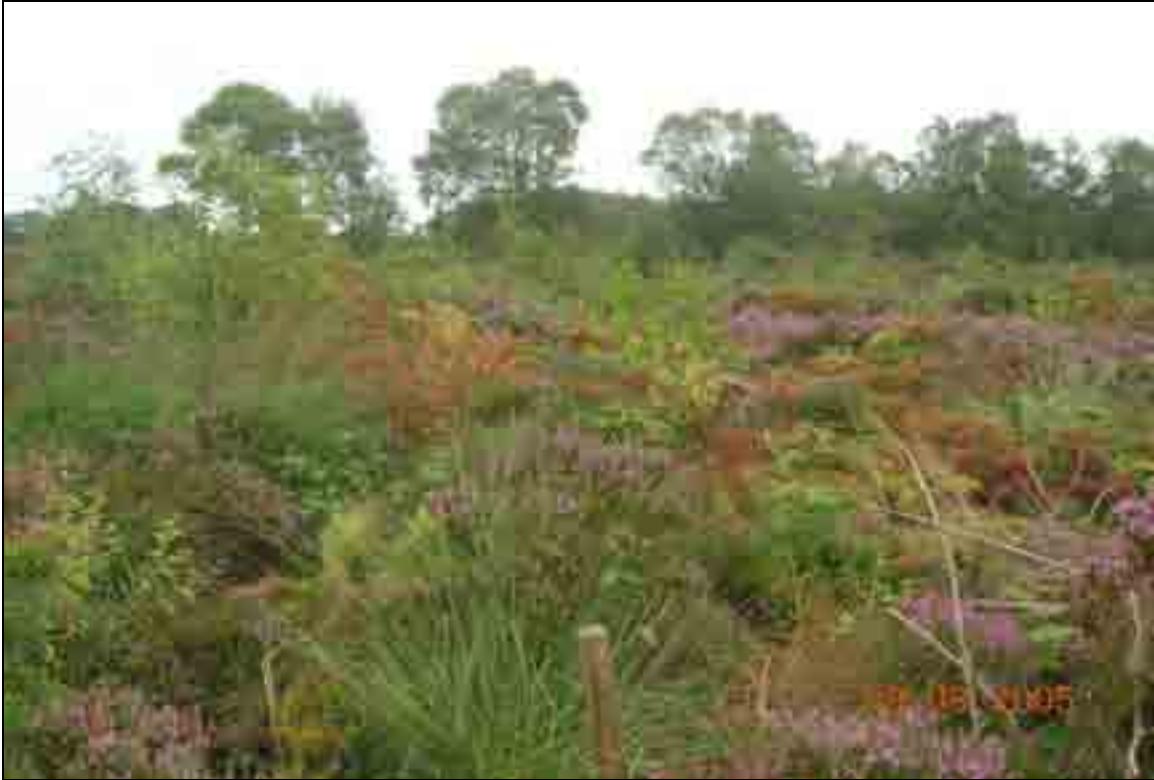
Ardagullion Quadrat 3, 2005

Quadrat 3: This quadrat is located towards on the southern margin of Ardagullion and occurred within young conifer plantation with a ground cover containing Ling Heather, Bilberry, Bramble and *Hypnum* moss. With the felling to waste of the conifers and blocking of drains, it can be seen that Downy Birch, Bramble and Ling Heather cover dominated. Over time, this bog margin will develop into wet birch woodland.

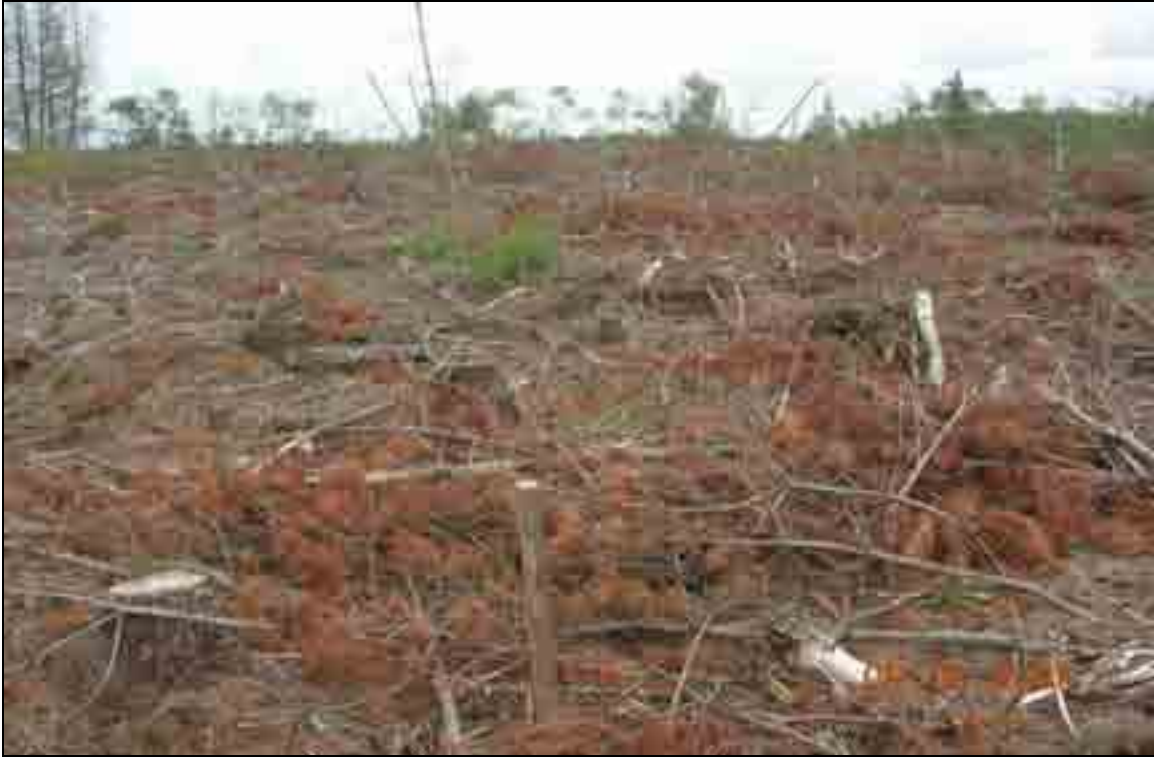
Ardagullion Quadrat 4, 2005

Quadrat 4: This quadrat is located towards the centre of the conifer plantation on the south-west margin of Ardagullion Bog and occurred under closed canopy conifers with a ground cover containing some *Sphagnum recurvum*, but mainly consisted of brash and pine needles. With the felling of the conifers and blocking of drains, it can be seen that Ling Heather and *Sphagnum* cover. Over time, if conditions remain wet, *Sphagnum* cover will increase further and active peat formation will occur.

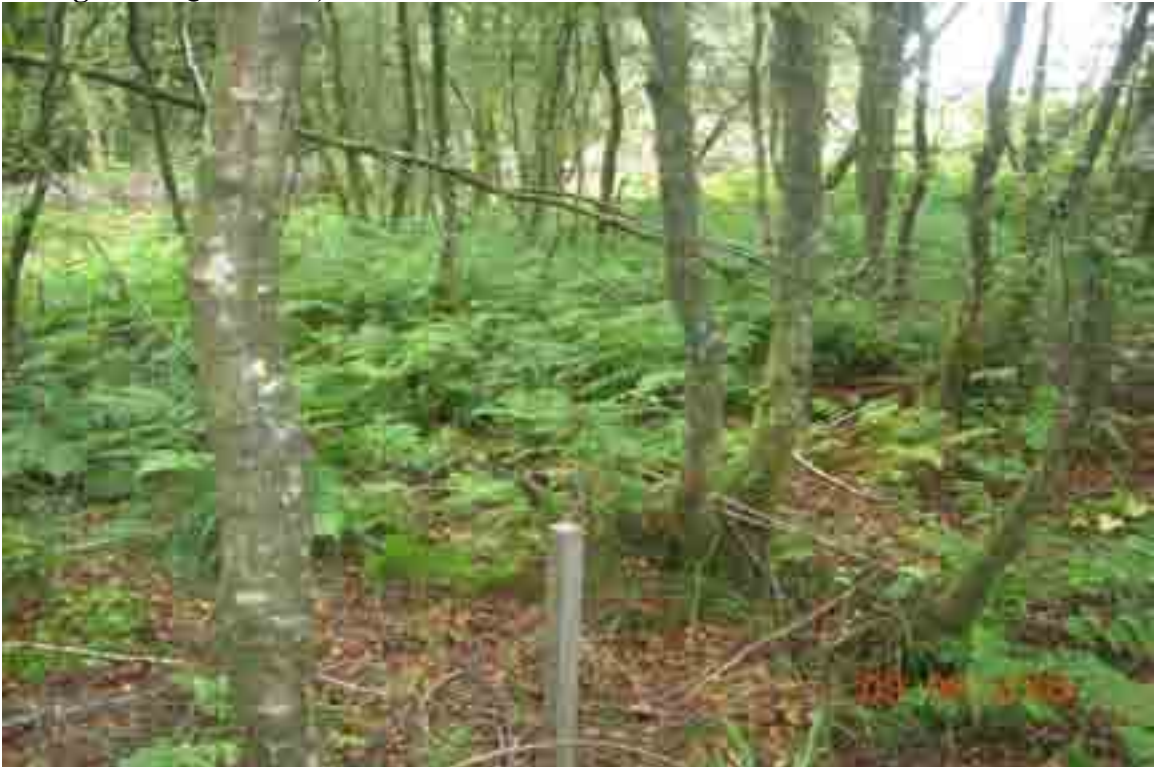
Ardagullion Quadrat 5, 2005

Quadrat 5: This quadrat is located towards the south-west margin of Ardagullion and occurred under closed canopy birch woodland with a ground cover containing Bracken, Tufted Hair-grass and *Sphagnum recurvum*. This area will be retained as birch woodland, which naturally occurs on raised bog margins.

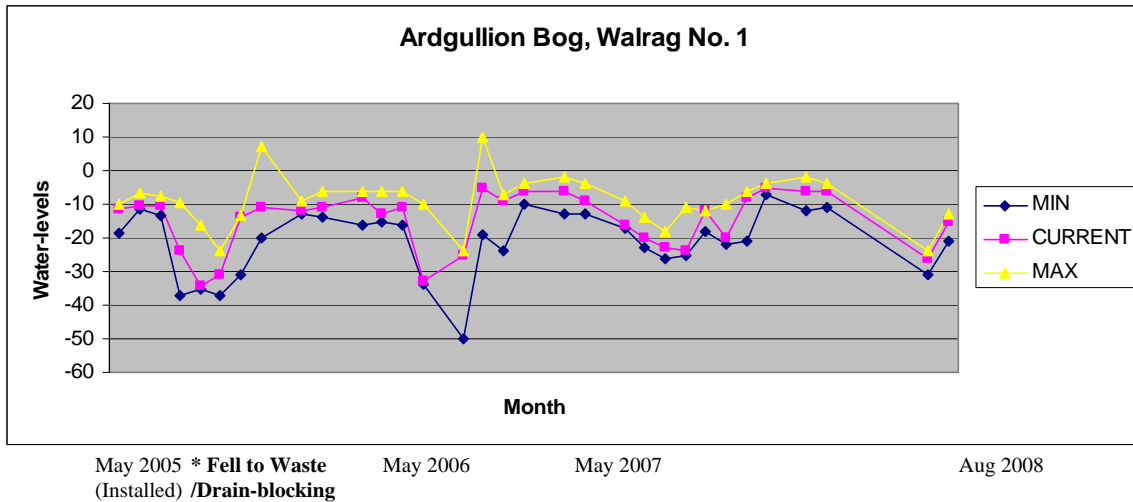
Ardgullion Bog Walrag 1: Fell to Waste on Cutover Bog (Water-levels remain below 10cm of bog surface post restoration*, due to shallow peat depth)

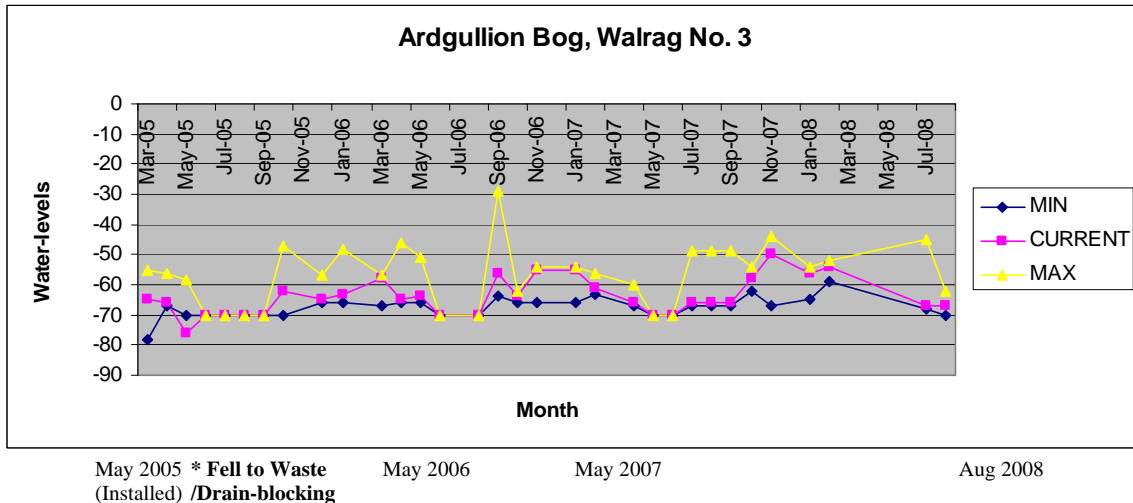
Ardgullion Bog Walrag 3: Fell to Waste on Cutover Bog (Water-levels remain 60cm below bog surface post restoration*, due to shallow peat depth)

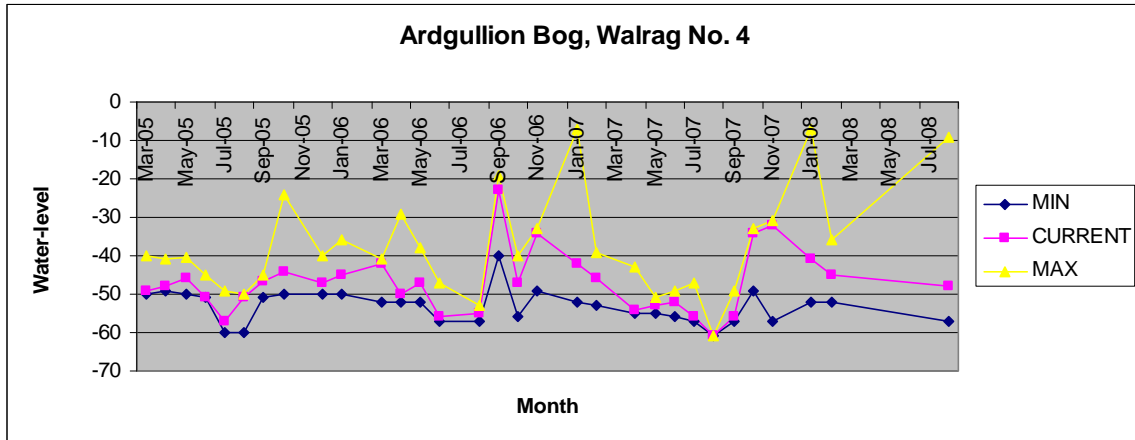
Ardgullion Bog Walrag 4: Fell to Waste on Cutover Bog (Water-levels remain 40cm below bog surface post restoration*, due to shallow peat depth)

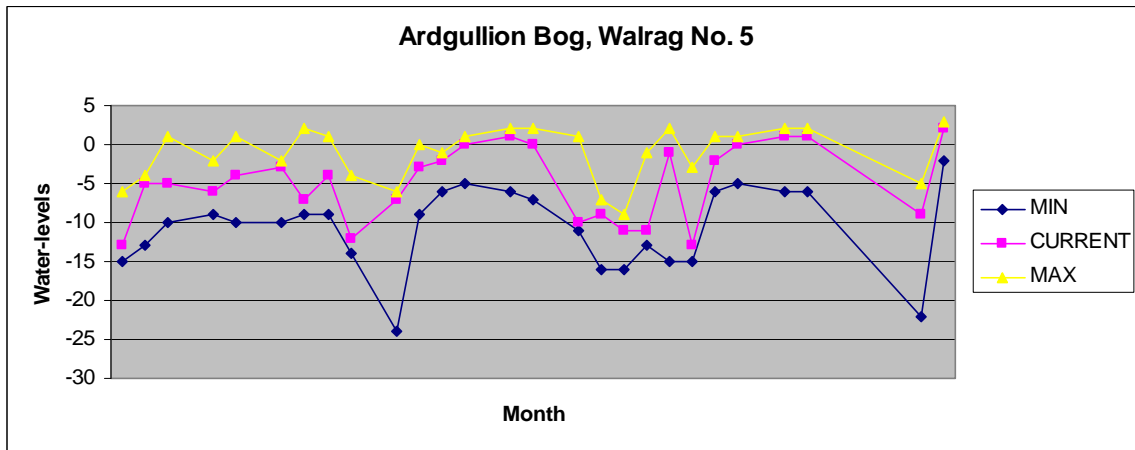
Ardgullion Bog Walrag 5: Clearfell on High Bog (Water-levels remain within 10cm of bog surface post restoration*, but decline in summer months)

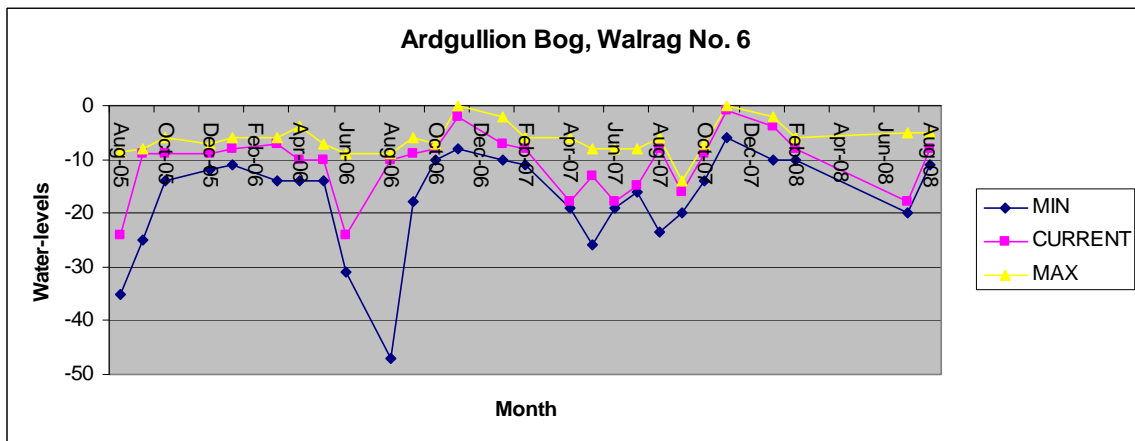
Ardgullion Bog Walrag 6: Open High Bog (Water-levels remain within 10cm of bog surface post restoration* on adjacent plantations, but a slight decline during summer months remains)

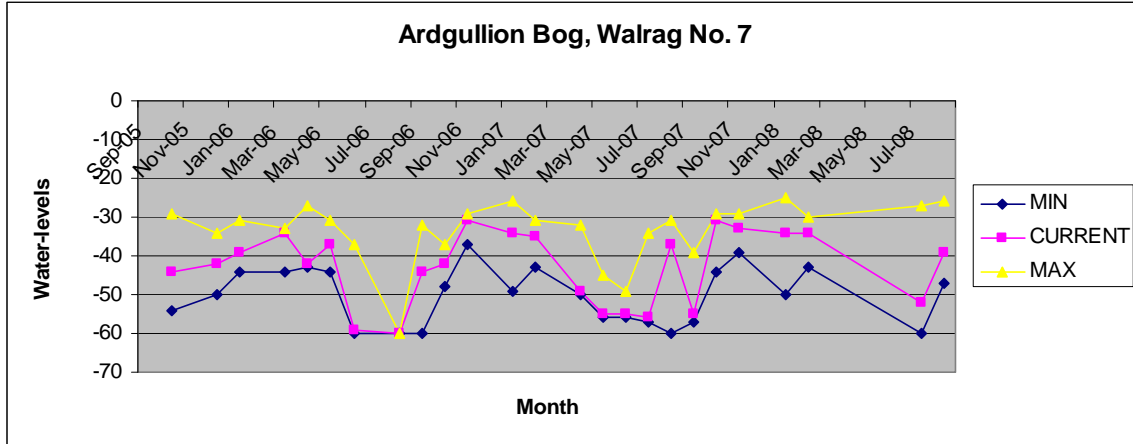
Ardgullion Bog Walrag 7: Fell to Waste on Cutover Bog

(Water-levels remain below 40cm of bog surface post restoration*, due to shallow peat depth)

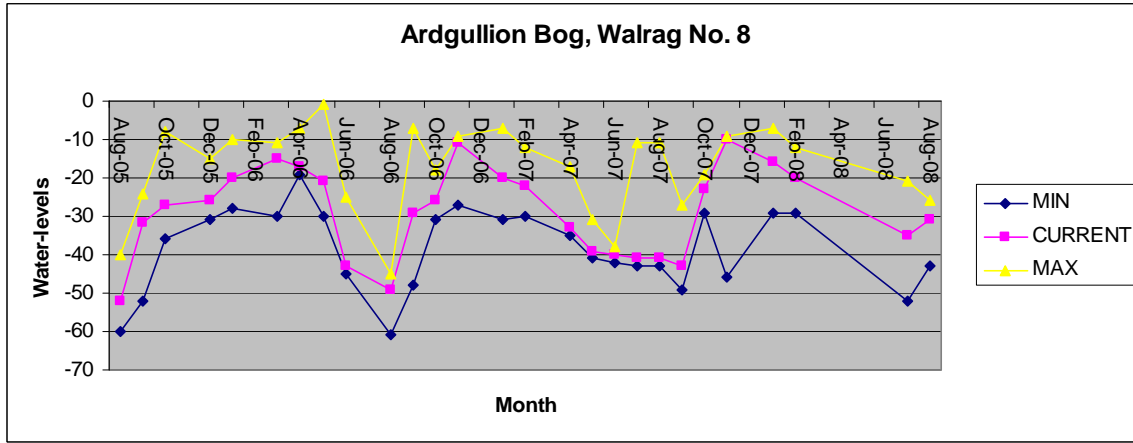
Ardgullion Bog Walrag 8: Fell to Waste on Cutover Bog

(Water-levels remain below 30cm of bog surface post restoration*, due to shallow peat depth)
