**RESTORING RAISED BOG IN IRELAND**  
**Project Reference: LIFE04 NAT/IE/000121**

**A REPORT ON THE RESTORATION OF PROJECT SITE No. 2**

**CAMDERRY BOG, Co. GALWAY**

**Compiled by: John Derwin,  
Project Ecologist,  
September 2008**

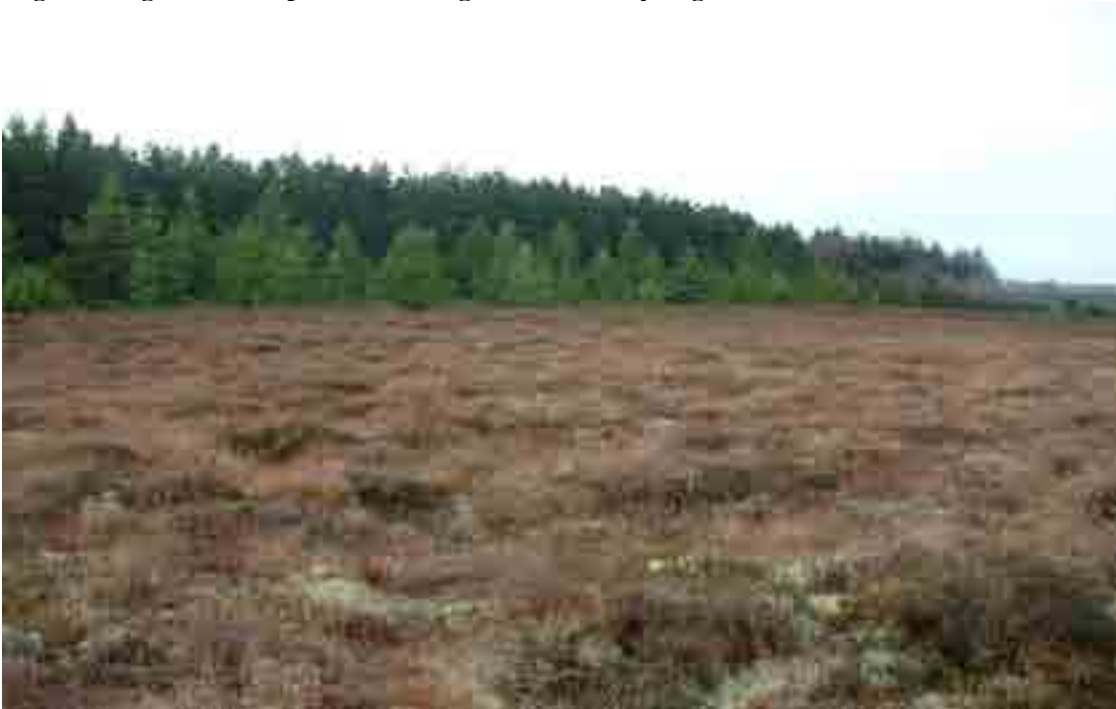
This large planted block adjoins intact raised bog dominated by species such as Ling Heather (*Calluna vulgaris*), Hare's tail Cotton-grass (*Eriophorum vaginatum*), Deer-grass (*Trichophorum cespitosum*) and Bog Asphodel (*Narthecium ossifragum*). Other frequent species include Bog Rosemary (*Andromeda polifolia*), Cross-leaved Heath (*Erica tetralix*), Common Cotton-grass (*Eriophorum angustifolium*), the lichen *Cladonia portentosa* and the mosses *Sphagnum capillifolium* and *S. papillosum*. This bog is wet in places and there are numerous bog pools on the high bog immediately to the south-east of the plantation. Immediately to the north of the main forestry block there is a zone (10-15m wide) of Lodgepole Pine regenerating on the bog (Conaghan, 2003).

### **Regenerating conifers at plantation margin on Camderry Bog**

At this site the main restoration measures undertaken were the clear-felling and removal of the mature conifer crop, wind-rowing of the remaining brash and blocking of drains with peat dams, to raise water-levels. Follow-up work included the control of the natural regeneration of conifer seedlings. Lodgepole pine regenerating on the open bog surface were also be felled as part of this project.

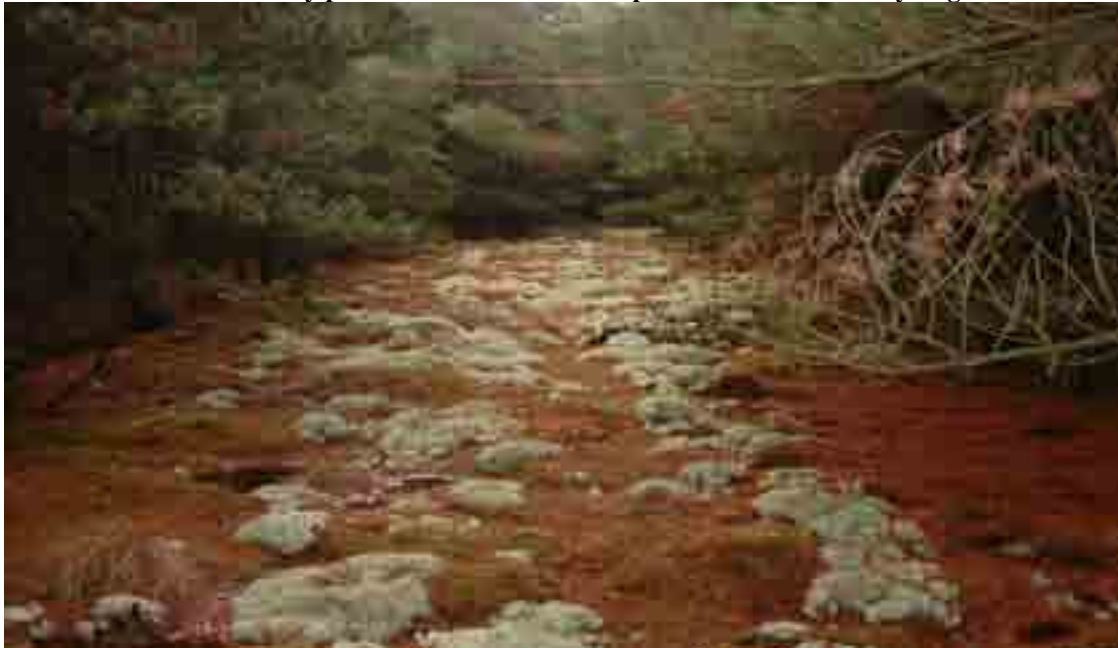
The vegetation of the project site was previously dominated by tall, closed-canopy coniferous plantation. As a result most of the ground flora was dominated by a thick layer of Lodgepole Pine needles with generally little bog vegetation present apart from scattered clumps of the mosses (mainly *Hypnum cupressiforme* and *Sphagnum capillifolium*). However, in the western half of the plantation where tree growth had not been as good and there were significant areas with a high cover of *Sphagnum* mosses and the lichen *Cladonia portentosa* (Conaghan, 2003).

#### **Ground flora dominated by pine needles under conifer plantation on Camderry Bog**

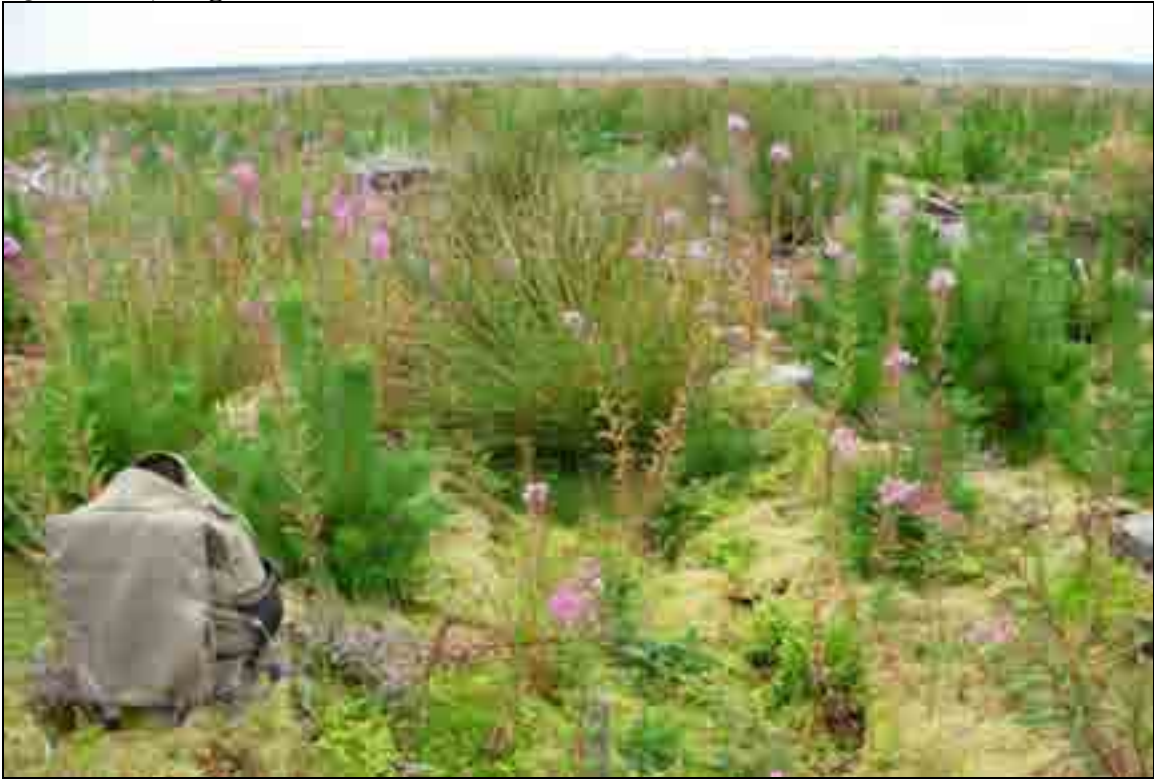
**Quadrat 1, Aug 2008**

**Quadrat 1:** This quadrat was located towards the southern margin of the plantation and occurred under closed canopy conifers with a ground cover containing *Hypnum* and some *Sphagnum* moss, but mainly consisted of pine needles. With the felling of the conifers and blocking of drains, it can be seen that Ling Heather, Cotton-grasses and *Sphagnum* cover increased along with Willow-herb. There is some natural regeneration of conifer seedlings, which needs to be controlled. Over time, if conditions remain wet, *Sphagnum* cover will increase further, Willow-herb will die out and raised bog habitat will be established.

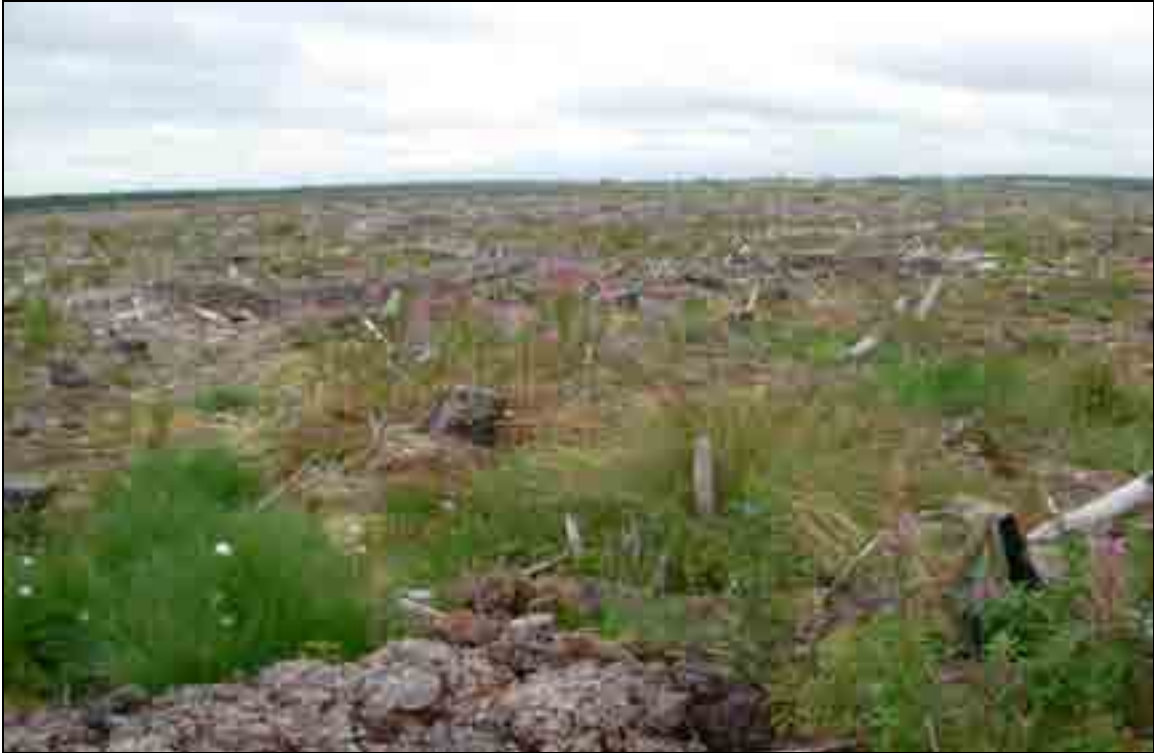
**Quadrat 2, Aug 2008**

**Quadrat 2:** This quadrat was located towards the centre of the plantation and occurred under closed canopy conifers with a ground cover containing some *Sphagnum* moss, but mainly consisted of pine needles and brash. With the felling of the conifers and blocking of drains, it can be seen that Ling Heather, Cotton-grass and *Sphagnum* cover increased along with Willow-herb. There is some natural regeneration of conifer seedlings, which needs to be controlled. Over time, if conditions remain wet, *Sphagnum* cover will increase further, Willow-herb will die out and raised bog habitat will be established.

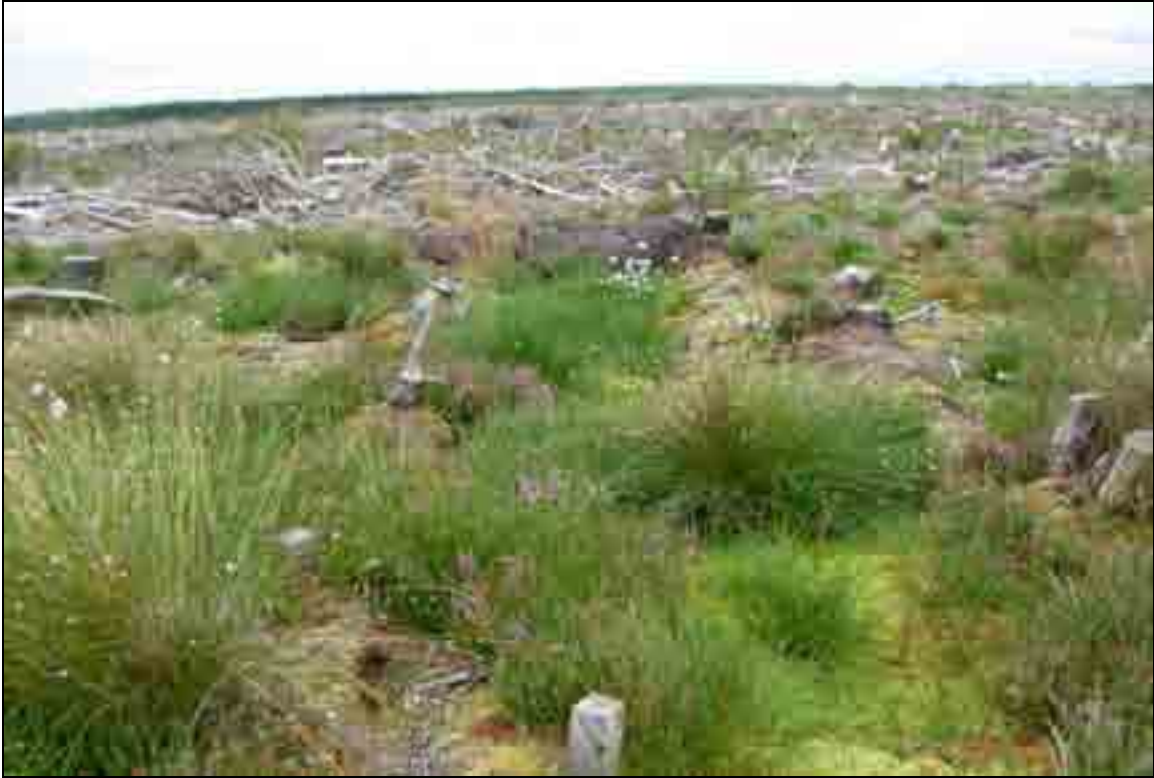
**Quadrat 3, Aug 2008**

**Quadrat 3:** This quadrat was located towards the northern margin of the plantation and occurred under closed canopy conifers with a ground cover containing some *Sphagnum* moss, but mainly consisted of pine needles and brash. With the felling of the conifers and blocking of drains, it can be seen that Ling Heather, Cottongrass and *Sphagnum* cover increased. Over time, if conditions remain wet, *Sphagnum* cover will increase further and active raised bog habitat will be established.

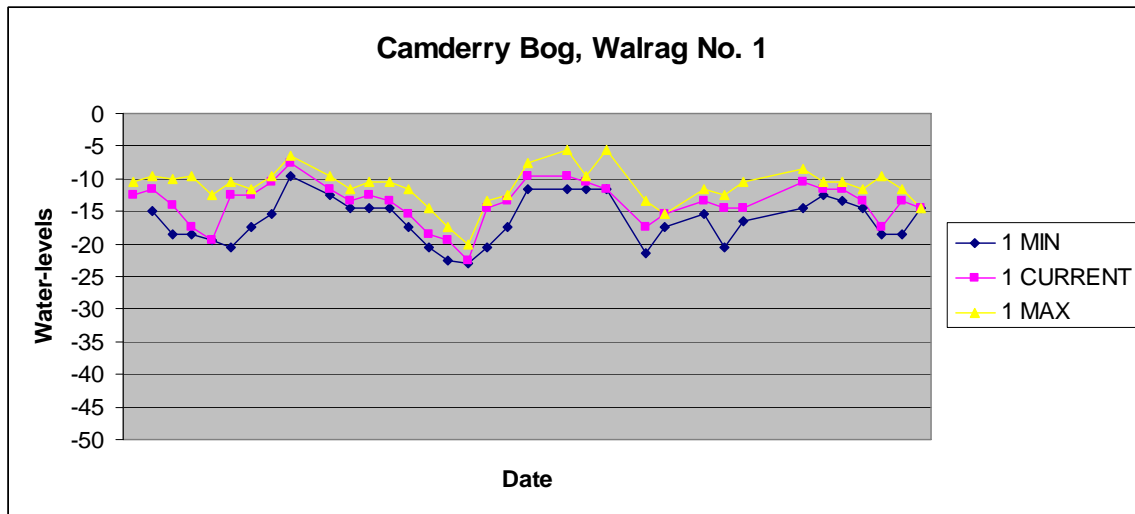
### Camderry Bog Walrag 1

(Clearfell on High Bog, water-levels 10cm below surface post restoration\*, lower in summer)

May 2005 (Installed) \*  
\*Clearfell & Drain-blocking

Prior to restoration, Walrags were installed in the conifer plantation to record any changes in water-levels, due to tree removal and drain blocking. With the removal of conifers and drain-blocking, water-levels were found to be maintained within **10cm** of the bog surface. The water-table within the project site remains close to the bog surface throughout most of the year, which will allow active raised bog habitat to establish.

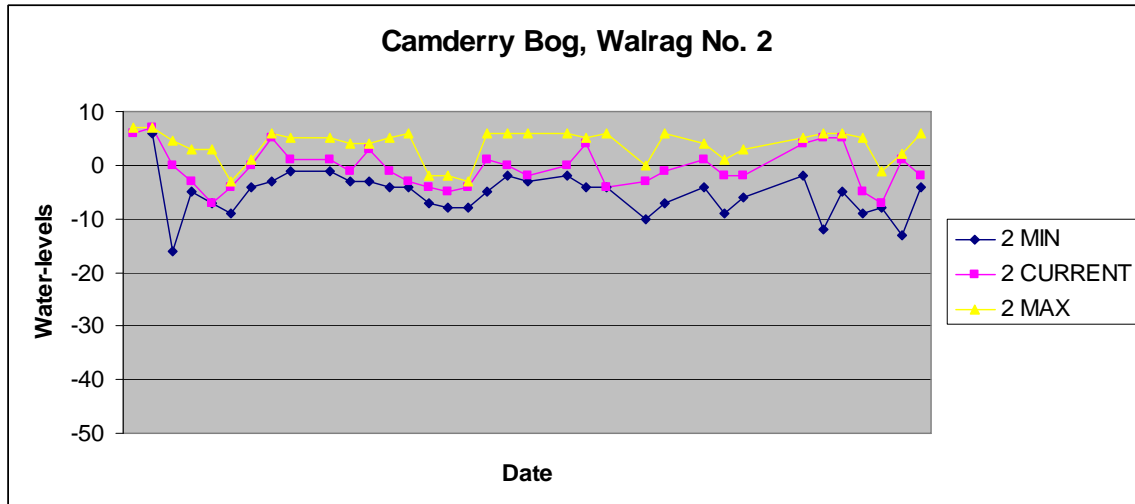
### Camderry Bog Walrag 2

(Clearfell on High Bog, water-levels within 10 cm of bog surface post restoration\*, lower in summer)

May 2005 (Installed) \*  
\*Clearfell & Drain-blocking

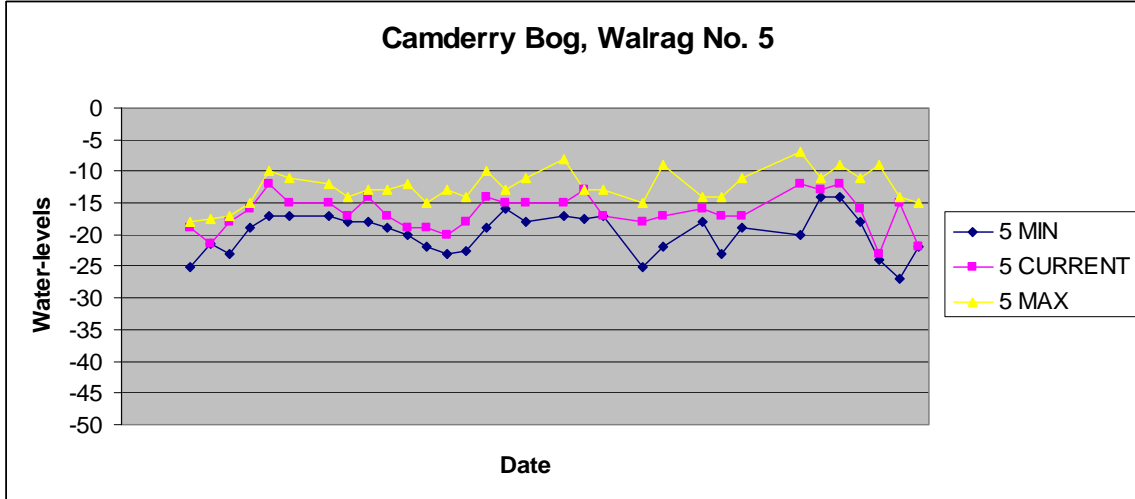
### Camderry Bog Walrag 5

(Clearfell on High Bog, water-levels below 10cm post restoration\*, lower in summer)

May 2005 (Installed) \*  
 \*Clearfell & Drain-blocking

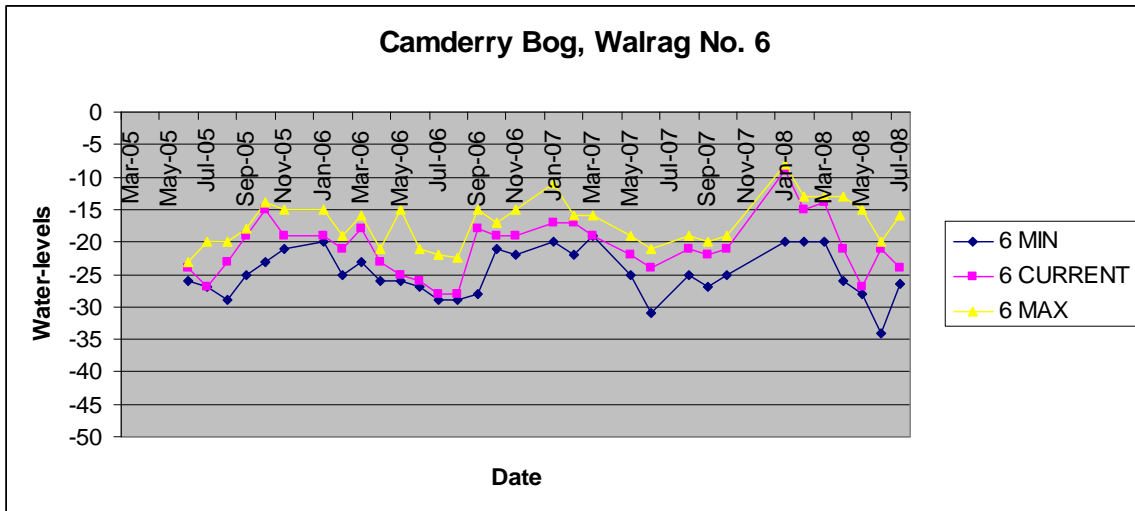
### Camderry Bog Walrag 6

(Clearfell on High Bog, water-levels below 10cm post restoration\*, lower in summer)

May 2005 (Installed) \*  
 \*Clearfell & Drain-blocking

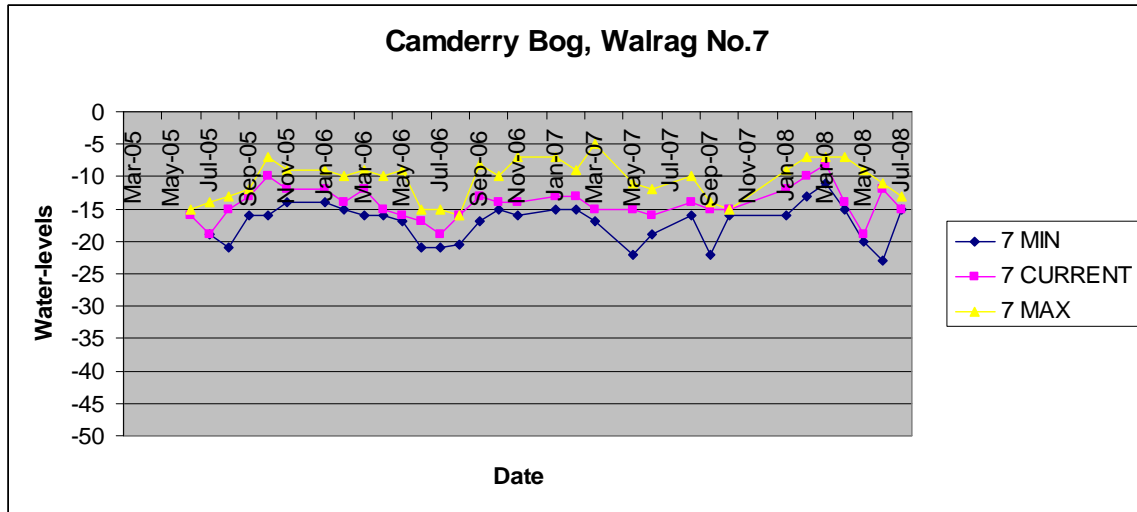
### Camderry Bog Walrag 7

(Clearfell on High Bog, water-levels below 10cm post restoration\*, lower in summer)

May 2005 (Installed) \*                      May 2006                      May 2007                      May 2008  
 \*Clearfell & Drain-blocking

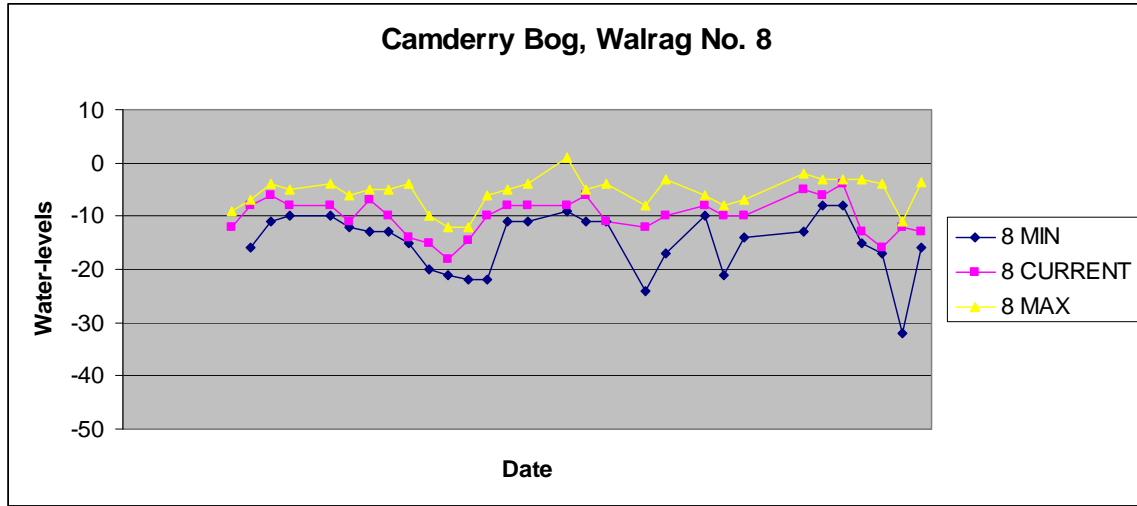
### Camderry Bog Walrag 8

(Clearfell on High Bog, water-levels at 10cm below bog surface post restoration\*, lower in summer)

May 2005 (Installed) \*                      May 2006                      May 2007                      May 2008  
 \*Clearfell & Drain-blocking
