**RESTORING RAISED BOG IN IRELAND**  
**Project Reference: LIFE04 NAT/IE/000121**

**A REPORT ON THE RESTORATION OF PROJECT SITE No. 11**

**CARN PARK BOG, Co. WESTMEATH**

**Compiled by: John Derwin,  
Project Ecologist,  
September 2008**

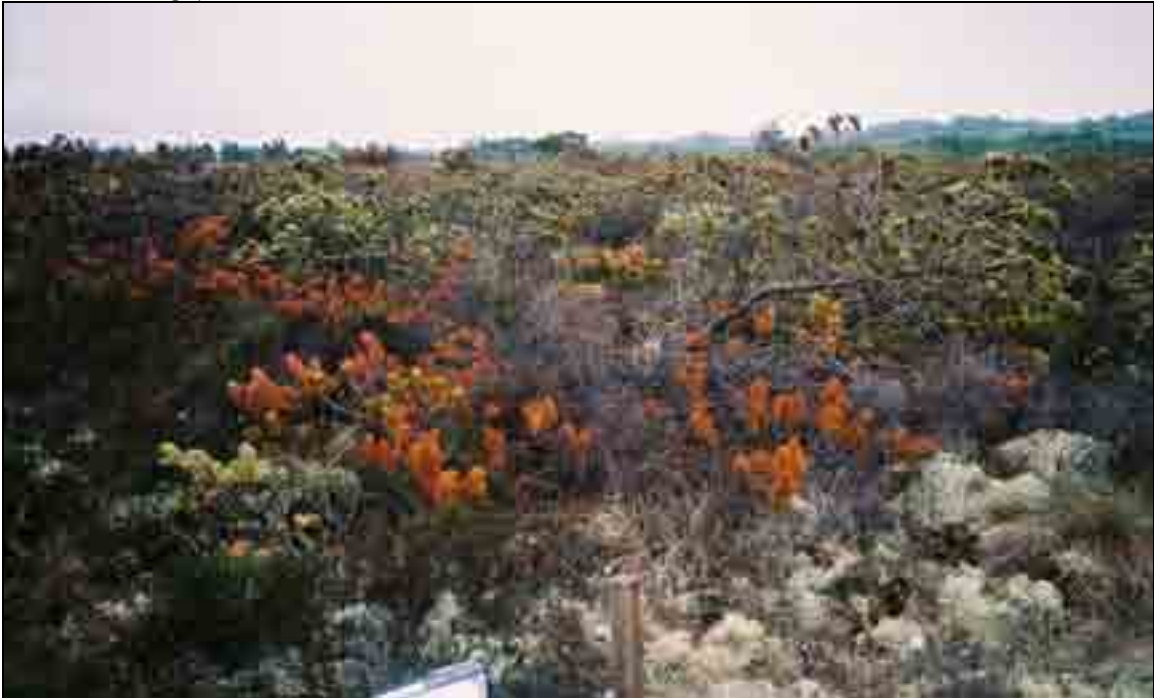
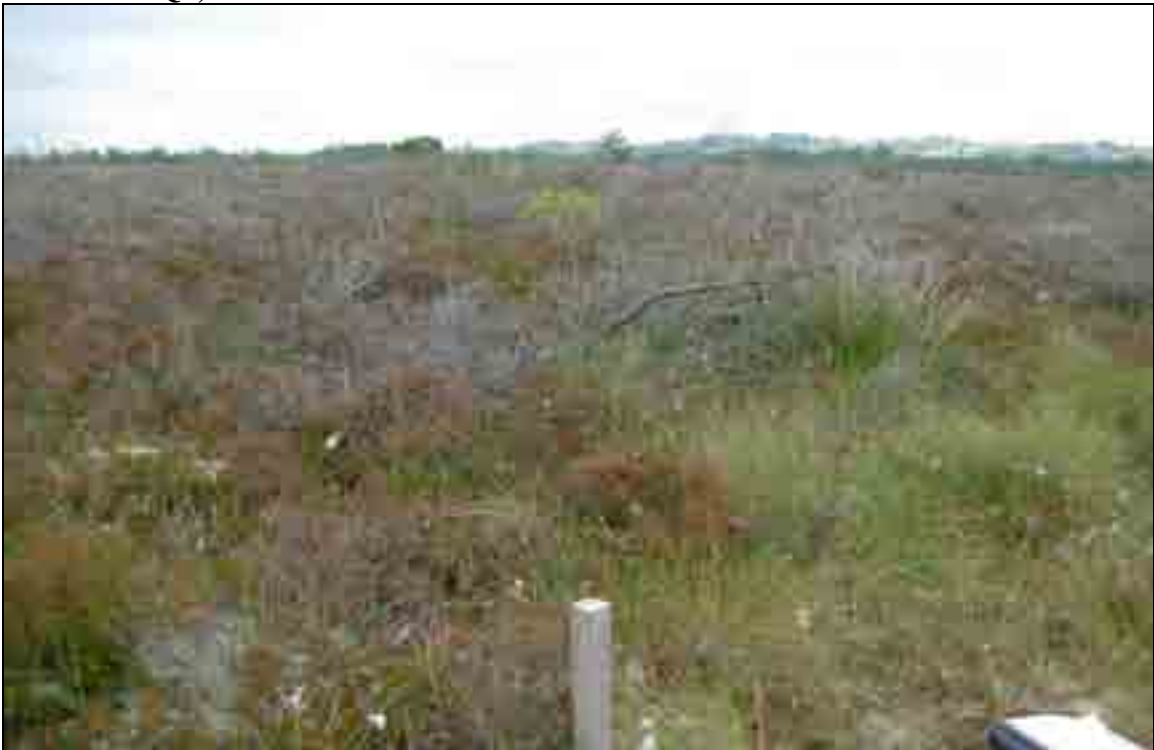
**Carn Park Q1, 2006**

**Carn Park Quadrat 1:** This quadrat is located at the northern margin of a failed plantation on the south-east margin of the high bog. Ling Heather, Hare's-tail Cottongrass

and *Sphagnum* moss dominate the open groundflora. With the felling of conifers, raised bog vegetation will recover and active raised bog habitat may be established if water-levels remain high.

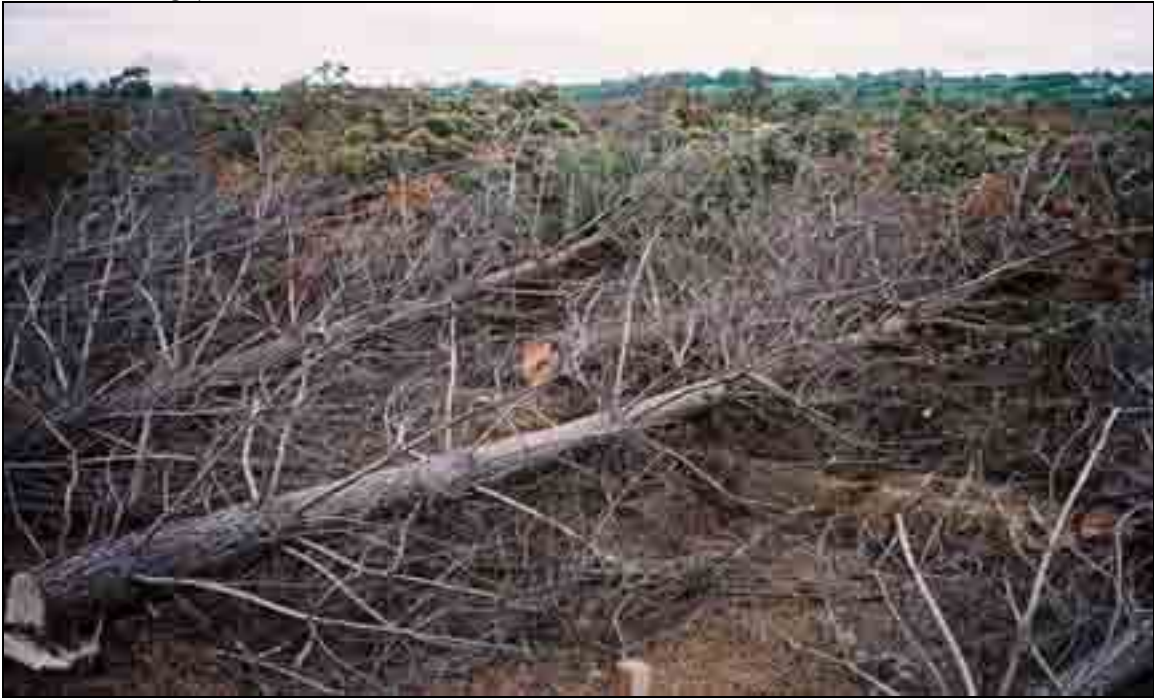
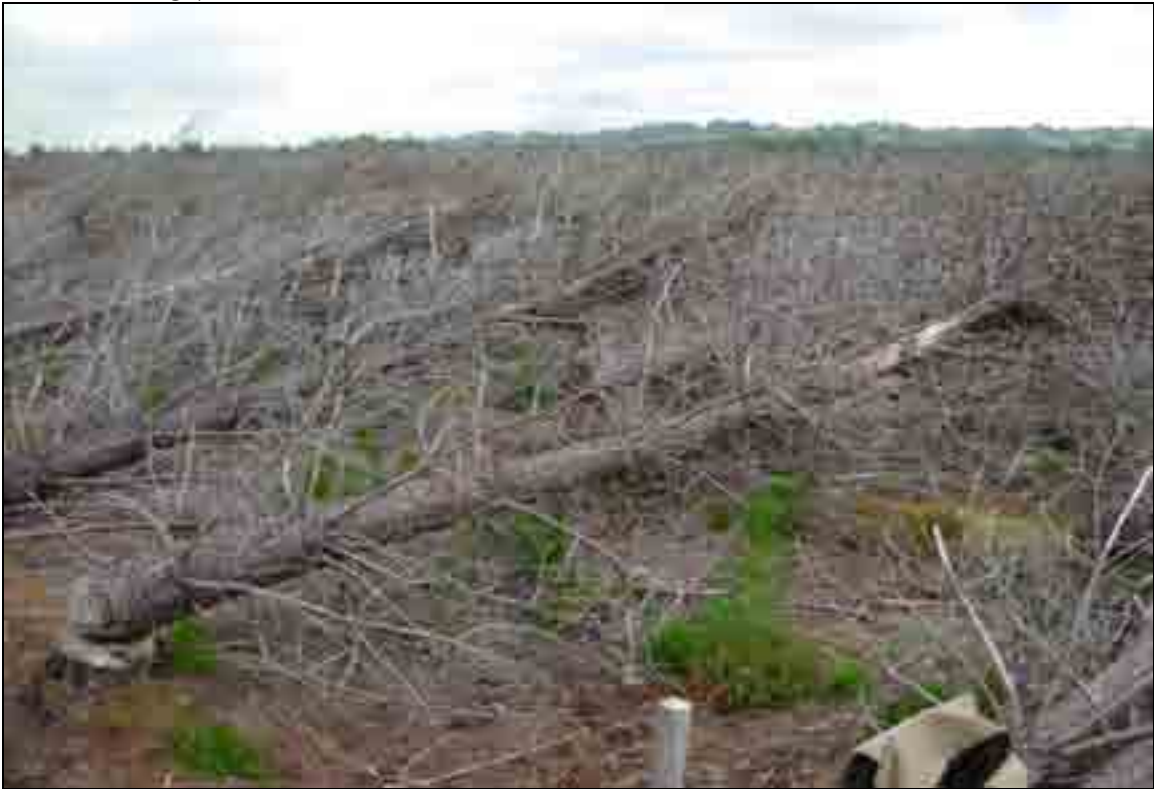
**Carn Park Q2, 2006**

**Carn Park Quadrat 2** is located under closed canopy conifer plantation to the south-east of the high bog. The groundflora is sparse with some *Hypnum* moss and is mainly dominated by pine needles. With the felling to waste of conifers, bog vegetation of Ling Heather and Crossed-leaved Heath is becoming established. Over time if conditions remain wet, *Sphagnum* moss will also recolonise.

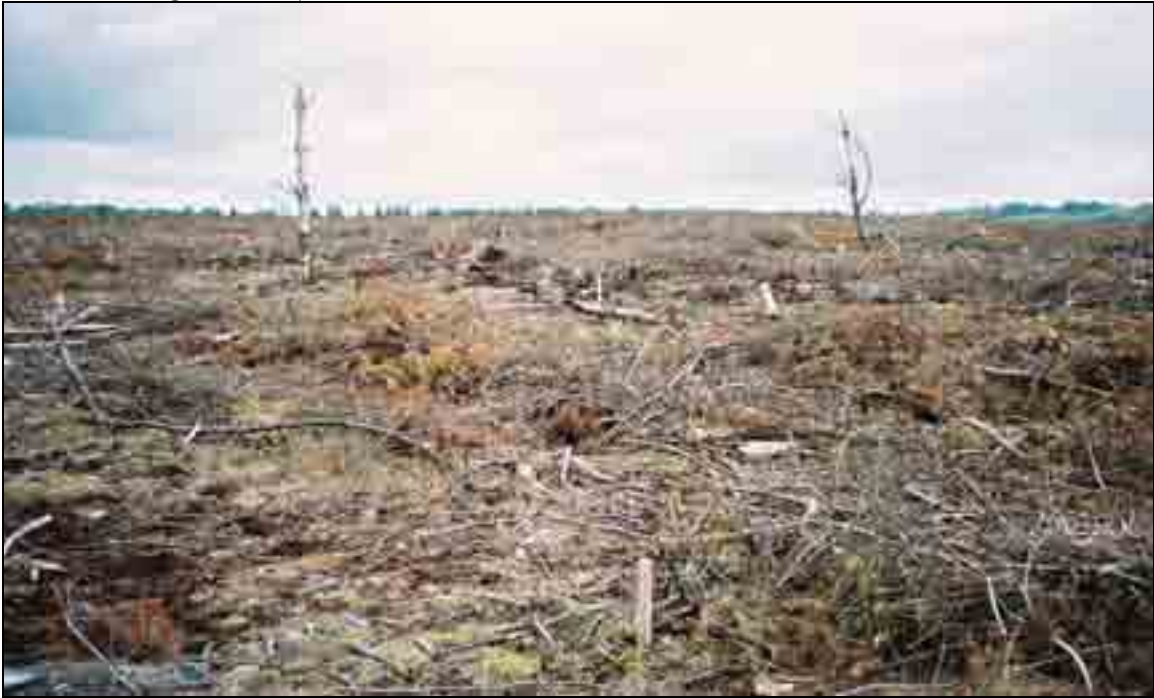
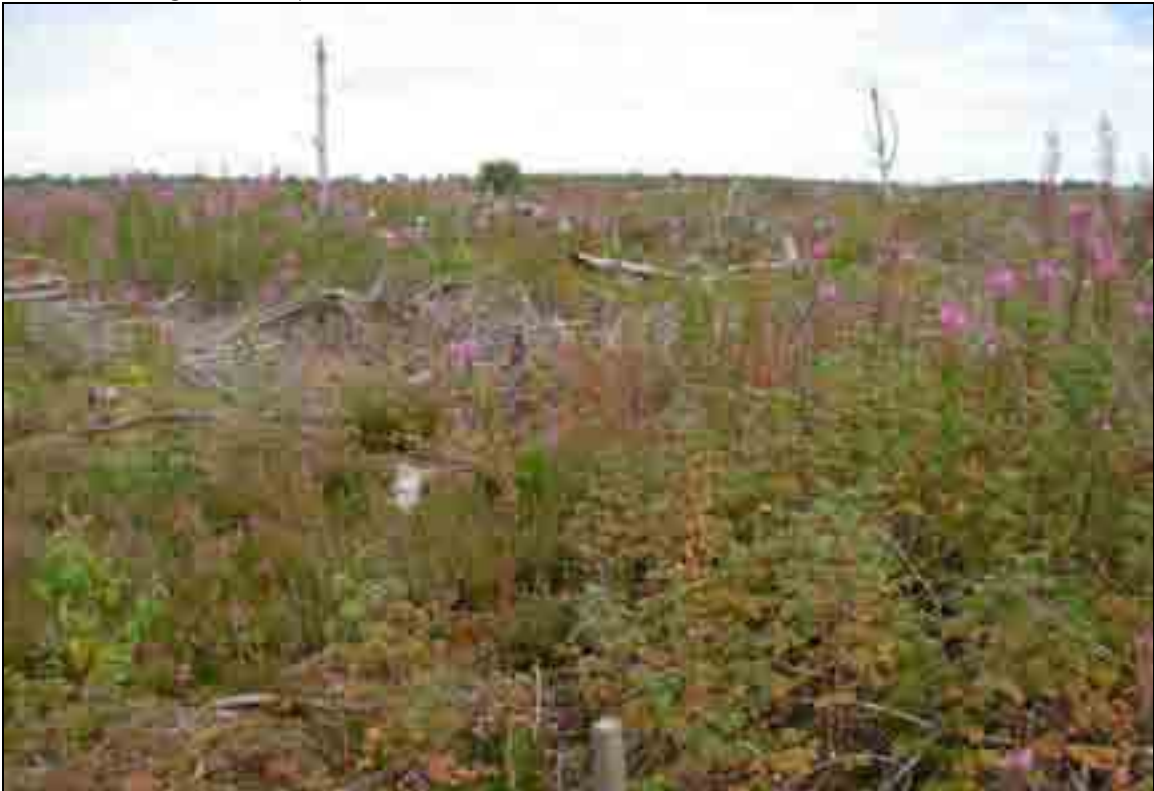
**Carn Park Quadrat 3, 2006**

**Carn Park Quadrat 3** is located on closed canopy conifer plantation to the south-west of the high bog. The groundflora consisted of Bramble and Willow-herb with abundant *Hypnum* moss. With the clear-felling of conifers and blocking of drains Bramble and Willow-herb cover increased, but Ling Heather and *Sphagnum* moss also became established. Over time if water-levels remain high raised bog vegetation will occur.

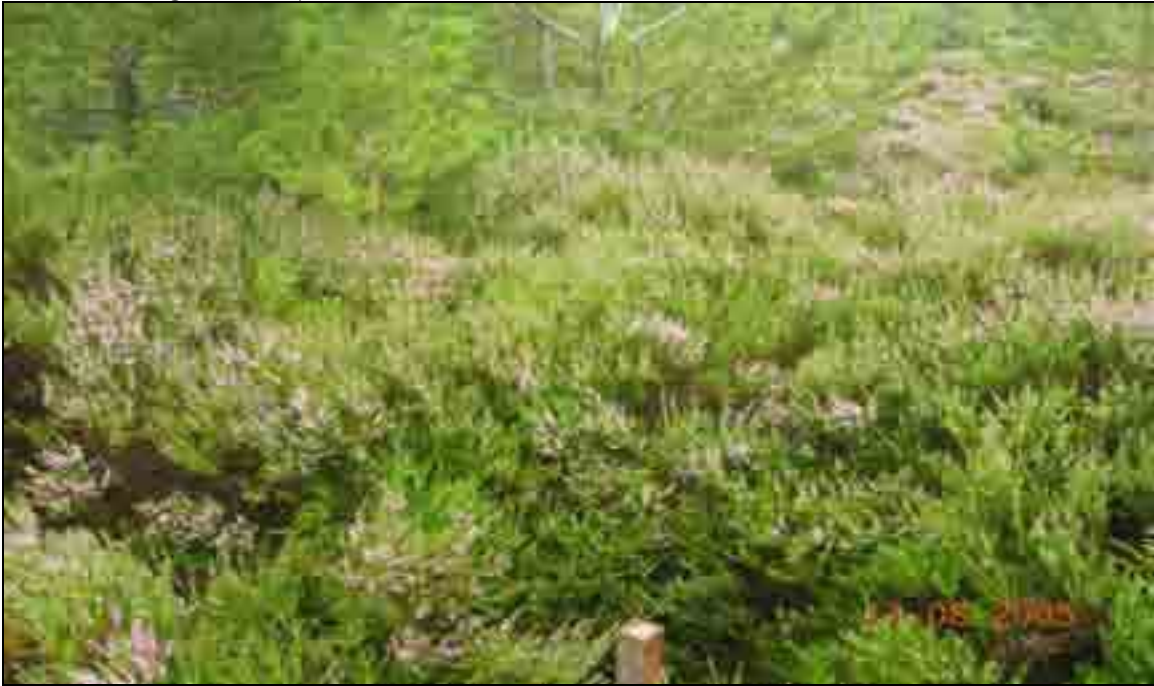
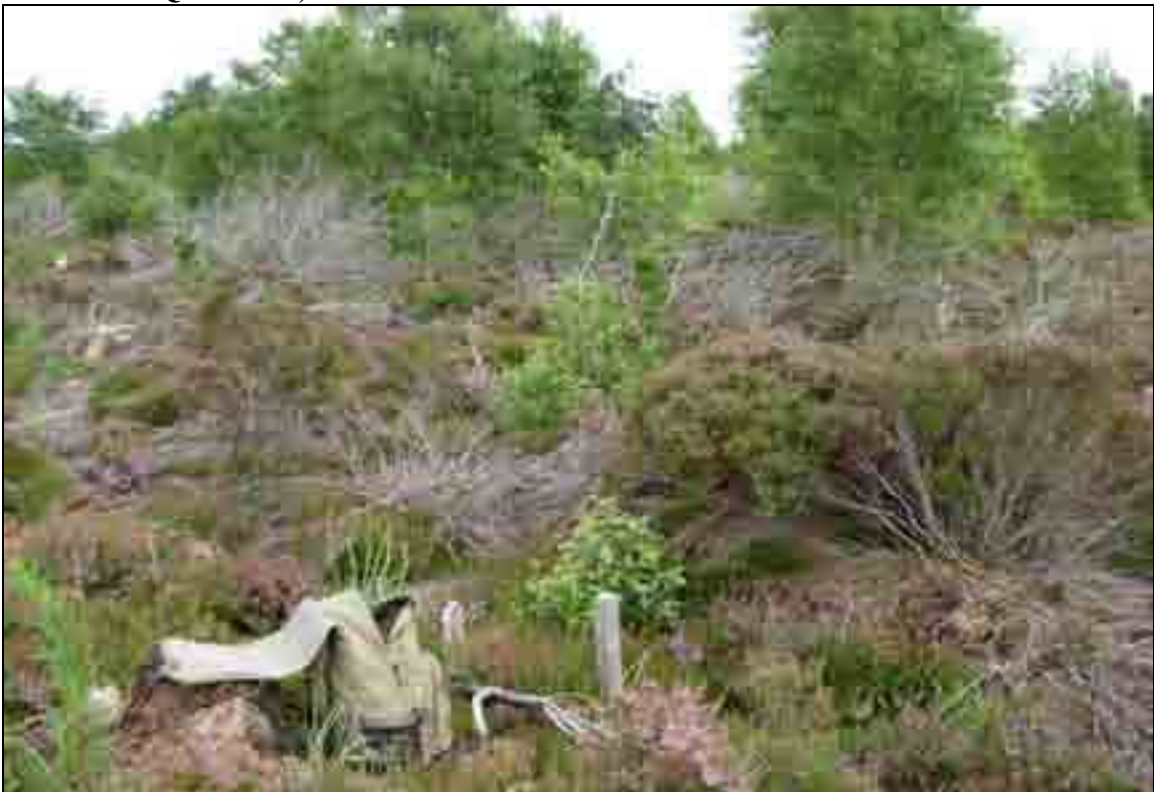
**Carn Park Quadrat 4, 2005**

**Carn Park Quadrat 4** is located in a young conifer plantation on cutover bog to the north-east of the site. The groundflora is dominated by Ling Heather with abundant *Hypnum* moss. With the felling to waste of conifers and blocking of drains, wet birch woodland with a groundflora of raised bog vegetation will become established on this bog margin.

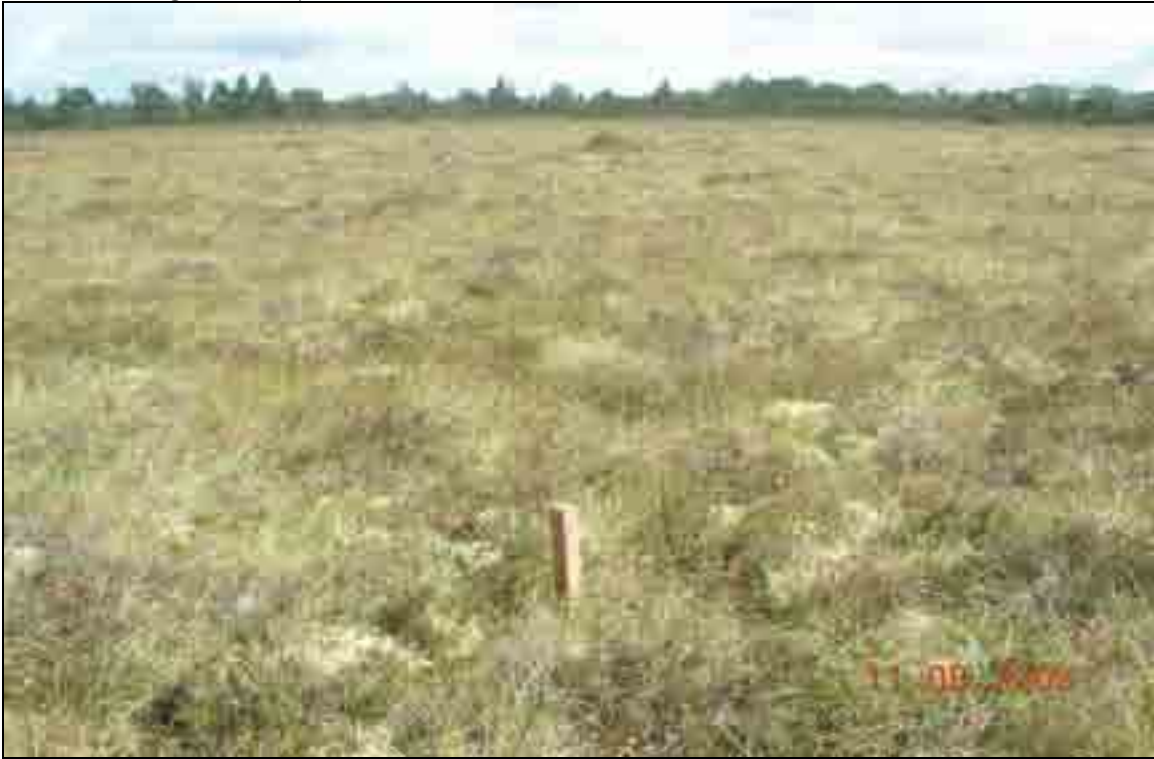
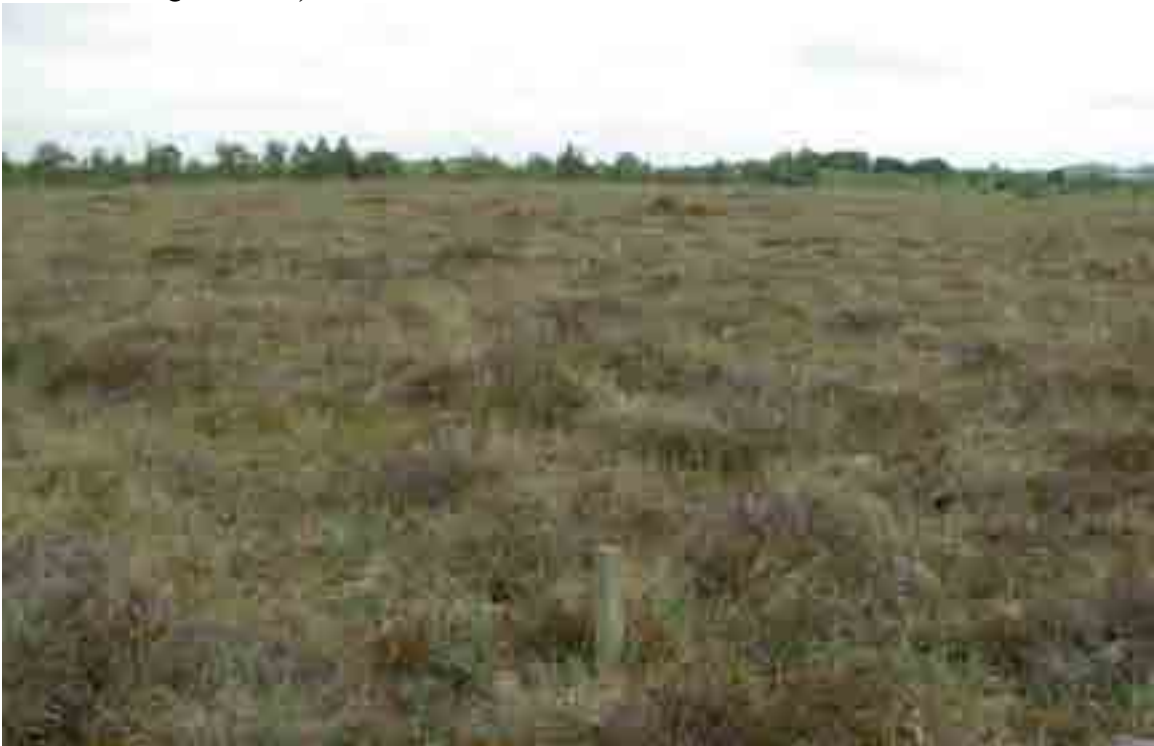
**Carn Park Quadrat 5, 2005**

**Carn Park Quadrat 5** is located on open high bog to the east of the raised bog. The vegetation is dominated by raised bog habitat of Ling Heather, Cross-leaved Heath, Hare's-tail Cotton-grass and Carnation Sedge with abundant *Sphagnum* moss. With the restoration measures on adjacent plantations, this raised bog habitat will be protected from further water-loss and over time may regenerate into active raised bog.

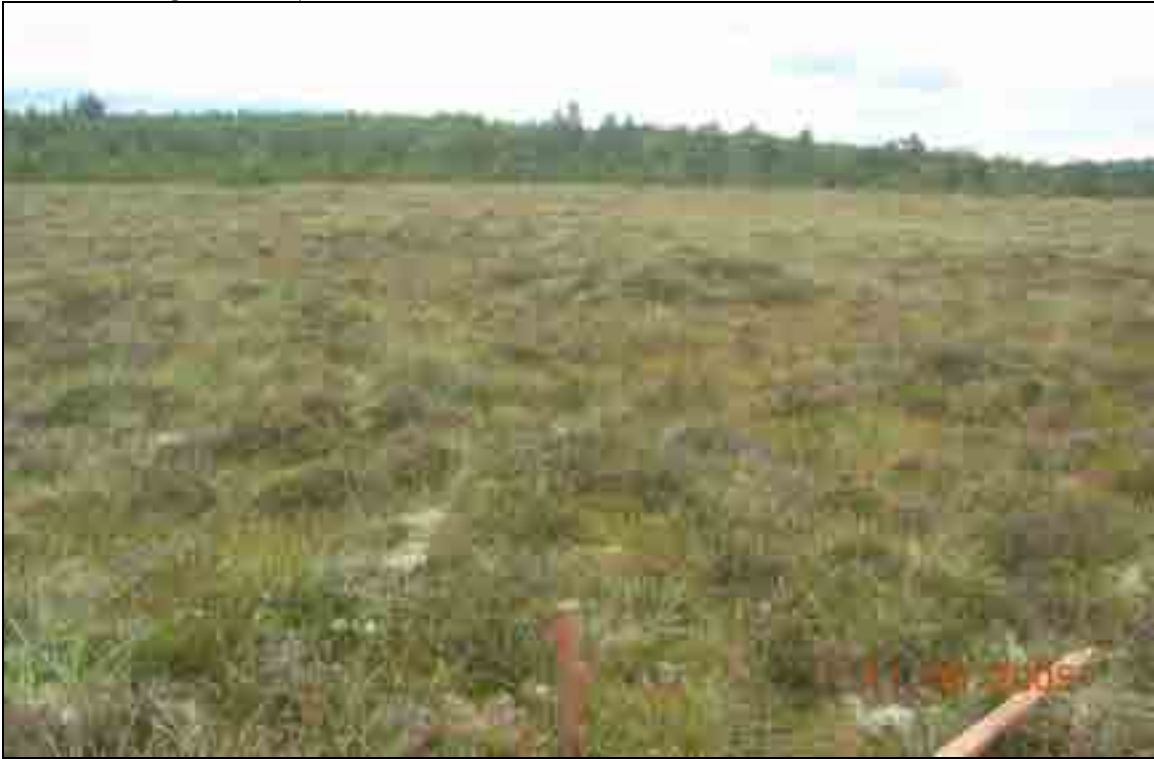
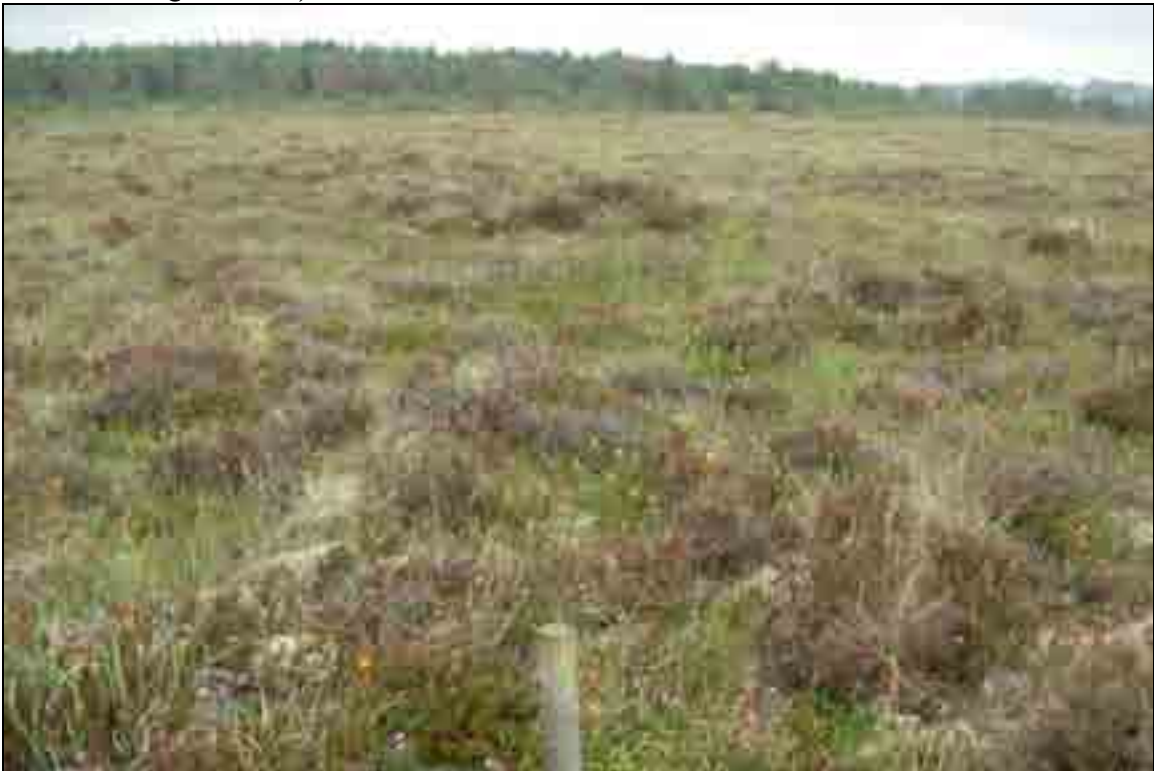
**Carn Park Quadrat 6, 2005**

**Carn Park Quadrat 6** is located on open high bog to the north of the raised bog. The vegetation is dominated by raised bog habitat of Ling Heather, Bog Asphodel, Hare's-tail Cotton-grass and Carnation Sedge with *Sphagnum* moss. With the restoration measures on adjacent plantations, this raised bog habitat will be protected from further water-loss and over time may regenerate into active raised bog.

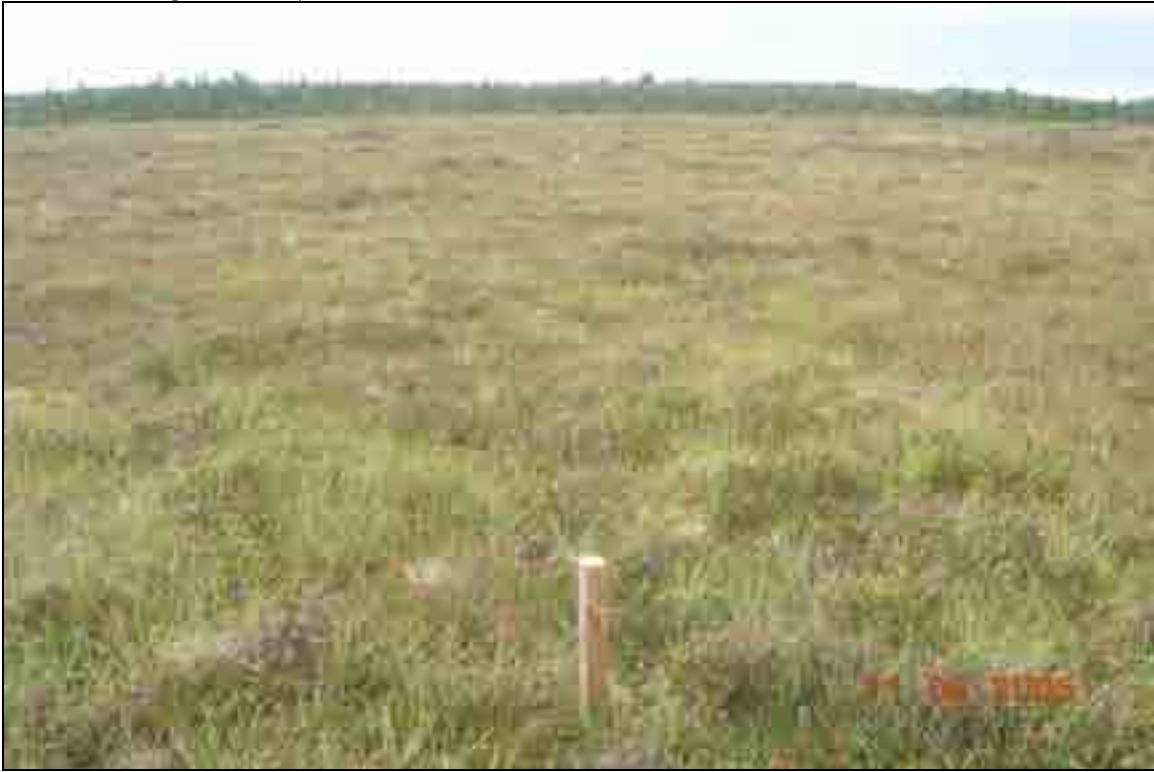
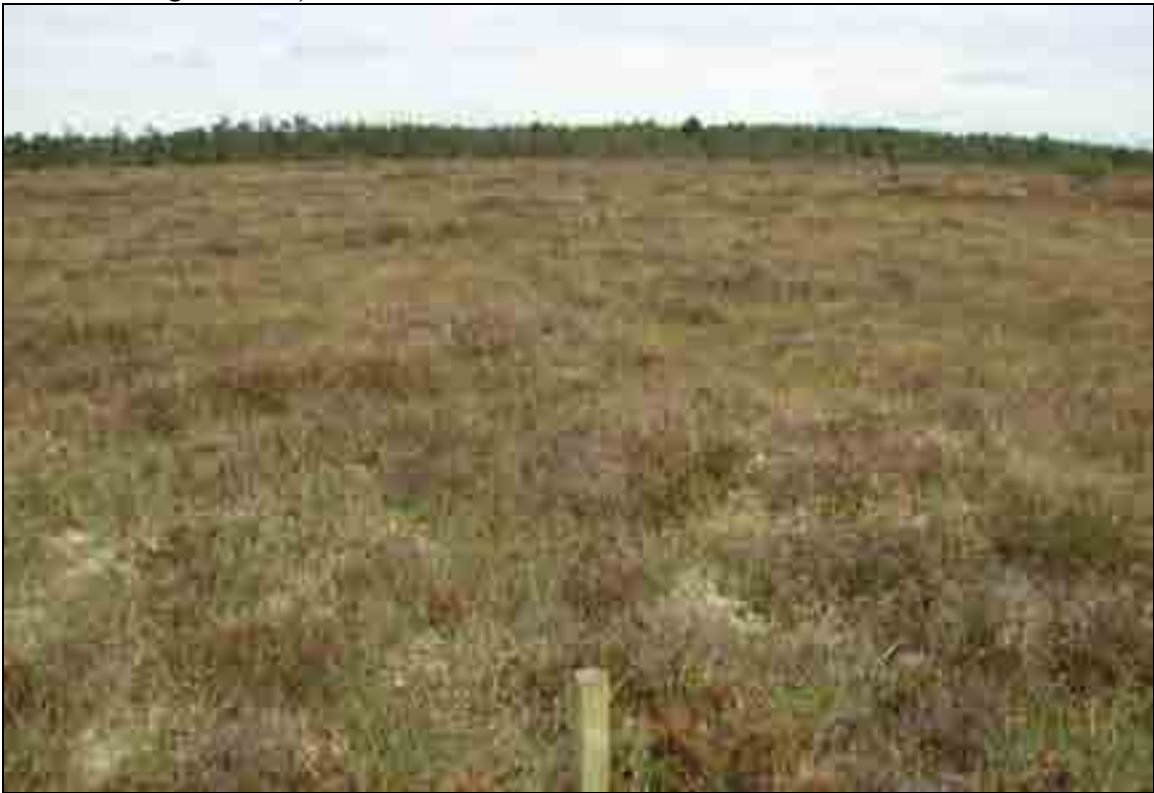
**Carn Park Quadrat 7, 2005**

**Carn Park Quadrat 7** is located on quaking high bog to the centre of the raised bog. The vegetation is dominated by raised bog habitat of Ling Heather, Crossed-leaved Heath, Hare's-tail Cotton-grass and Carnation Sedge with abundant *Sphagnum* moss. With the restoration measures on adjacent plantations, this active raised bog habitat will be protected from further water-loss.

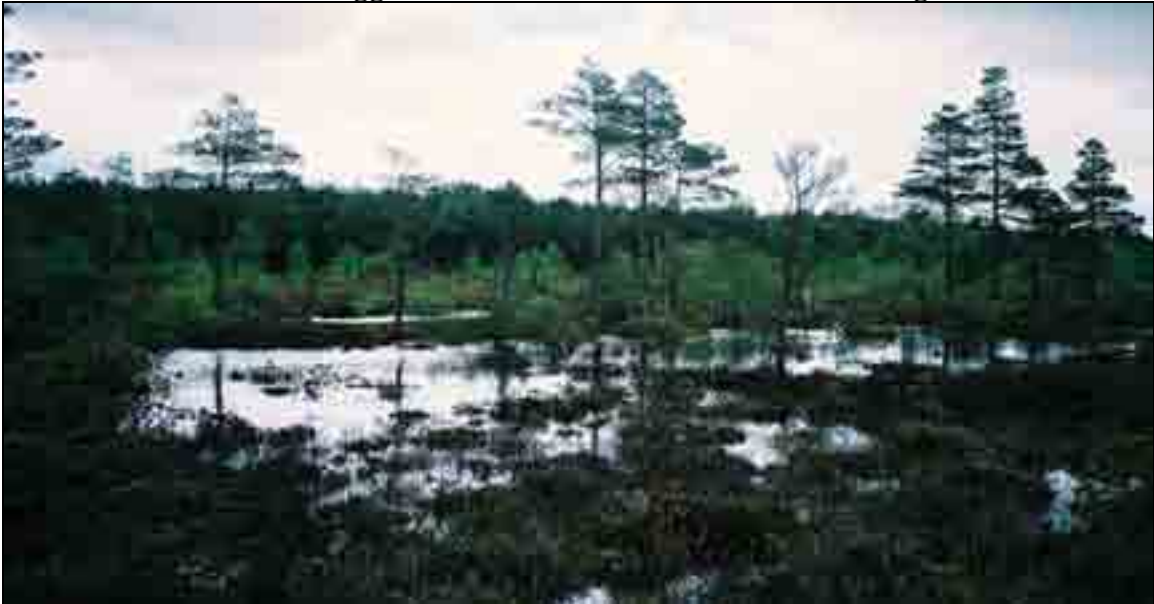
Prior to restoration, Walrags were installed in the conifer plantation and adjoining open bog, to record any changes in water-levels, due to tree removal and drain blocking. Water-levels were found to be up to **60cm** below the surface under mature conifer plantations, but remained close to the surface on the open bog. With the removal of conifers and drain-blocking, there was a significant rise in the water-table within the project site. Extensive areas of open water were created at the lagg zone to the north and cutover bog to the south and the water-table remains close to the bog surface throughout most of the year.

### **Raised water-levels on Lagg zone at Carn Park after drain-blocking**

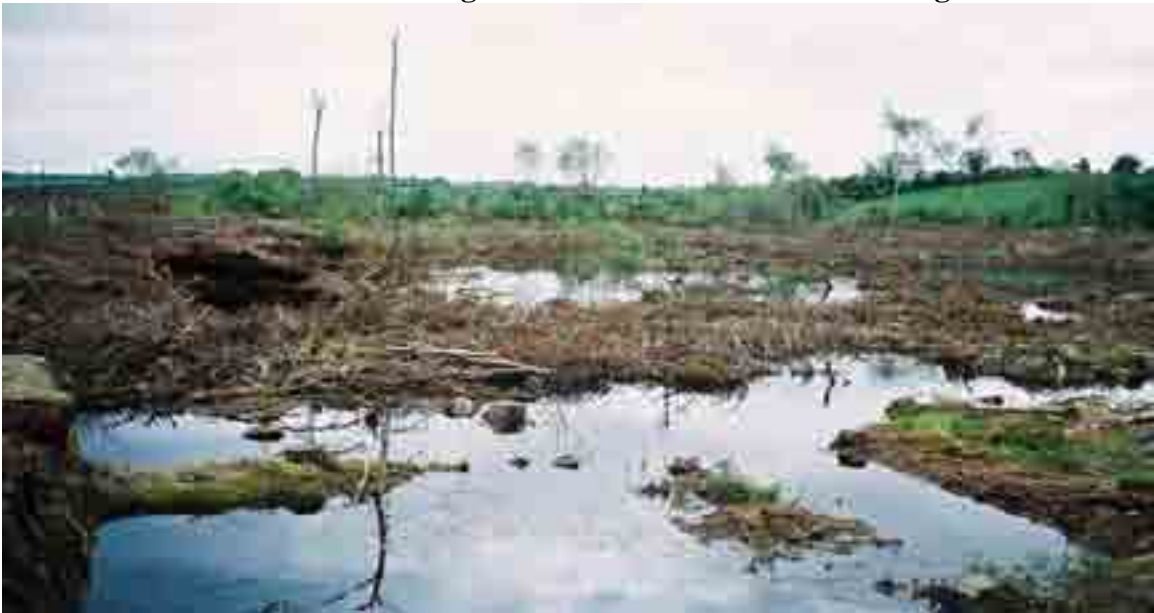
### **Raised water-levels on cutover bog at Carn Park after drain-blocking**

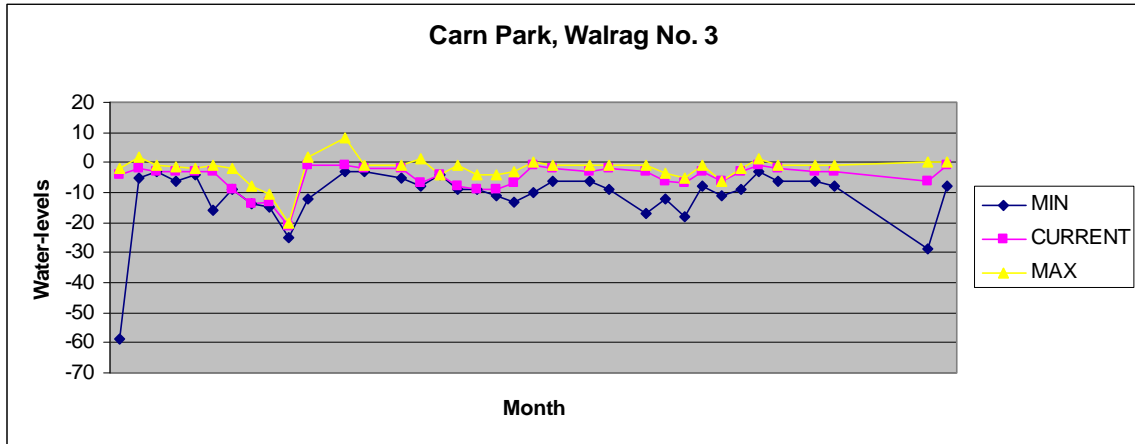
**Carn Park Bog Walrag 3: Fell to Waste on High Bog**

(Water-levels remain within 10cm of bog surface post restoration\*, decline n summer months)

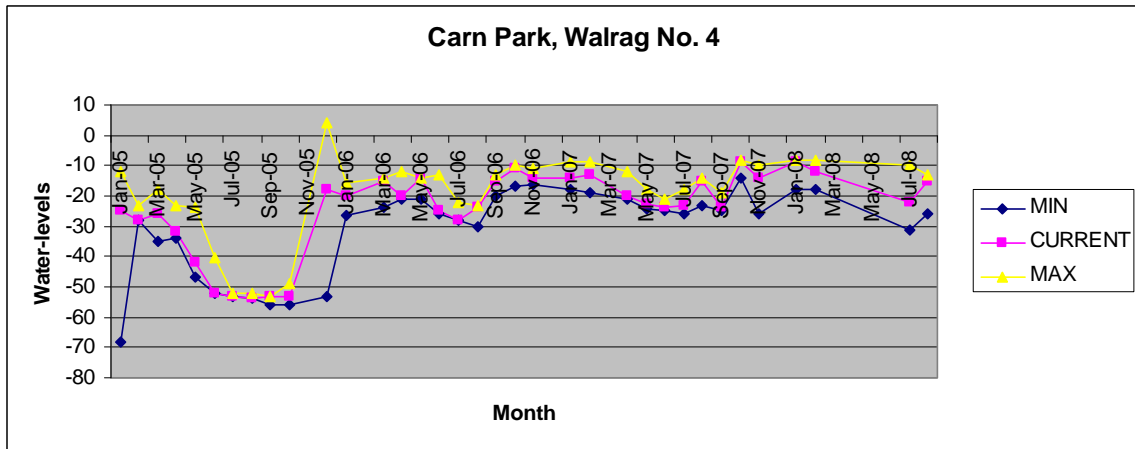
**Carn Park Bog Walrag 4: Clearfell Conifer Plantation on High Bog**

(Water-levels increase sharply to within 20cm of bog surface post restoration\*)
