RESTORING RAISED BOG IN IRELAND
Project Reference: LIFE04 NAT/IE/000121

A REPORT ON THE RESTORATION OF PROJECT SITE No. 8

CLOONSHANVILLE BOG, Co. ROSCOMMON

**Compiled by: John Derwin,
Project Ecologist,
September 2008**

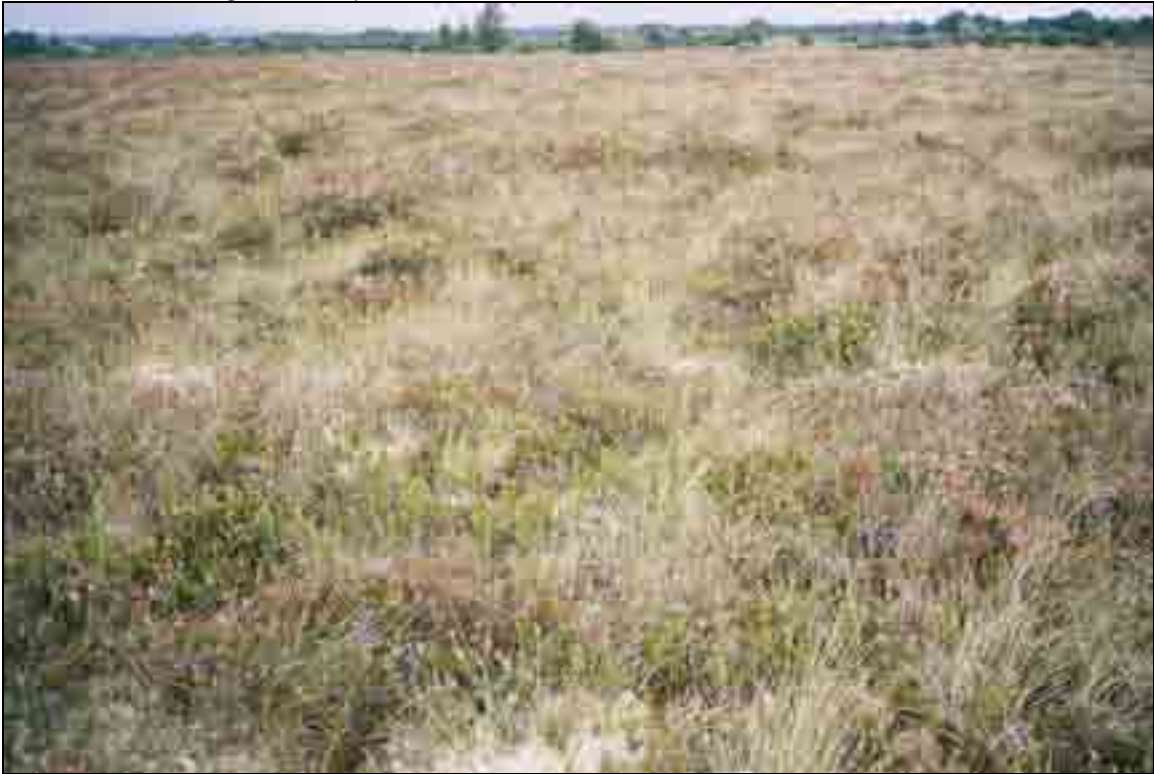
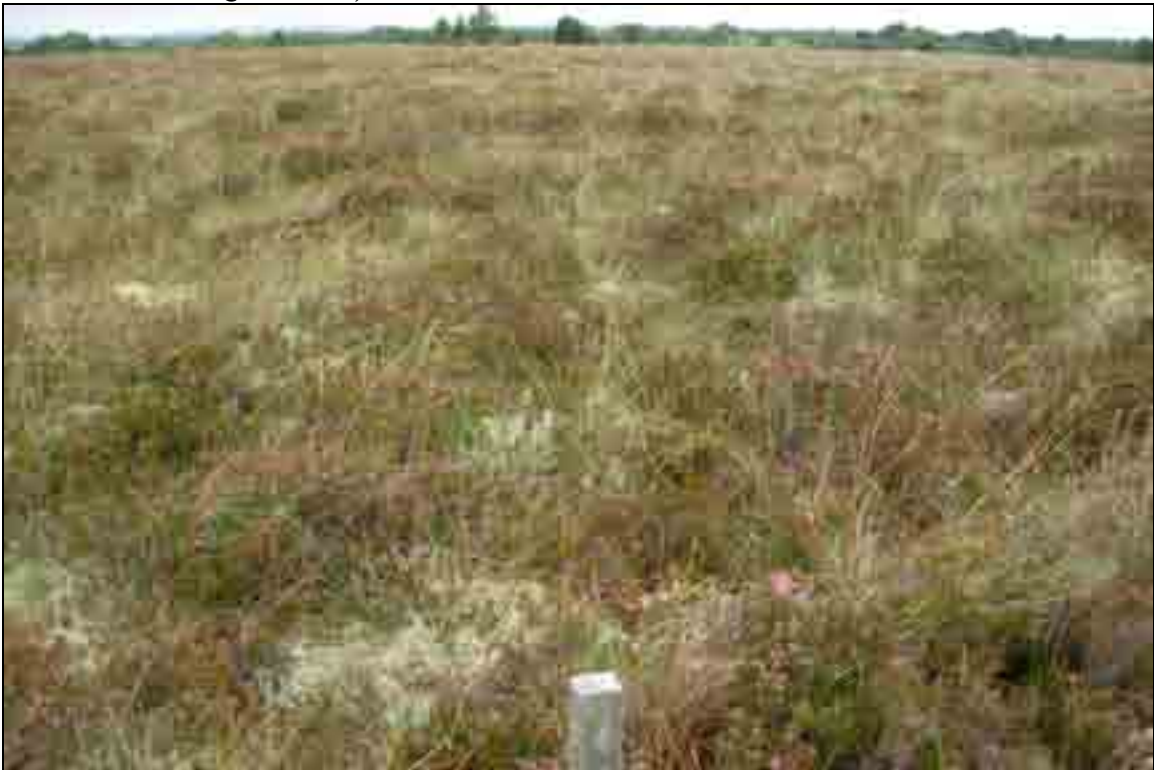
Cloonshanville Quadrat 1

Quadrat 1: This quadrat is located on the northern margin of Cloonshanville Bog and occurred on open bog with a ground cover of Ling Heather, Cross-leaved Heath, Hare's-tail Cotton-grass and *Sphagnum* moss. Over time, as the adjoining plantation becomes wetter, conditions of this raised bog habitat will improve and *Sphagnum* cover may increase further.

Cloonshanville Quadrat 1, 2005

Cloonshanville Quadrat 1, 2008

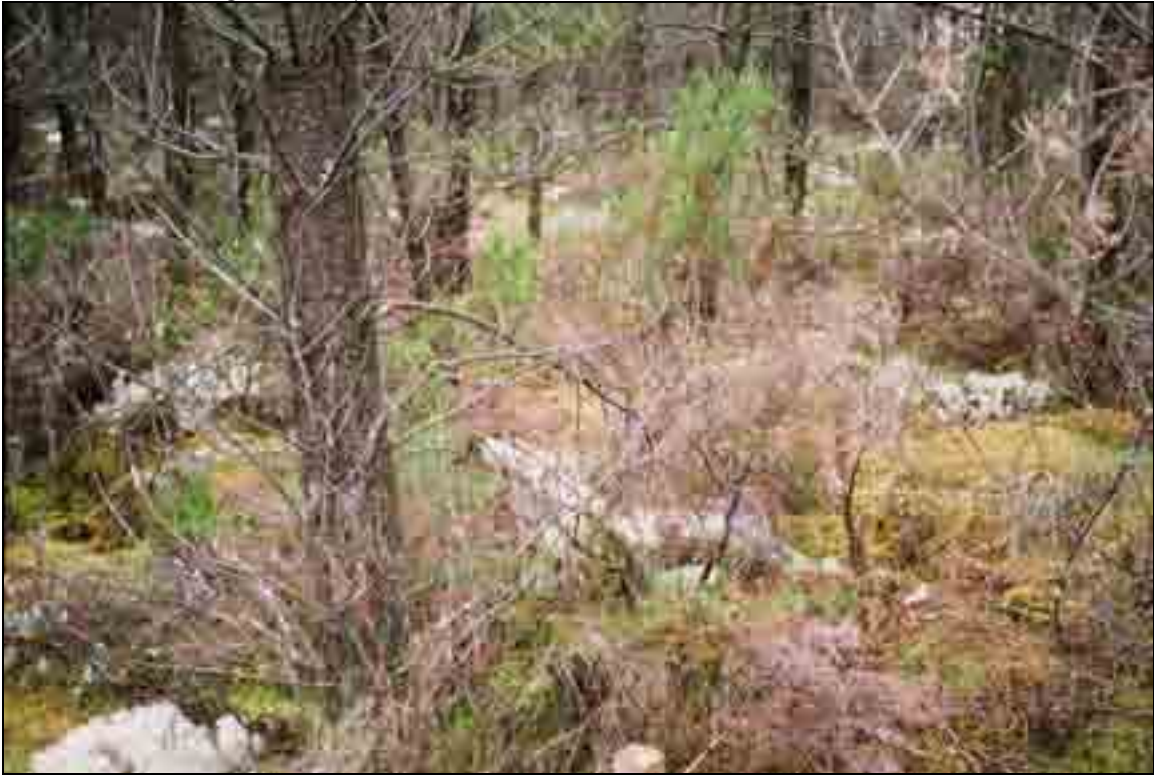
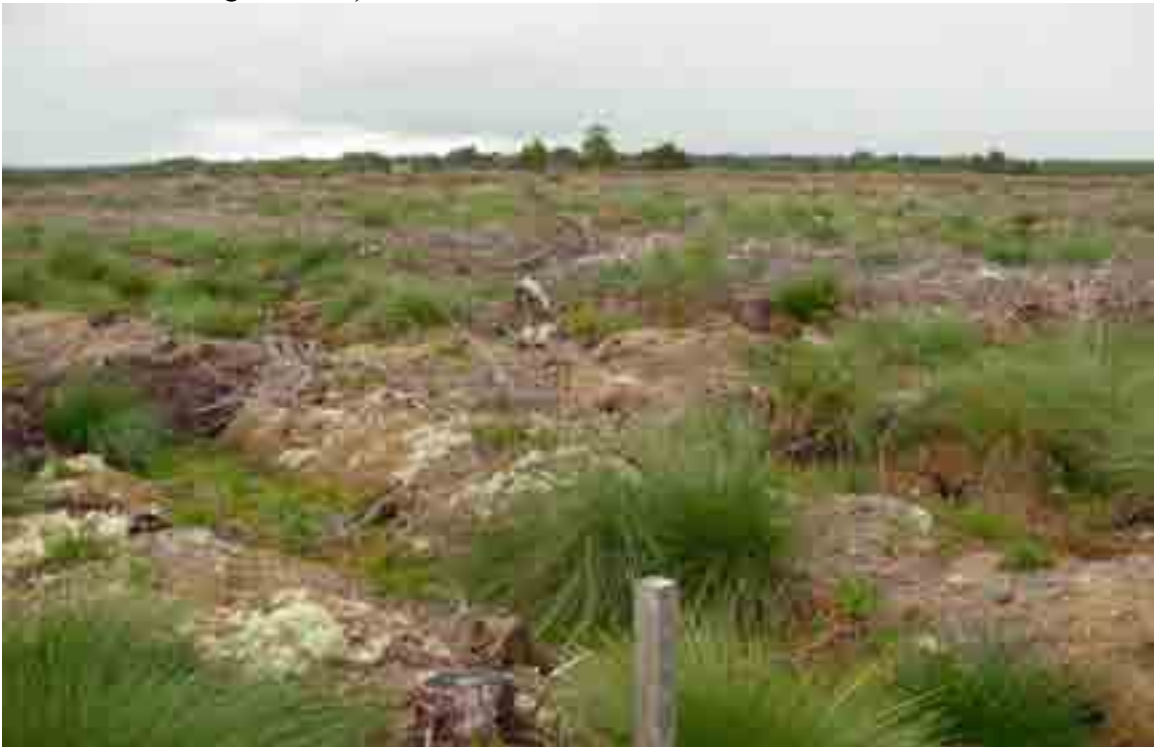
Cloonshanville Quadrat 2

Quadrat 2: This quadrat is located on the northern margin of Cloonshanville Bog and occurred within an open canopy conifer plantation with a ground cover containing Ling Heather, Hare's-tail Cotton-grass some Cranberry and *Sphagnum* moss. With the felling to waste of the conifers and blocking of drains, bog vegetation cover will increase. Over time, raised bog habitat will establish.

Cloonshanville Quadrat 2, 2005

Cloonshanville Quadrat 2, 2008

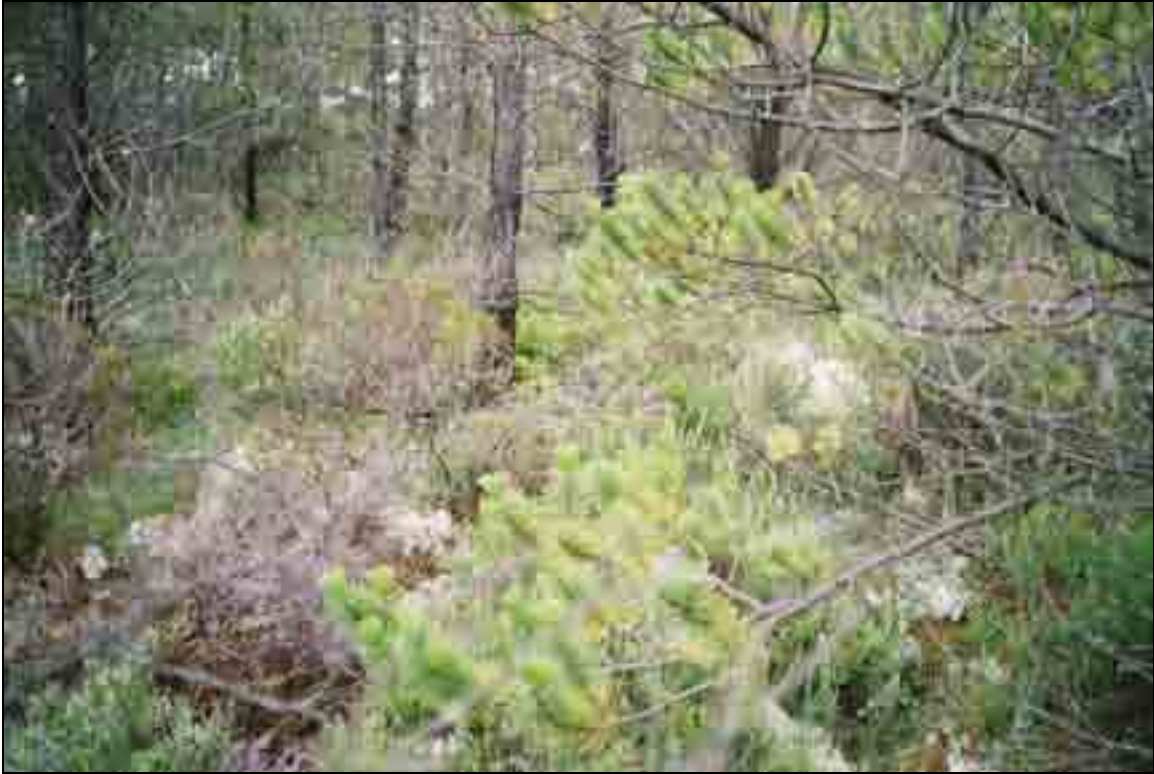
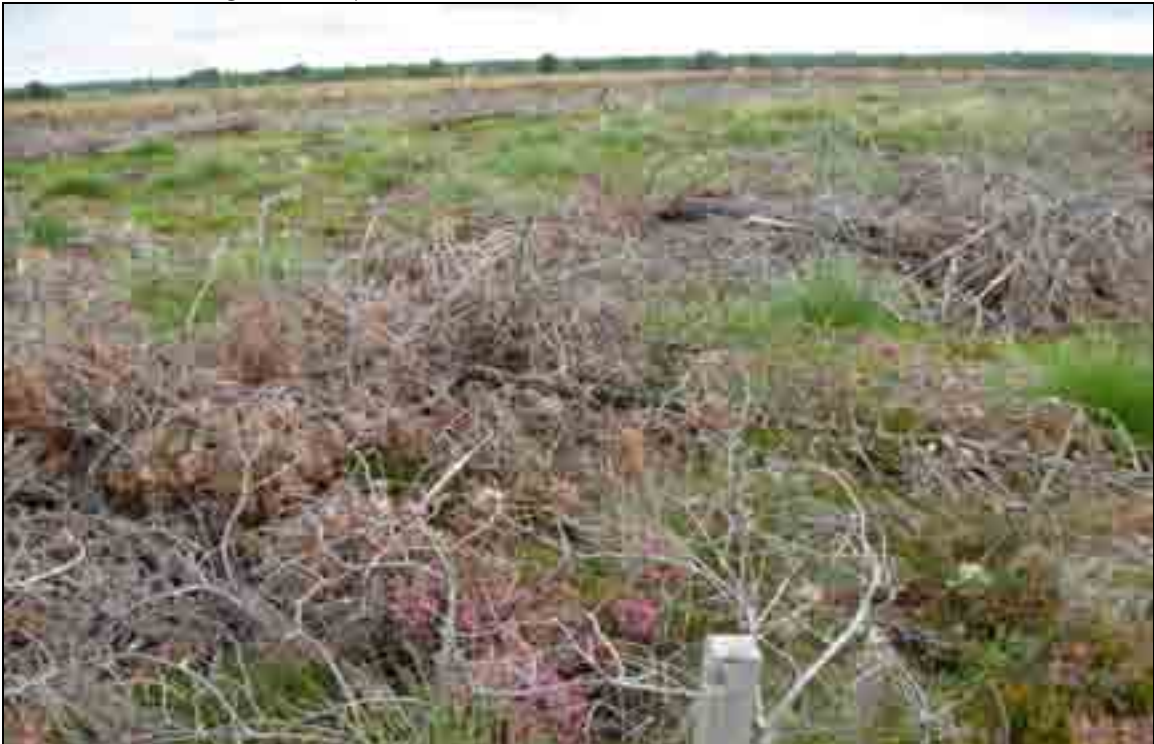
Cloonshanville Quadrat 3

Quadrat 3: This quadrat is located on the southern margin of the northern plantation on Cloonshanville Bog. This quadrat occurred within open canopy conifer plantation with a flushed ground cover containing Ling Heather, Crowberry, Hare's-tail cotton-grass, abundant Cranberry and *Sphagnum* moss. With the felling to waste of the conifers and blocking of drains, bog vegetation cover will increase. Over time, raised bog habitat will establish, with the possible extension of the Bog woodland habitat from the adjacent flush.

Cloonshanville Quadrat 3, 2005

Cloonshanville Quadrat 3, 2008

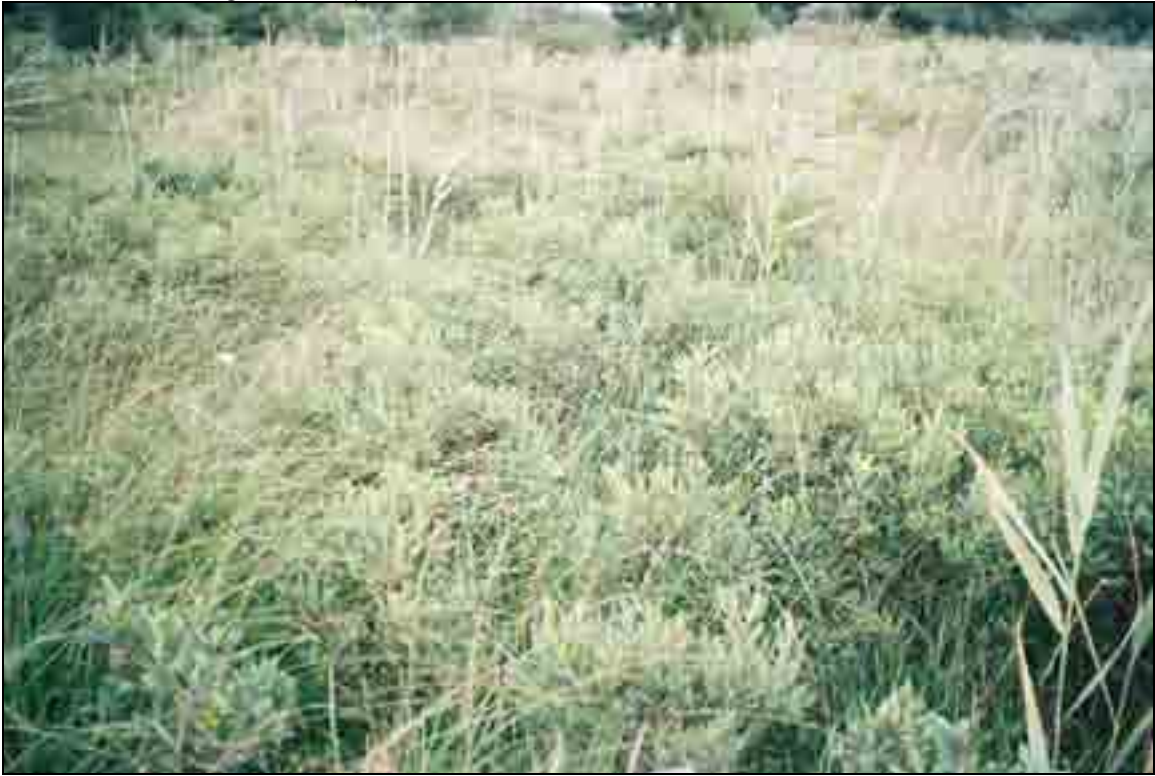
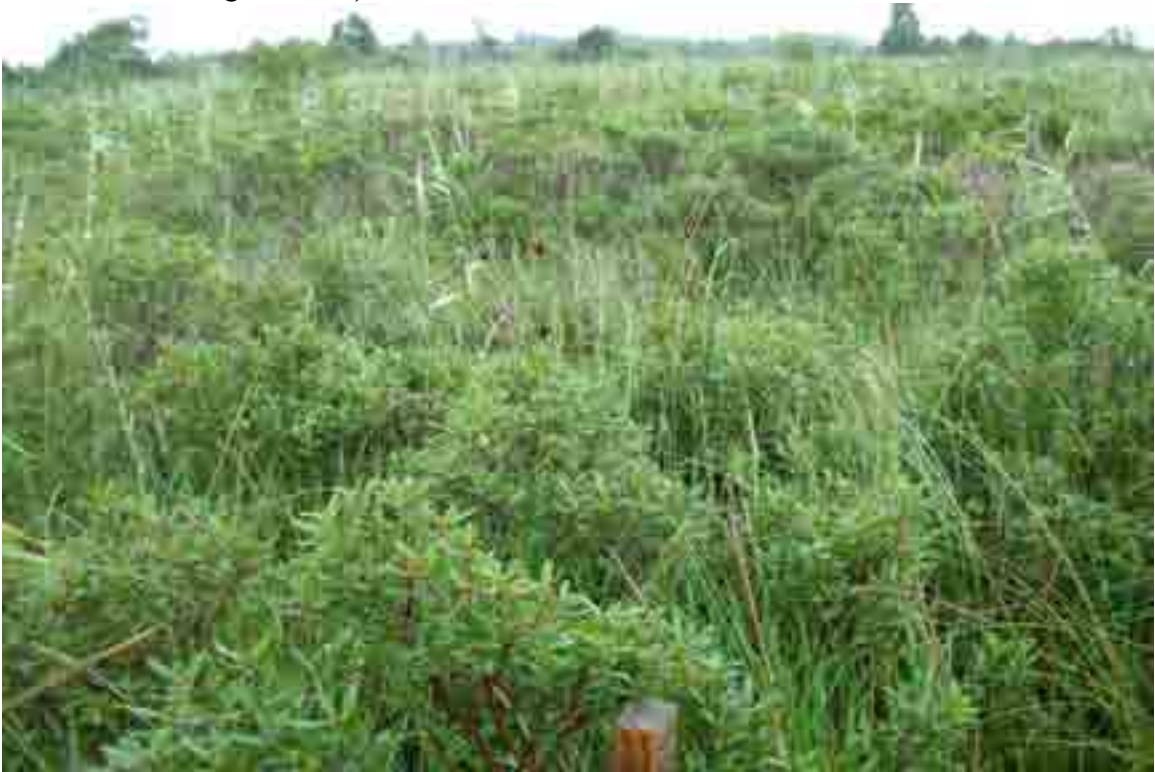
Cloonshanville Quadrat 4

Quadrat 4: This quadrat is located on the north-eastern margin of Cloonshanville Bog and occurred within stunted conifer plantation, planted on calcareous fen with a ground cover containing Purple Moor-grass, Bog Myrtle, Common Reed, Ling Heather and some *Sphagnum* moss. With the felling to waste of the conifers, fen vegetation dominates and over time calcareous fen habitat will be re-established.

Cloonshanville Quadrat 4, 2005

Cloonshanville Quadrat 4, 2008

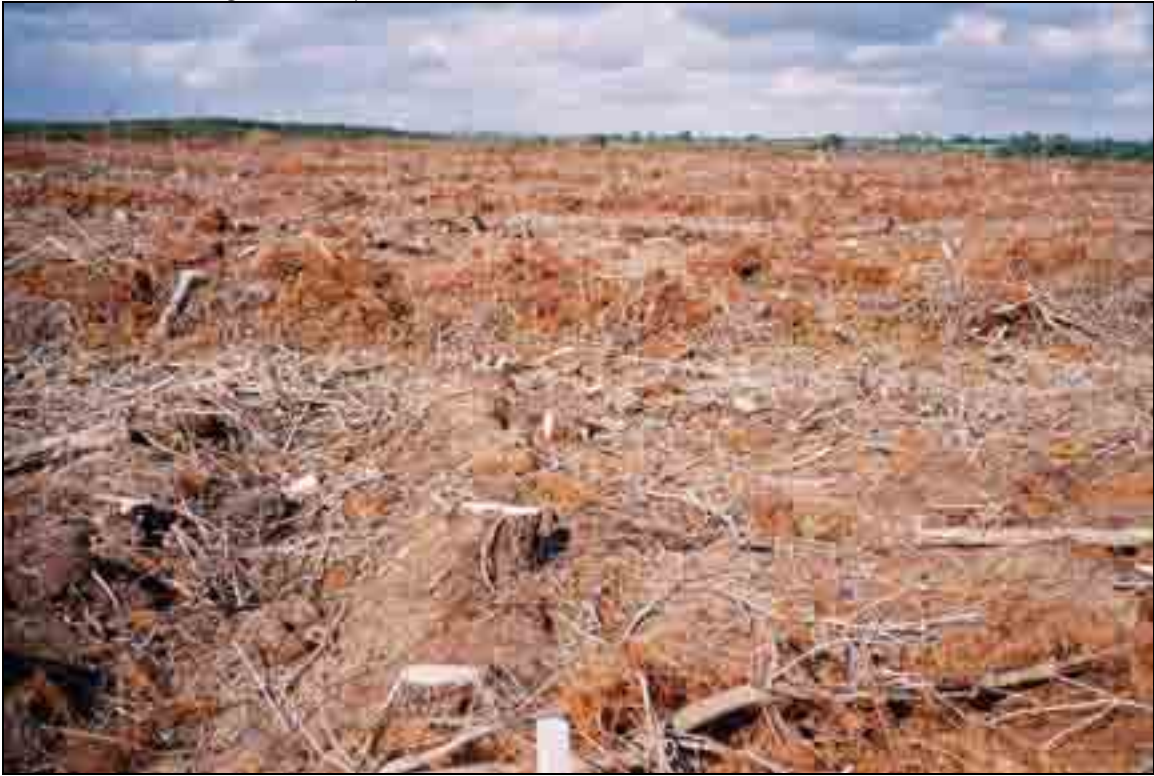
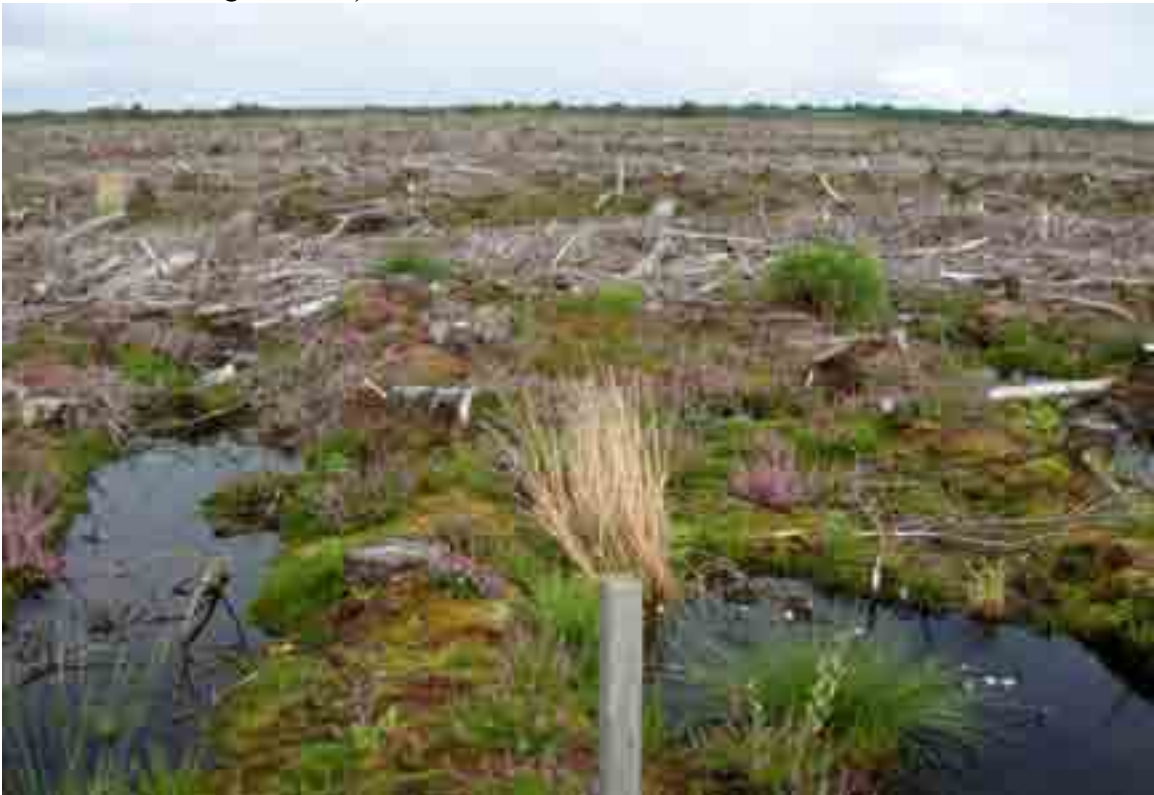
Cloonshanville Quadrat 5

Quadrat 5: This quadrat is located within the mature conifer plantation on the southern margin of Cloonshanville Bog and occurred under closed canopy conifers with a ground cover containing some *Hypnum* moss, but mainly dominated by pine needles. With the felling to waste of the conifers and blocking of drains, it can be seen that raised bog vegetation of Ling Heather and *Sphagnum* established. Over time, as this area becomes wetter, raised bog habitat cover will be increased.

Cloonshanville Quadrat 5, 2006

Cloonshanville Quadrat 5, 2008

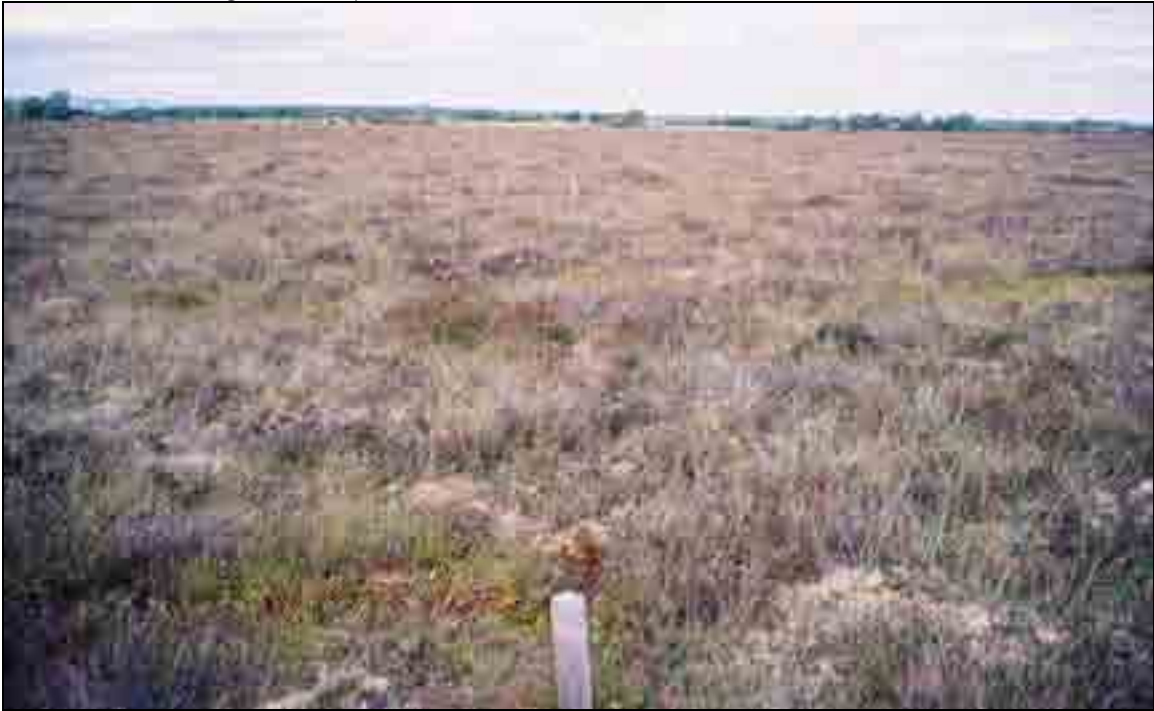
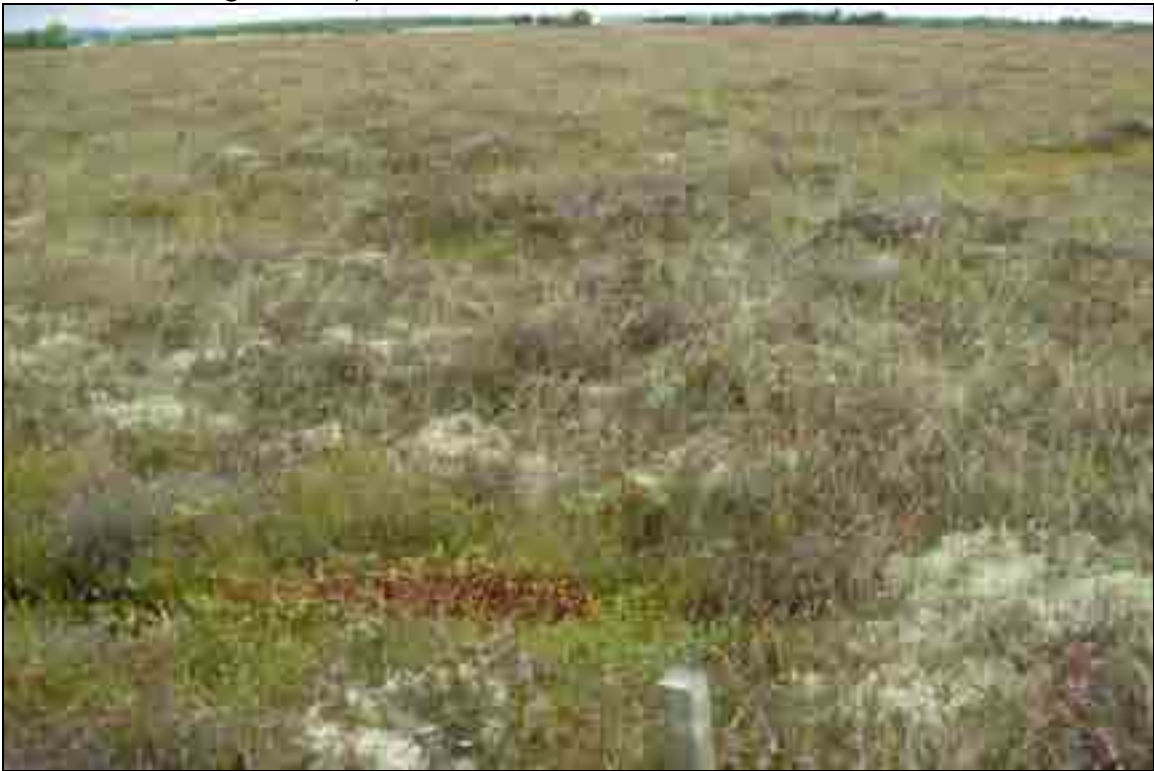
Cloonshanville Quadrat 6

Quadrat 6: This quadrat is located on the north-west margin of Cloonshanville Bog and occurred on open bog with pools and ground cover containing Ling Heather, Cross-leaved Heath, White-beaked Sedge, Hare's-tail cotton-grass, Bog Asphodel, Bog Bean and abundant *Sphagnum* moss. This active raised bog habitat will be protected by felling of conifers and drain- blocking in adjoining plantations.

Cloonshanville Quadrat 6, 2006

Cloonshanville Quadrat 6, 2008

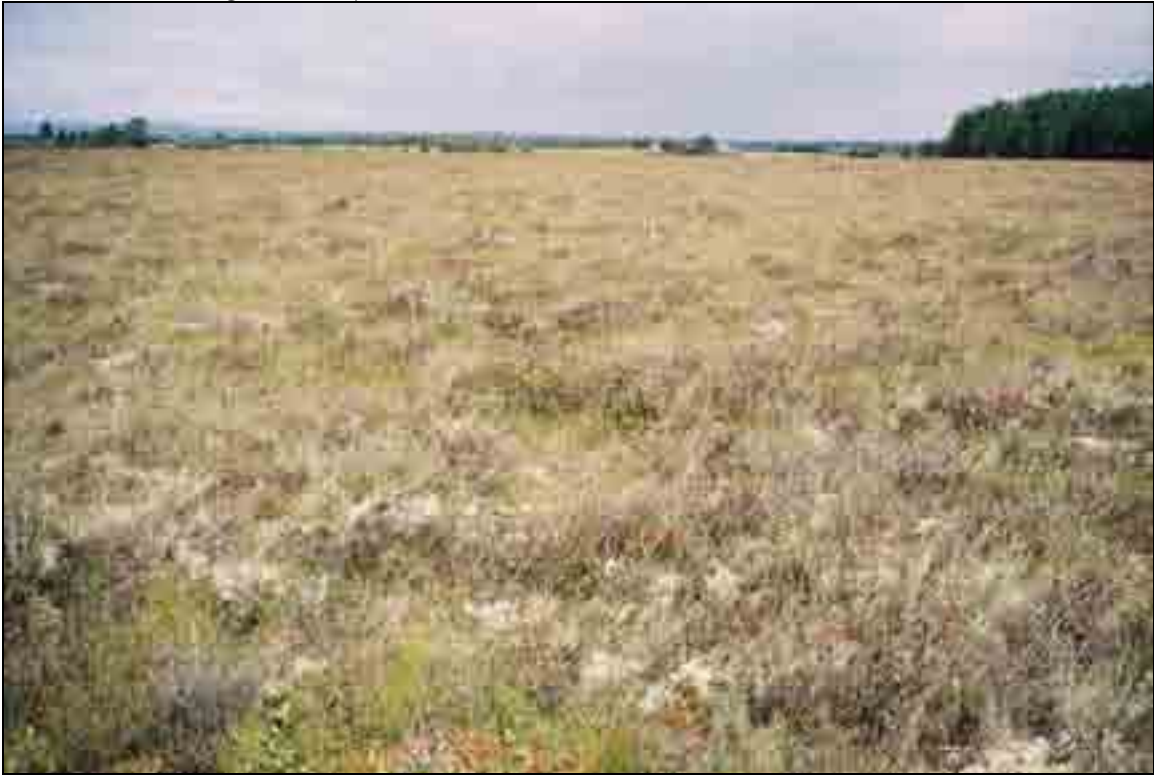
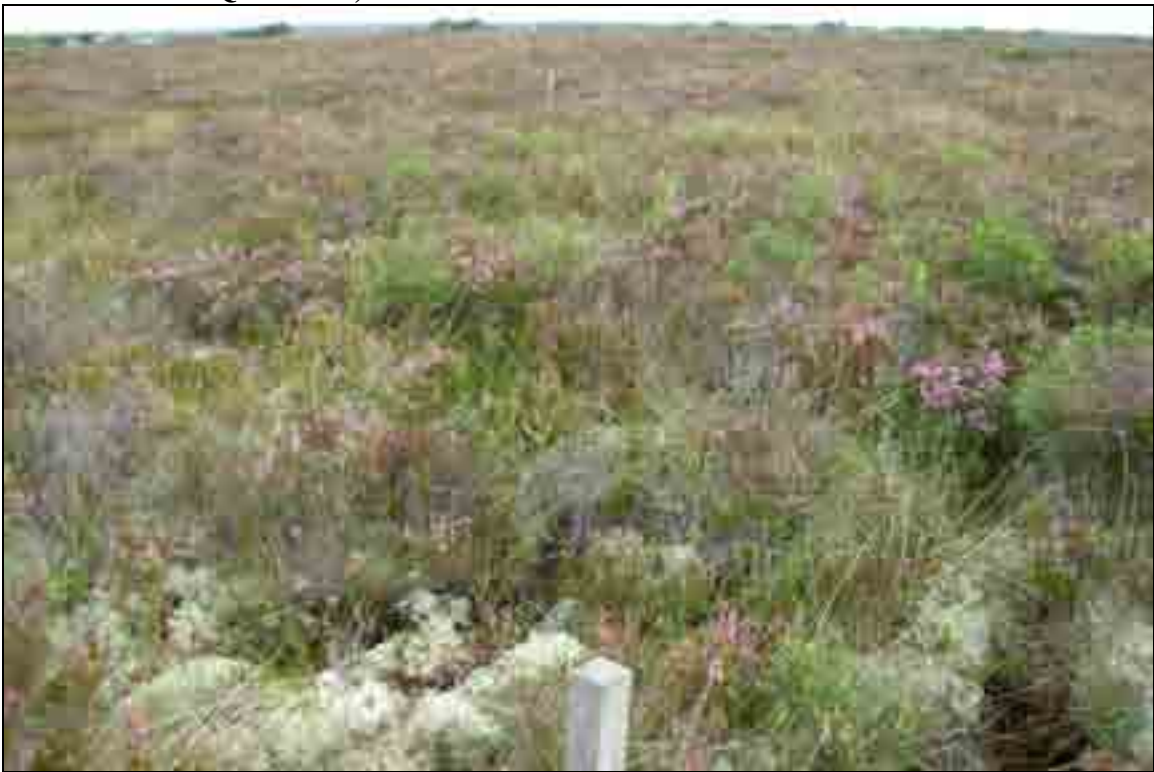
Cloonshanville Quadrat 7

Quadrat 7: This quadrat is located to the south-west of the northern plantation on Cloonshanville Bog and occurred on open bog with a ground cover containing Ling Heather, Cross-leaved Heath, Hare's-tail Cotton-grass, Bog Myrtle, Bog Bean and abundant *Sphagnum* moss. With the felling to waste of the conifers on the adjoining plantation and blocking of drains, this active raised bog habitat will be protected.

Cloonshanville Quadrat 7, 2005

Cloonshanville Quadrat 7, 2008

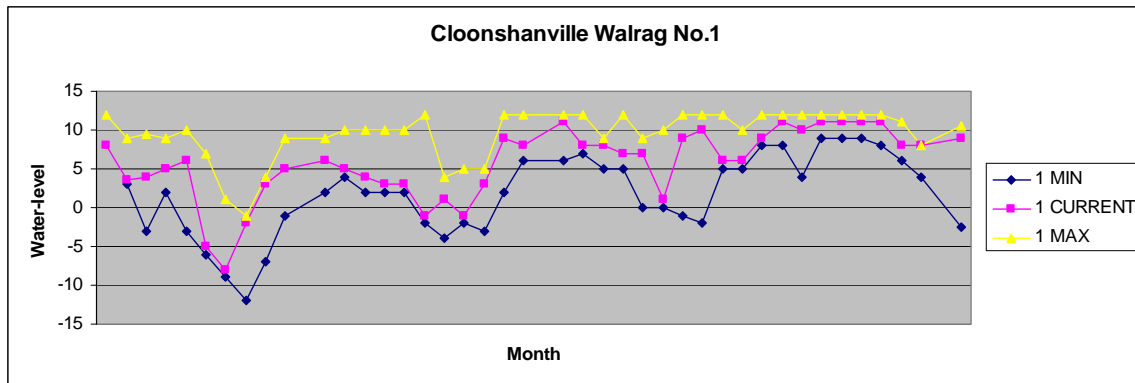
Cloonshanville Bog Walrag 1

Located in firebreak beside clearfell on high bog, water-levels drop 10cm below surface prior restoration*, at ground level or above post restoration

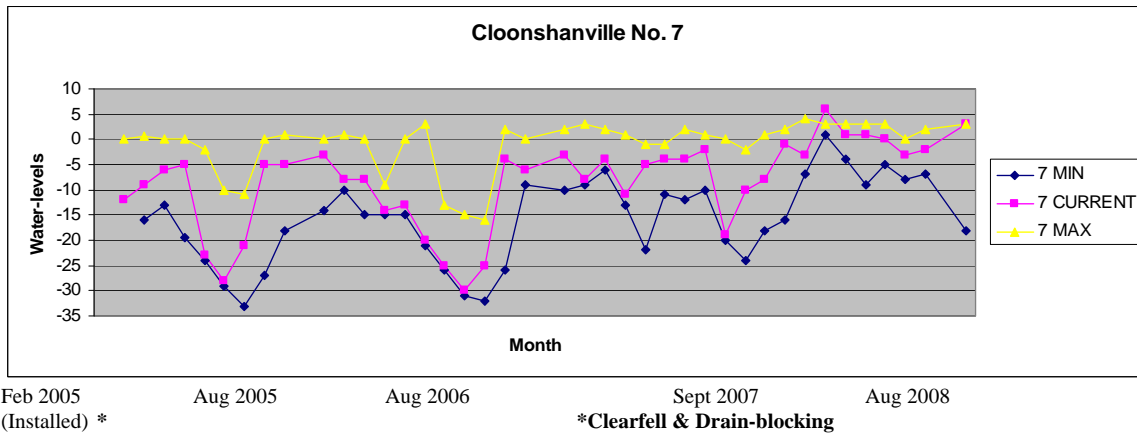
Cloonshanville Bog Walrag 7

Located within fell to waste on cutover bog, water-levels drop below 30cm during summer months prior restoration*, have risen to within 20cm post restoration
