RESTORING RAISED BOG IN IRELAND
Project Reference: LIFE04 NAT/IE/000121

A REPORT ON THE RESTORATION OF PROJECT SITE No. 14

COOLRAIN BOG, Co. LAOIS

**Compiled by: John Derwin,
Project Ecologist,
September 2008**

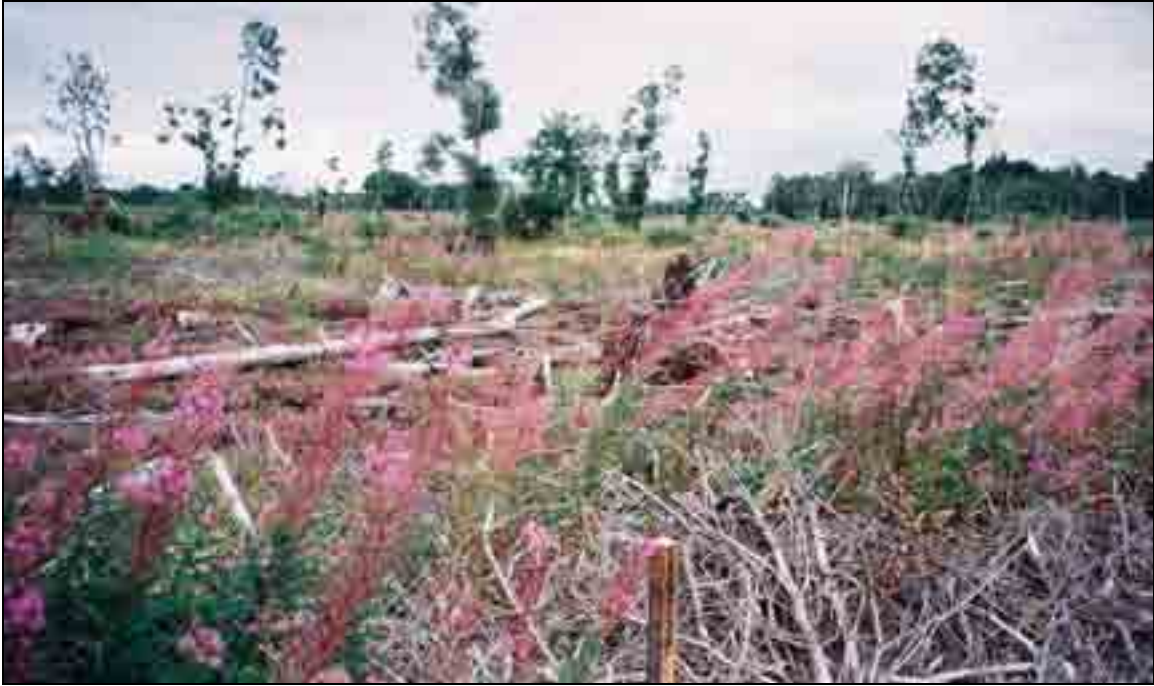
Coolrain Quadrat 1, 2005

Quadrat 1: This quadrat was located towards the eastern margin of the project site and occurred on recently clear-felled conifer plantation with a ground cover containing Ling Heather, Willow-herb and some *Hypnum* moss. With the felling of the conifers and blocking of drains, it can be seen that Birch, Ling Heather cover increased along with Willow-herb. There is some natural regeneration of conifer seedlings, which needs to be controlled. Over time, if conditions remain the same, birch woodland will dominate this bog margin, retaining an understory of Ling Heather and the Willow-herb will die out.

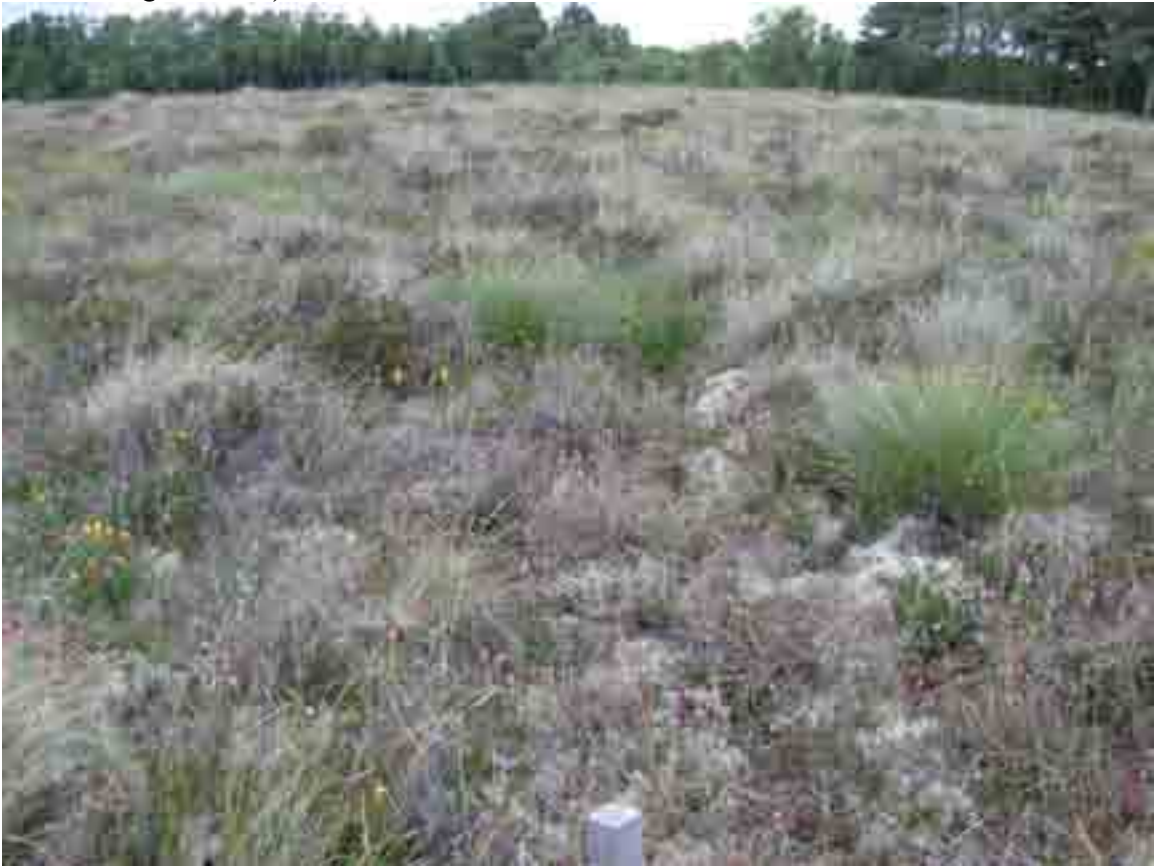
Coolrain Quadrat 2, 2008

Quadrat 2: This quadrat was located on the north-eastern margin of the high bog and supports raised bog vegetation of Ling Heather, Cross-leaved Heath, Bog Asphodel, Hare's-tail Cotton-grass, Deergrass and *Sphagnum* moss. Over time, as the adjoining cutover becomes wetter, conditions on this margin will improve and *Sphagnum* cover may increase further.

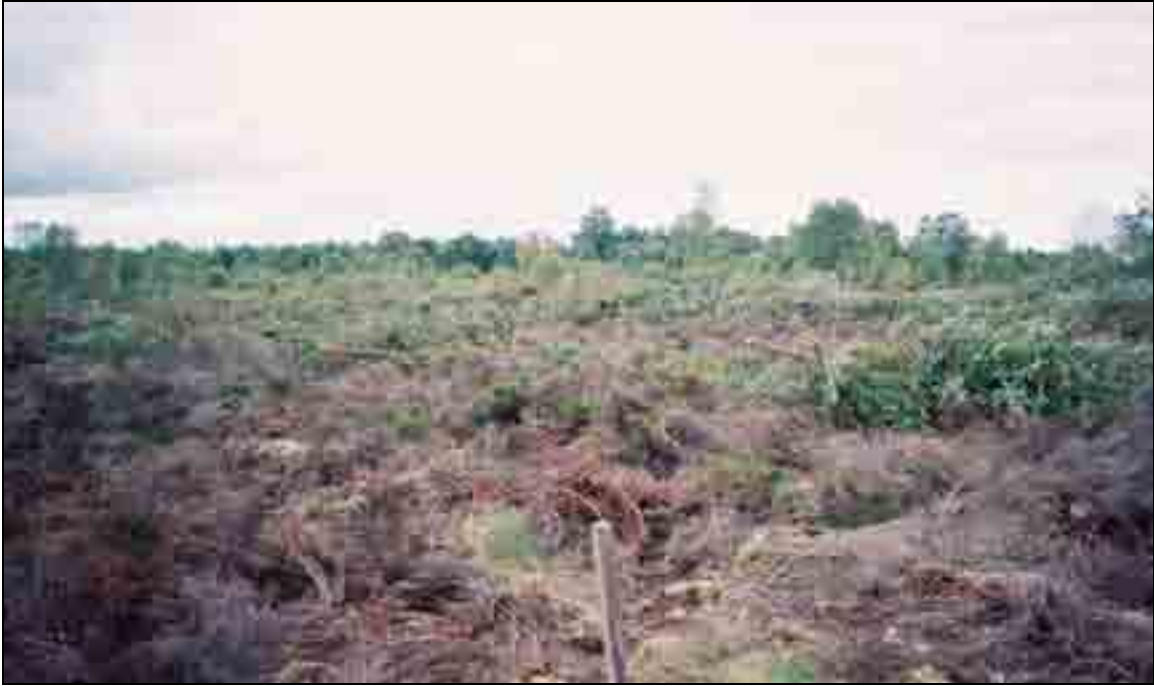
Coolrain Quadrat 3, 2005

Quadrat 3: This quadrat was located towards the northern margin of the raised bog and occurred on cutover bog under open canopy of young conifers. The ground cover contained Ling Heather, Cross-leaved Heath, Hare's-tail Cottongrass and Purple Moor-grass with some *Sphagnum* moss. With the felling to waste of the conifers and blocking of drains, it can be seen that Ling Heather, Cotton-grass and *Sphagnum* dominate. There is some natural regeneration of birch seedlings, which needs to be controlled. Over time, if conditions remain wet, *Sphagnum* cover will increase further and active raised bog habitat may be established.

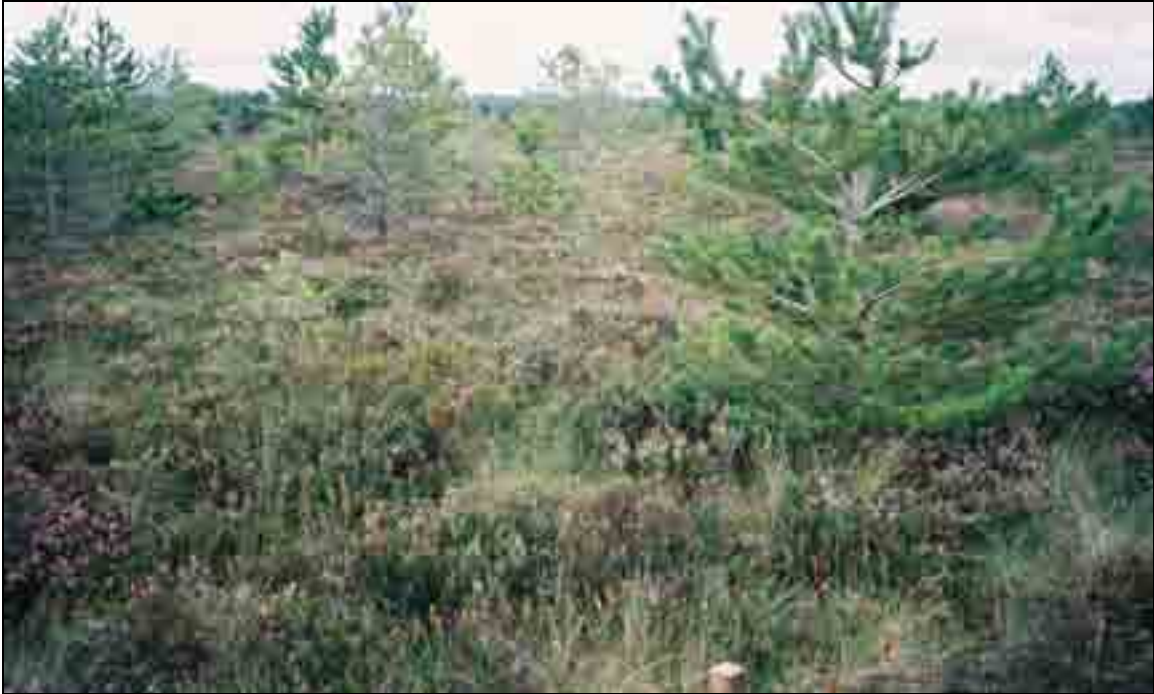
Coolrain Quadrat 4, 2005

Quadrat 4: This quadrat was located in Bog Woodland habitat under an open canopy of conifers. The ground cover contained Ling Heather, Cross-leaved Heath, Crow-berry, Cotton-grasses and abundant *Sphagnum* mosses. Bog woodland is a Priority Annex I Habitat of the EU Habitats Directive and adds to the ecological importance of this site. Therefore no restoration actions occurred here and the Bog Woodland vegetation was retained.

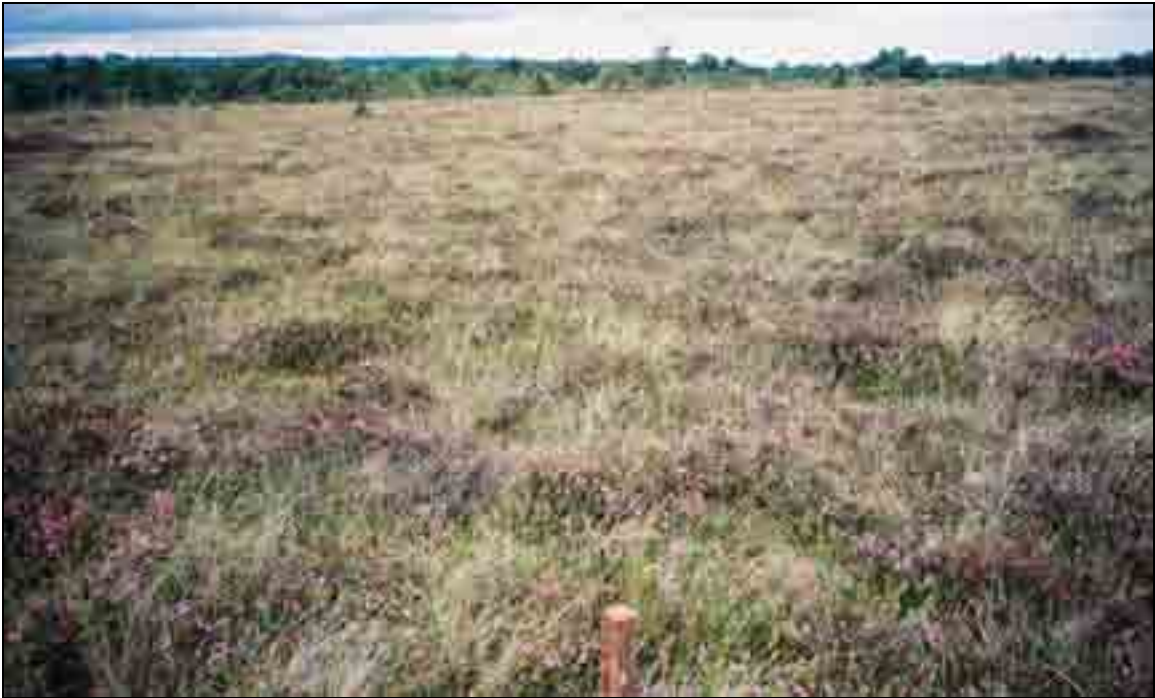
Coolrain Quadrat 5, 2005

Quadrat 5: This quadrat was located towards the centre of the high bog and occurred on active raised bog supporting Ling Heather, Cross-leaved Heath, Bog Asphodel and Hare's-tail Cottongrass with abundant *Sphagnum* moss. As this area supports active raised bog habitat, no restoration measures were carried out and the active raised bog habitat was protected.

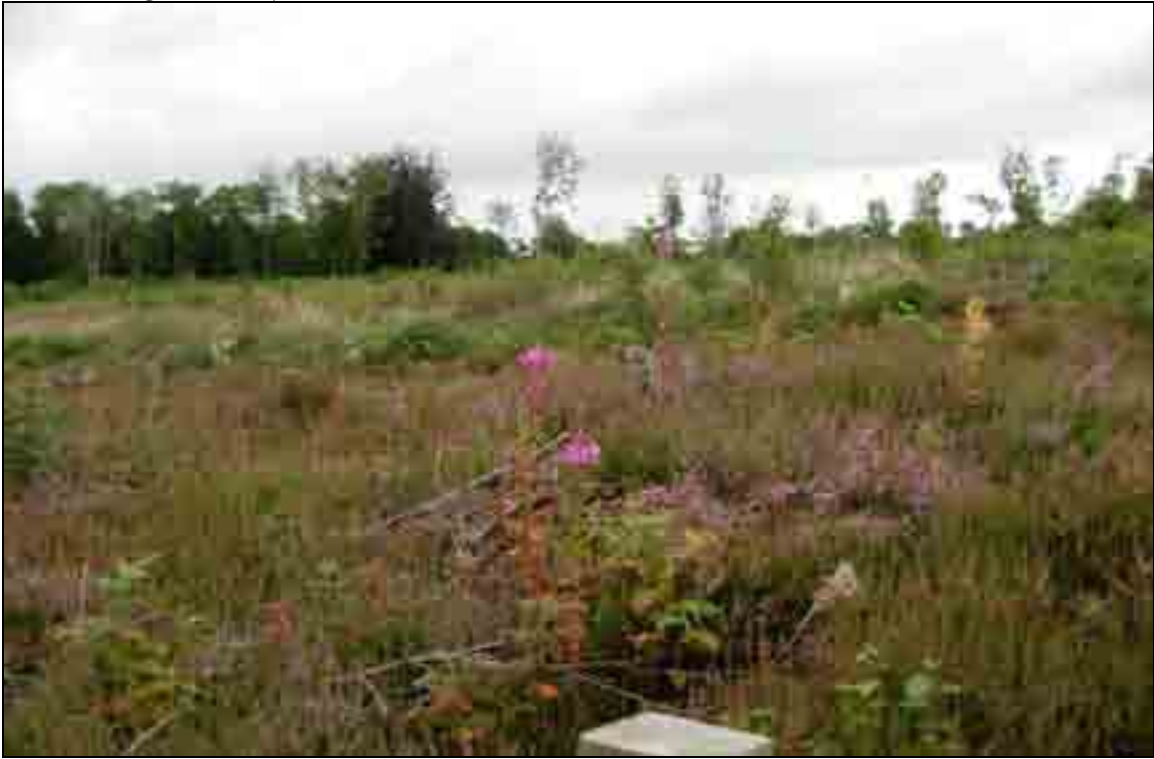
Coolrain Quadrat 6, 2008

Quadrat 6: This quadrat was located in the north-western conifer plantation and occurred under closed canopy conifers with a ground cover containing some Ling Heather, Purple Moor-grass, *Hypnum* and *Sphagnum* mosses, but mainly consisted of pine needles. With the felling of the conifers and blocking of drains, Ling Heather, Purple Moor-grass and *Sphagnum* dominate along with encroaching birch. Over time, wet birch woodland will dominate this area with a ground flora of bog vegetation.

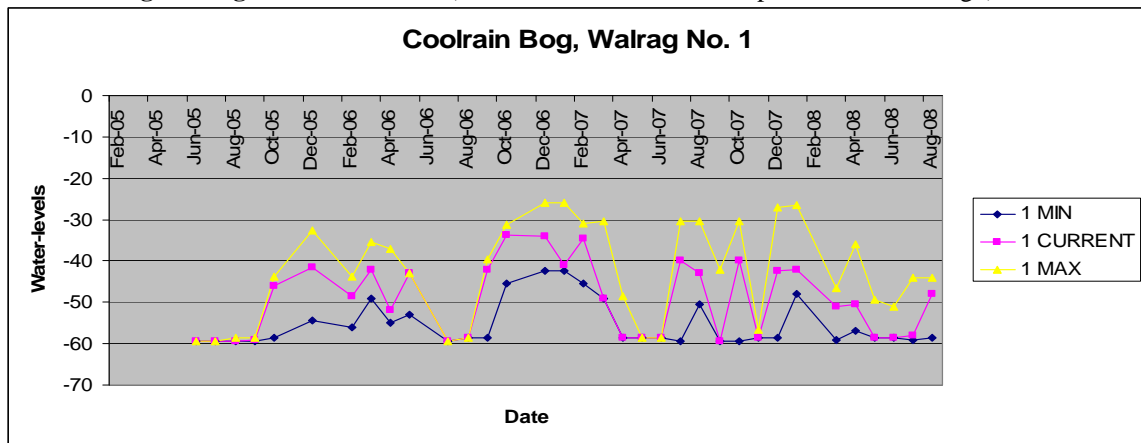
Coolrain Bog Walrag 1: Clearfell 2004 (Limited rise in water-levels post Drain Blocking*)

Feb 2005 (Installed) *Drain-blocking Feb2006 Feb2007 Aug 2008

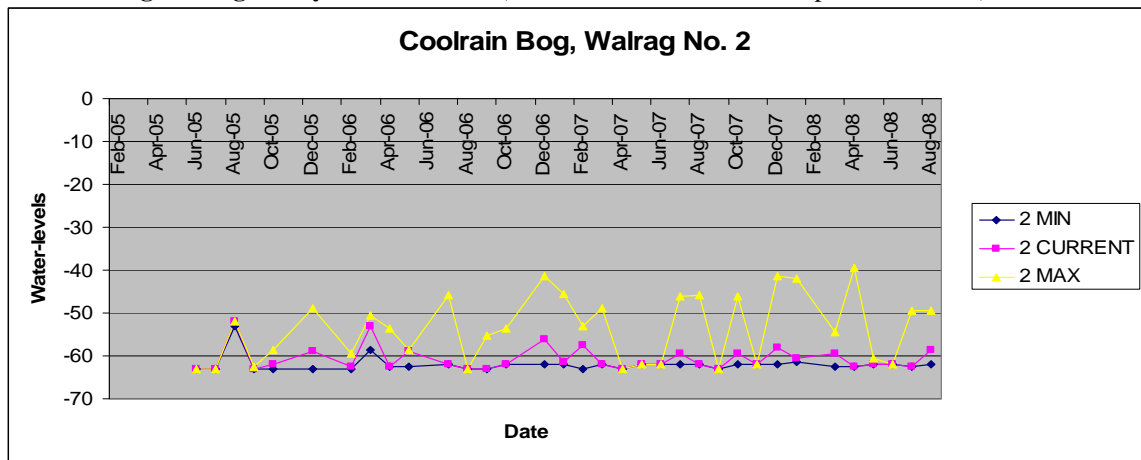
Coolrain Bog Walrag 2: Dry Clearfell 2005 (Limited rise in water-levels, post restoration)

Feb 2005 (Installed) Feb 2006 Feb 2007 Aug 2008
*Clearfell & Drain-blocking

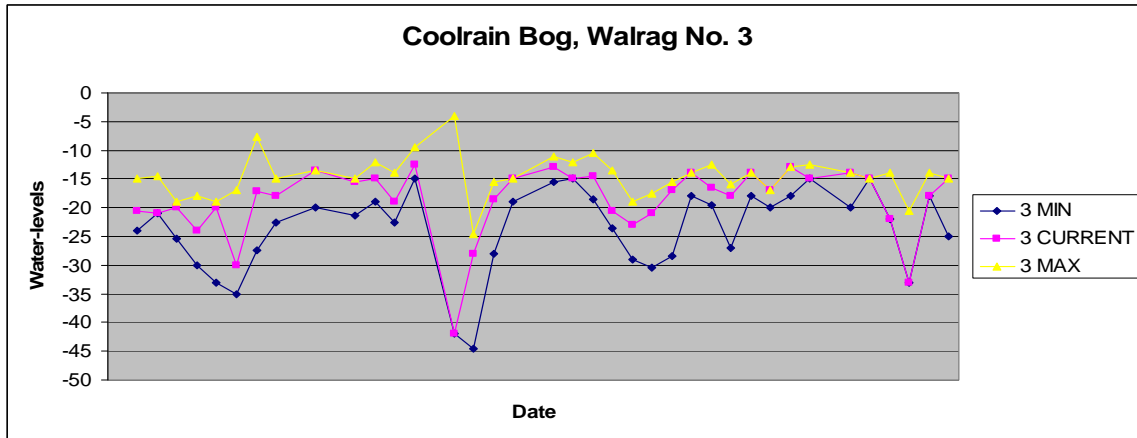
Coolrain Bog Walrag 3: Open Bog, (Distinct drop in water-levels during summer months)

Feb 2005 (Installed) Aug 2005 Aug 2006 Aug 2007 Aug 2008

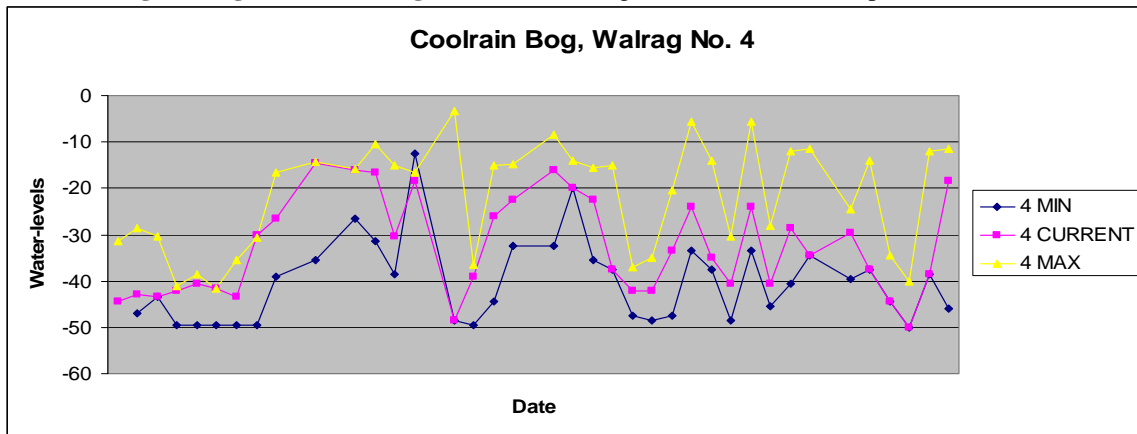
Coolrain Bog Walrag 4: Cutover Bog, fell to waste (Slight rise in water-levels post restoration*)

Feb 2005 (Installed) *Aug 2005 Aug 2006 Aug 2007 Aug 2008

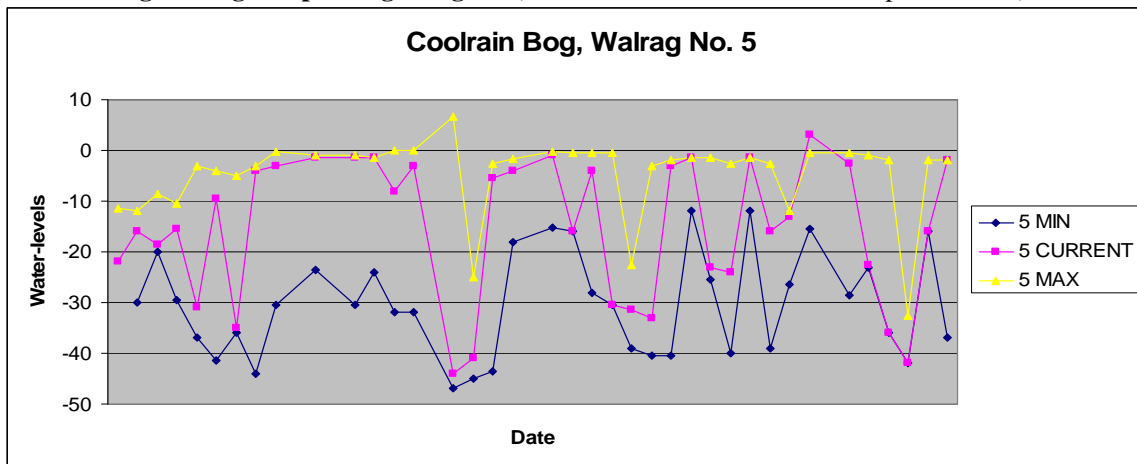
Coolrain Bog Walrag 5: Open Bog Marginal (Variable water-levels, distinct drop in summer)

Feb 2005 (Installed) *Aug 2005 Aug 2006 Aug 2007 Aug 2008

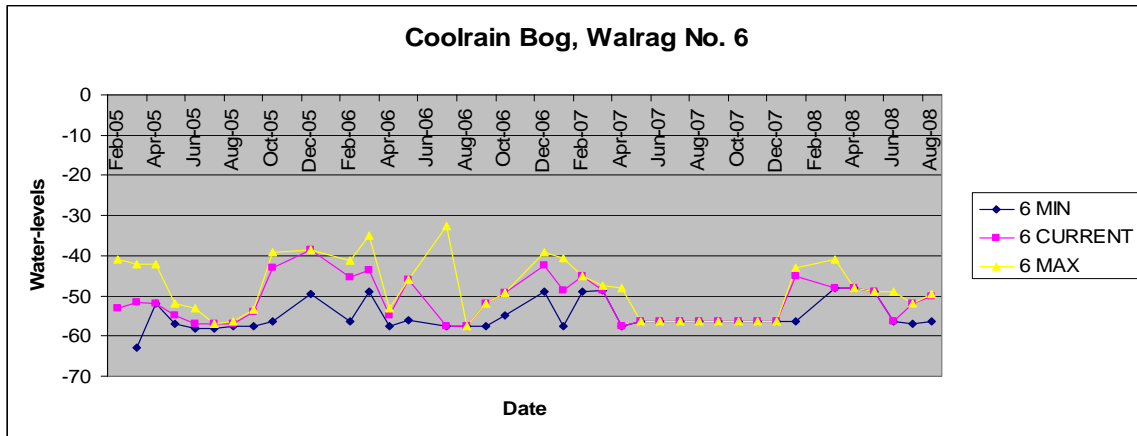
Coolrain Bog Walrag 6: Clearfell 2004, (Limited rise in water-levels post Drain Blocking)

Feb 2005 (Installed) *Aug 2005
*Clearfell & Drain-blocking Aug 2006 Aug 2007 Aug 2008

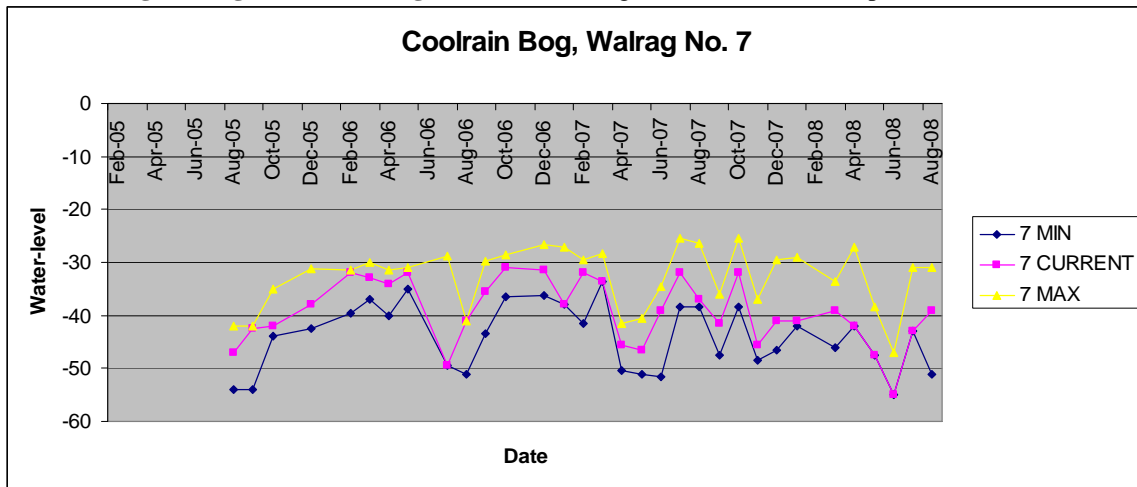
Coolrain Bog Walrag 7: Cutover Bog, fell to waste (Slight rise in water-levels post restoration*)

Feb 2005 *Aug 2005 (Installed)
*Clearfell & Drain-blocking Aug 2006 Aug 2007 Aug 2008

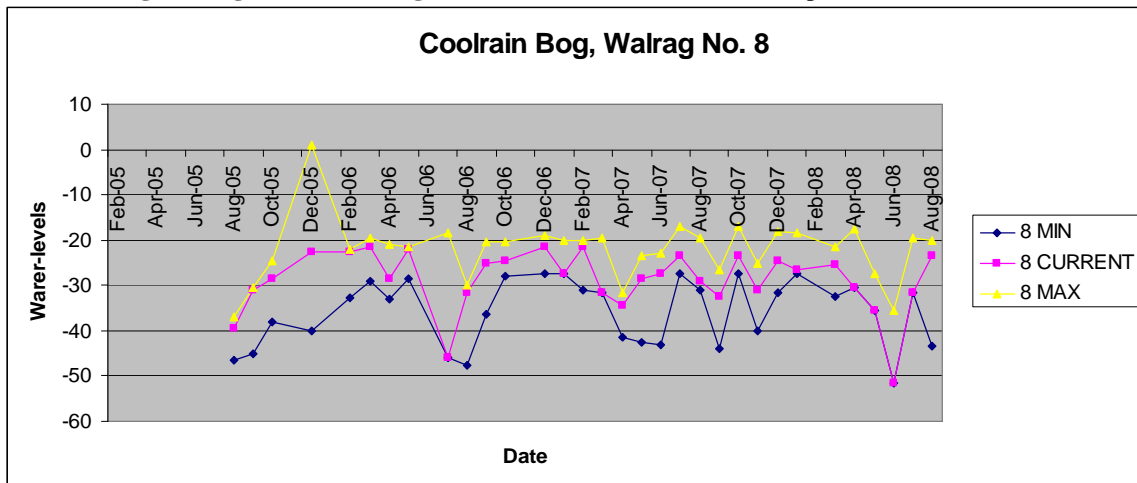
Coolrain Bog Walrag 8: Cutover Bog, fell to waste (Rise in water-levels post restoration*)

Feb 2005 *Aug 2005 (Installed)
*Clearfell & Drain-blocking Aug 2006 Aug 2007 Aug 2008
