RESTORING RAISED BOG IN IRELAND
Project Reference: LIFE04 NAT/IE/000121

A REPORT ON THE RESTORATION OF PROJECT SITE No. 12

CROSSWOOD BOG, Co. WESTMEATH

**Compiled by: John Derwin,
Project Ecologist,
September 2008**

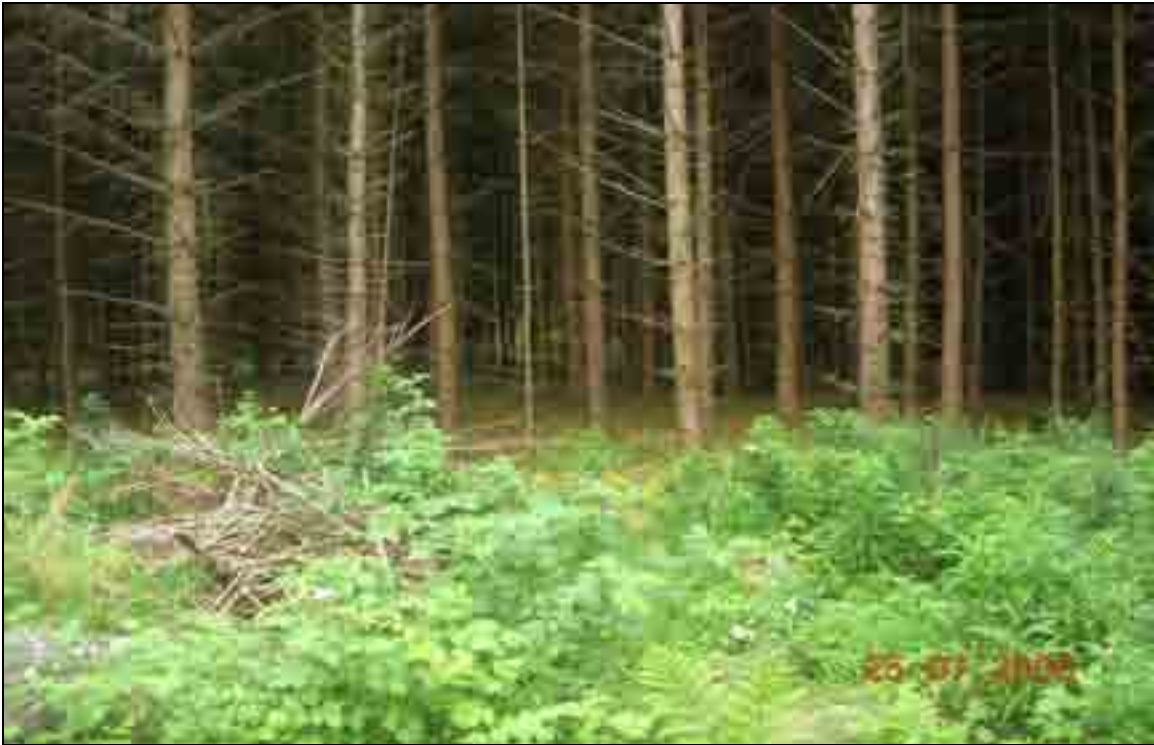
Crosswood Bog Closed Canopy Conifer Plantation, 2005

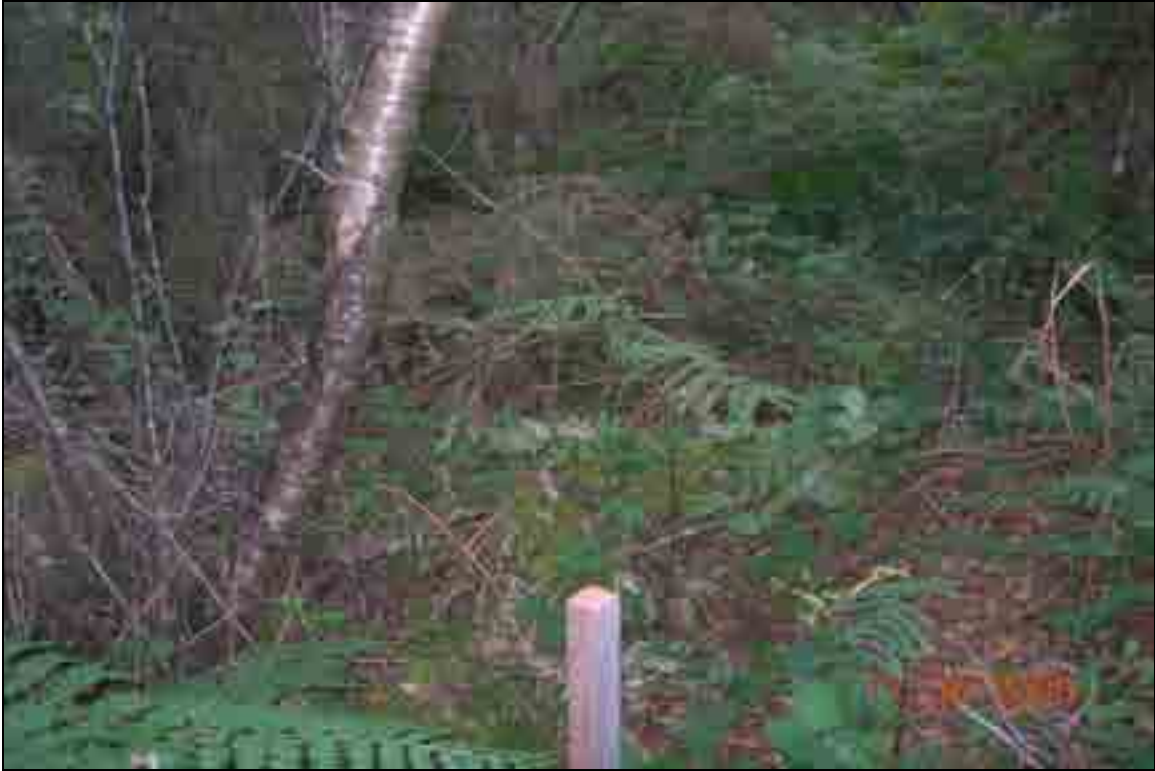
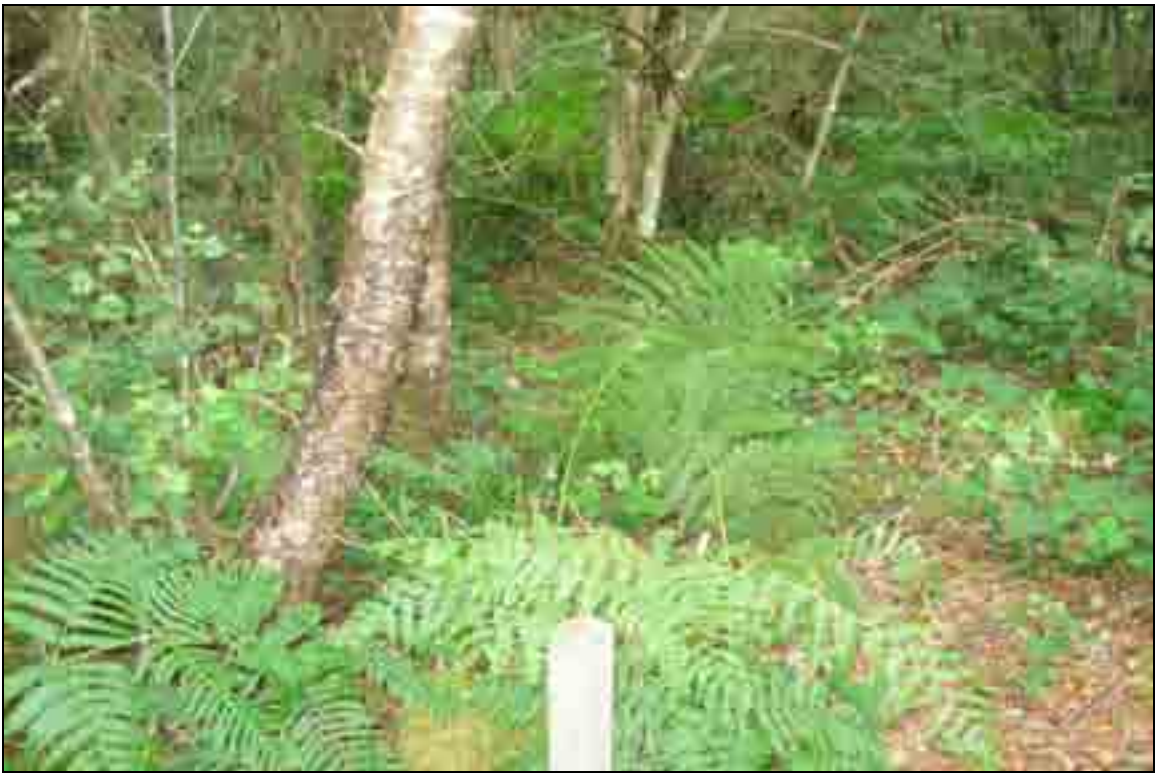
Crosswood Quadrat 1

Quadrat 1: This quadrat is located towards the eastern margin of the plantation and occurred under wet woodland of Birch and Rowen with an understory of Bramble. The ground flora is dominated by Hypnum moss. This birch woodland is the natural vegetation of raised bog margins and will be allowed to develop further.

Crosswood Quadrat 1, 2005

Crosswood Quadrat 1, 2008

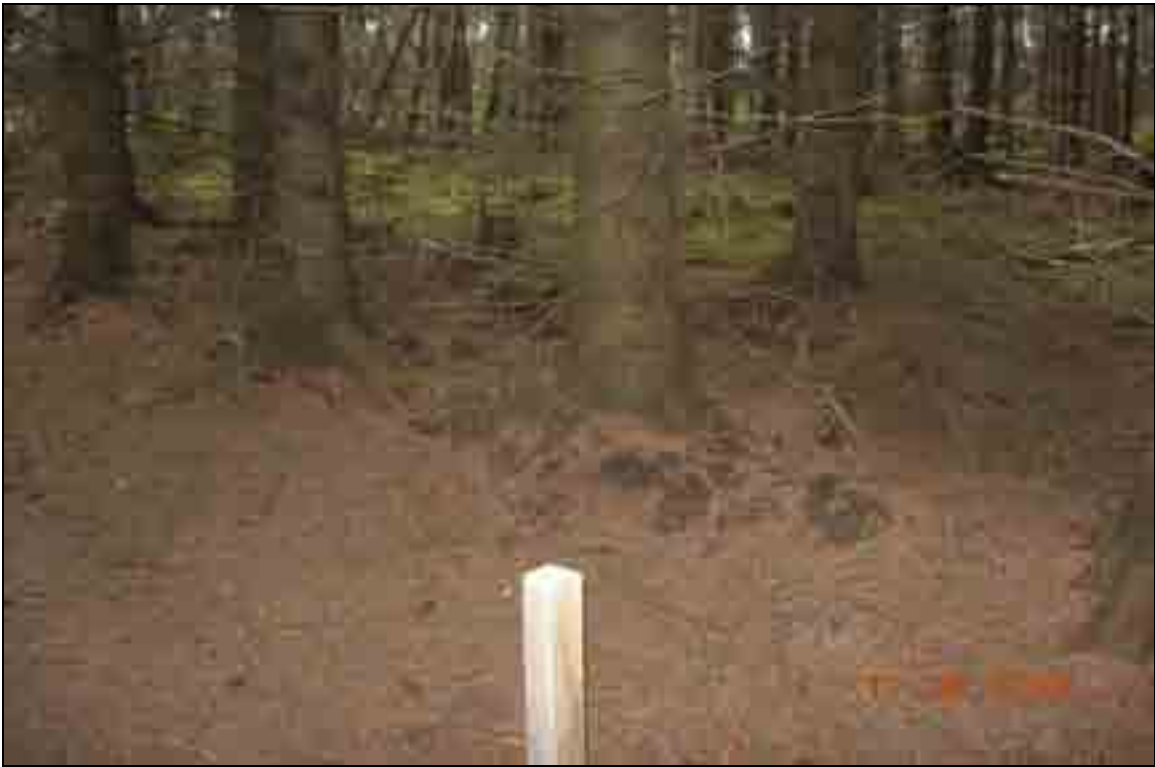
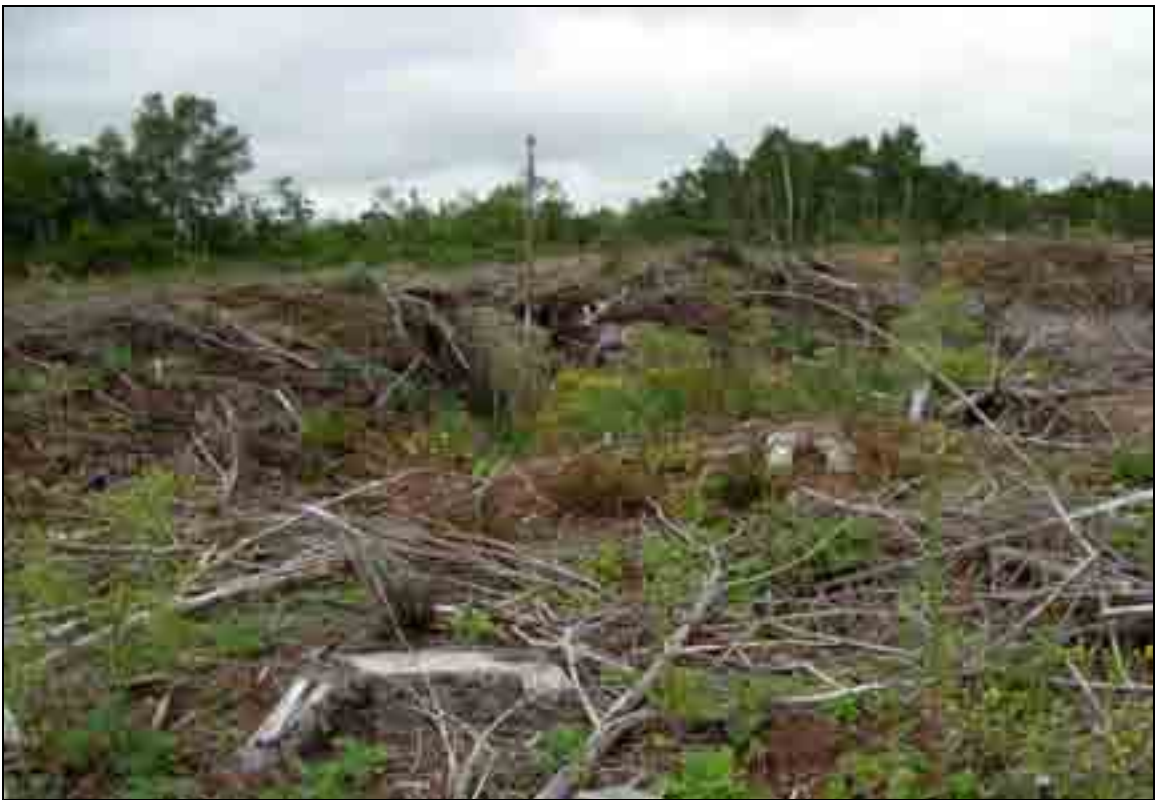
Crosswood Quadrat 2

Quadrat 2: This quadrat is located along the southern margin of the plantation and occurred under closed canopy conifers with a ground cover containing some Hypnum moss, but mainly consisted of pine needles. With the felling of the conifers, it can be seen that Purple Moor-grass, Foxglove and Fireweed are dominating the sparse groundflora. Bog vegetation has not established due to the dry nature of the site. Over time, if conditions become wetter with the blocking of drains, Ling Heather cover and *Sphagnum* cover will increase.

Crosswood Quadrat 2, 2005

Crosswood Quadrat 2, 2008

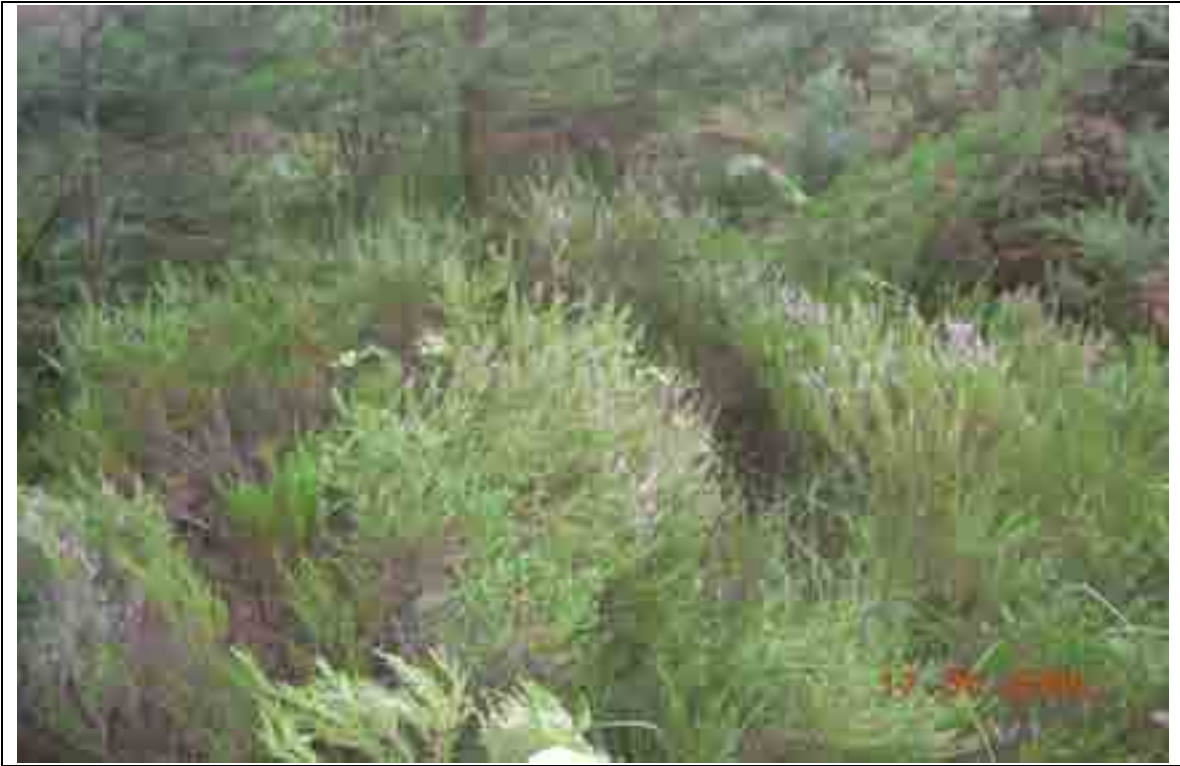
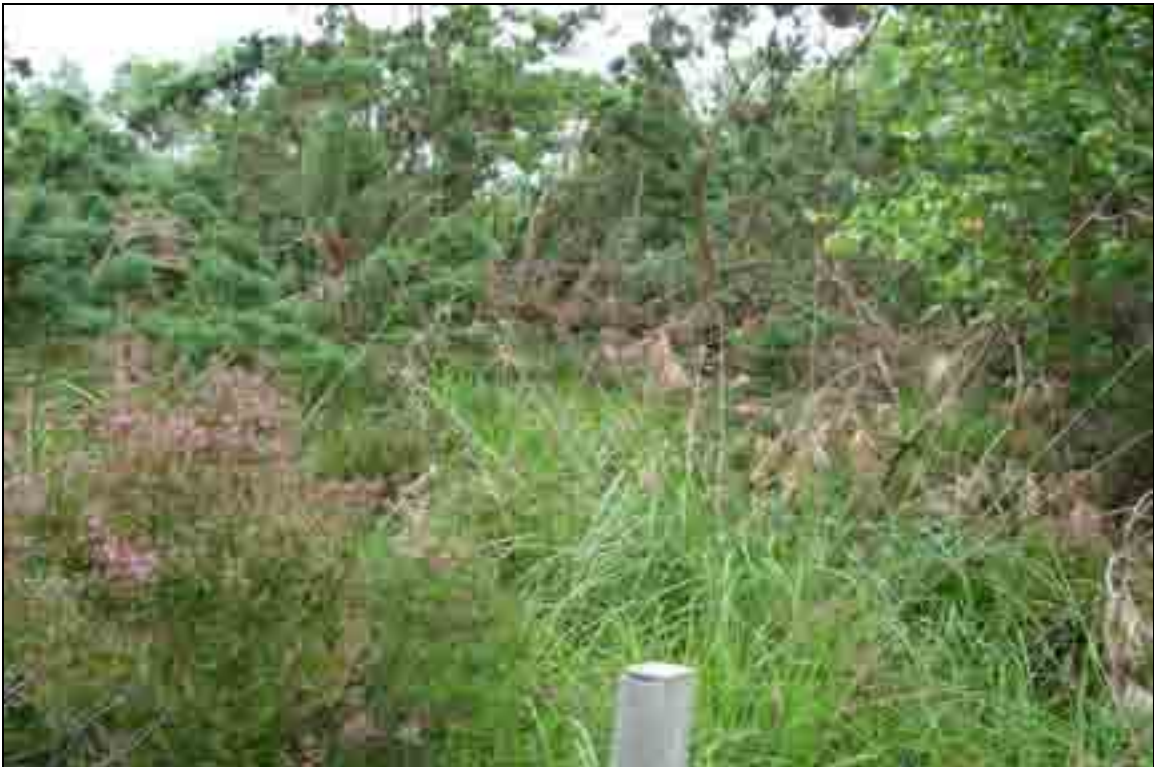
Crosswood Quadrat 3

Quadrat 3: This quadrat is located along the southern margin of the project site and occurred under scrub of Pine, Birch and Gorse with an understory of Ling Heather, Purple Moor-grass and Bracken. With the felling of the conifers, it can be seen that Purple Moor-grass cover increased and Ling Heather decreased in the groundflora. Birch and Gorse dominate this scrub. Birch woodland is the natural vegetation of raised bog margins this woodland will be allowed to develop further

Crosswood Quadrat 3, 2005

Crosswood Quadrat 3, 2008

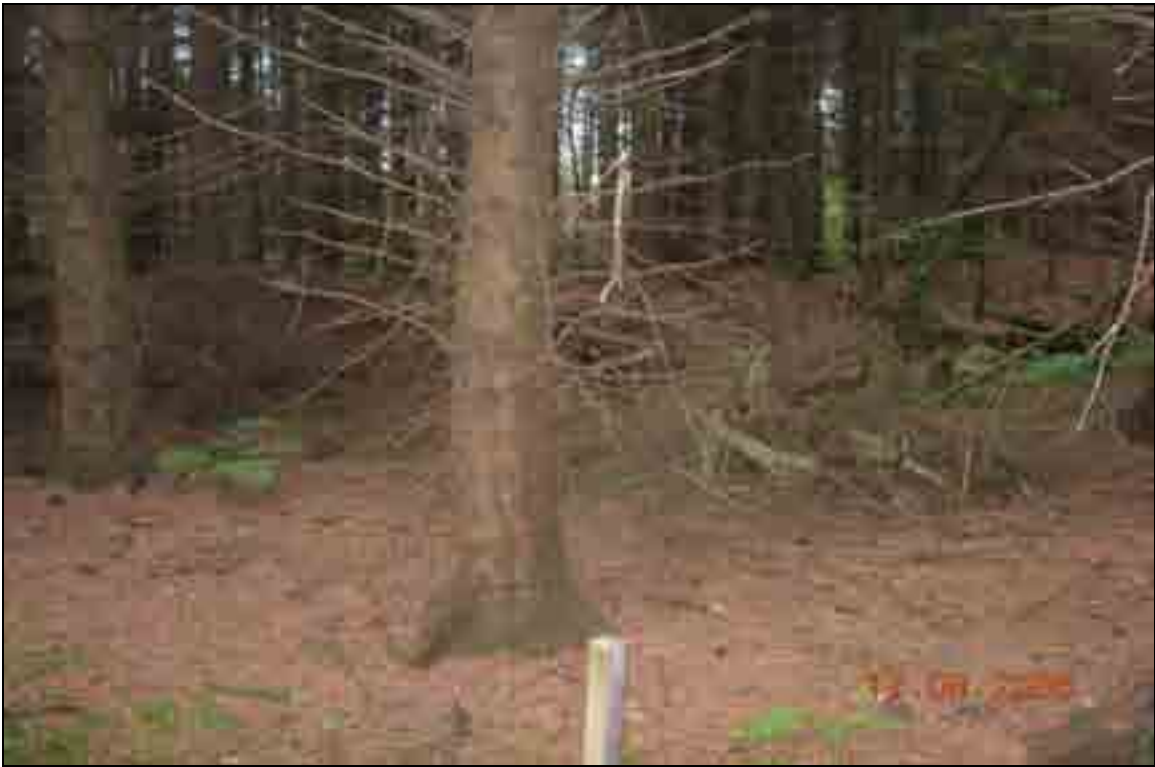
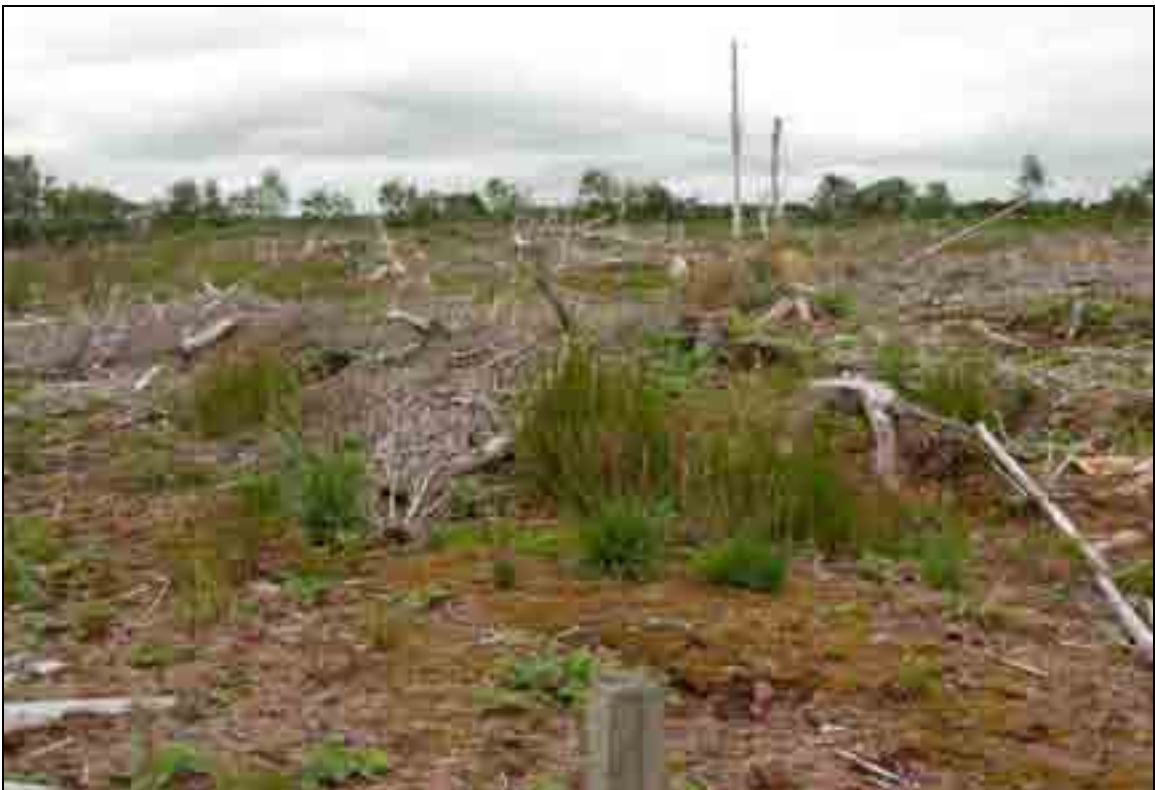
Crosswood Quadrat 4

Quadrat 4: This quadrat is located to the south-west of the plantation and occurred under closed canopy Sitka Spruce with a ground cover containing some Hypnum moss, but mainly consisted of pine needles. With the felling of the conifers, it can be seen that Bramble, and Ragwort are dominating the sparse groundflora. Bog vegetation has not established due to the dry nature of the site. Drains remain un-blocked in this area due to the close proximity of peat-cutting and will not be blocked until peat-cutting has ceased.

Crosswood Quadrat 4, 2005

Crosswood Quadrat 4, 2008

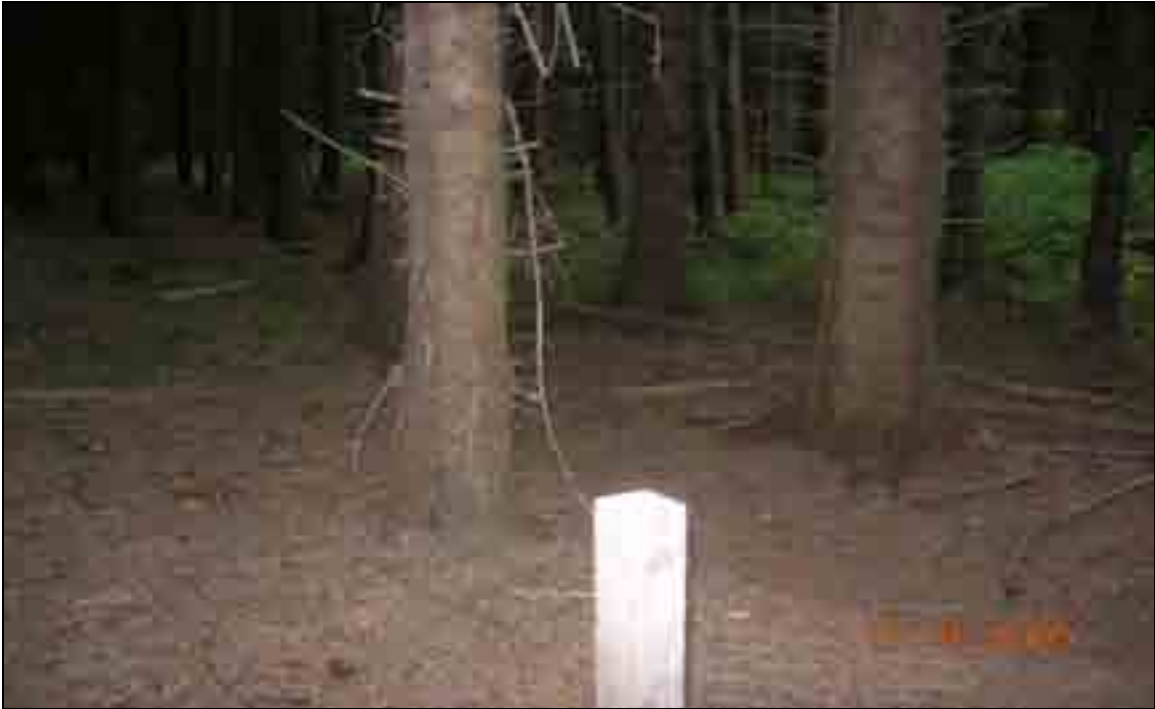
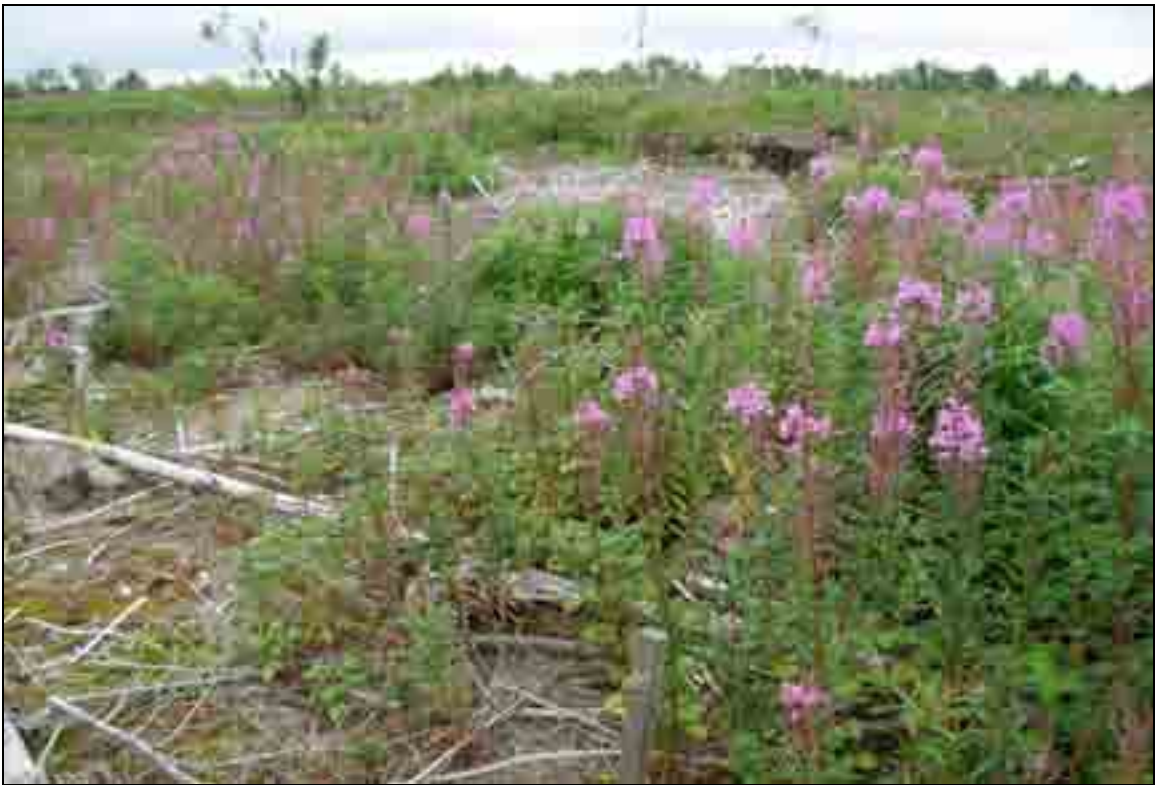
Crosswood Quadrat 5

Quadrat 5: This quadrat is located at the south-western margin of the plantation and occurred under closed canopy Sitka Spruce with a ground cover containing some *Hypnum* moss, but mainly consisted of pine needles. With the felling of the conifers, it can be seen that Fireweed and Bramble are dominating the sparse groundflora. Bog vegetation has not established due to the dry nature of the site. Drains remain un-blocked in this area due to the close proximity of peat-cutting and will not be blocked until peat-cutting has ceased.

Crosswood Quadrat 5, 2005

Crosswood Quadrat 5, 2008

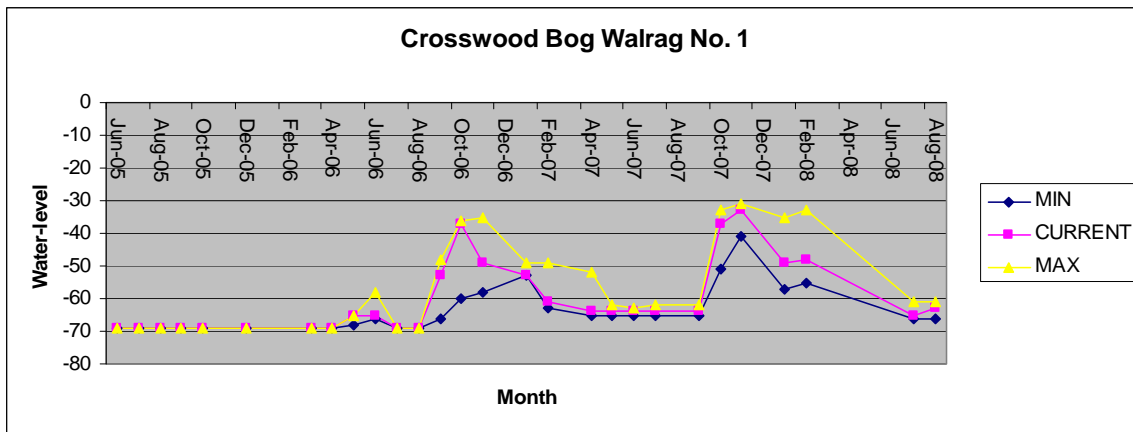
Crosswood Bog Walrag 1: Closed Canopy Conifer Plantation on Cutover Bog. (Water-levels were raised after tree-felling and drain-blocking* but declined again once drains were reopened)

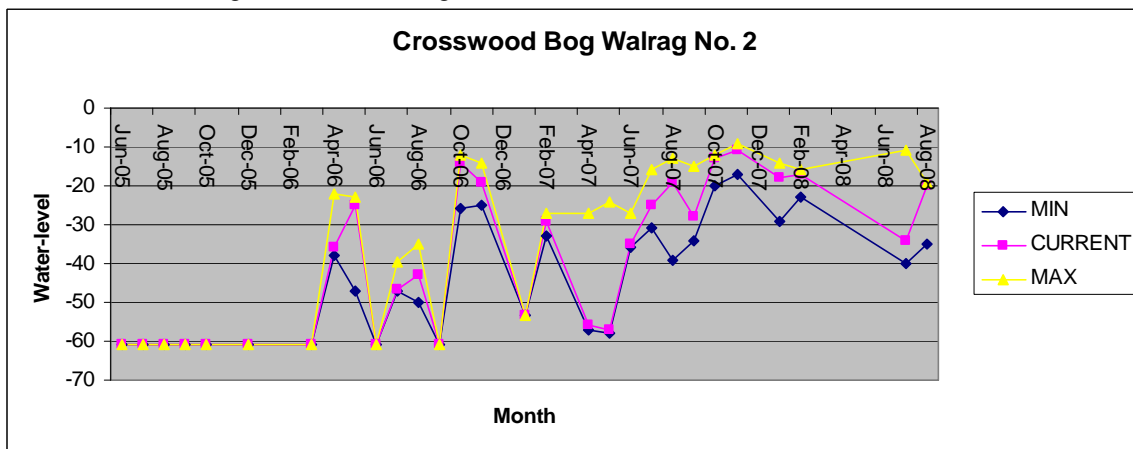
Crosswood Bog Walrag 2: Closed Canopy Conifer Plantation on Cutover Bog. (Water-levels were raised after tree-felling and drain-blocking*)

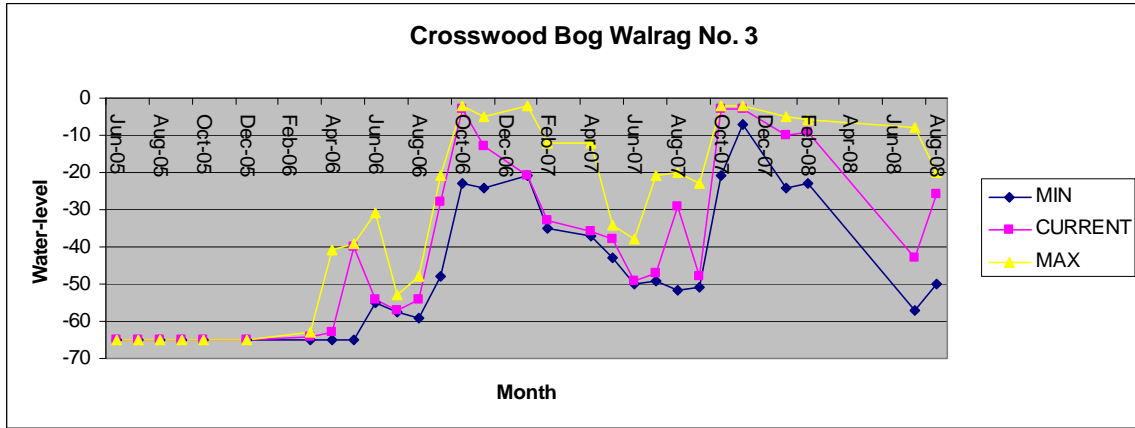
Crosswood Bog Walrag 3: Closed Canopy Conifer Plantation on High Bog. (Water-levels were raised after tree-felling and drain-blocking* but declined again once drains were reopened)

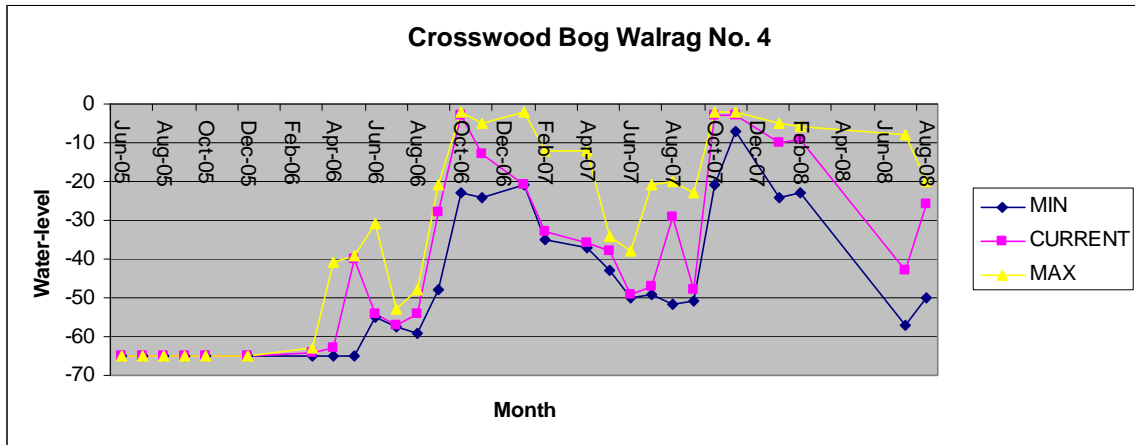
Crosswood Bog Walrag 4: Birch woodland on Cutover Bog. (Water-levels have been raised post restoration* on adjacent conifer plantations. However water-levels still decline during summer months.)

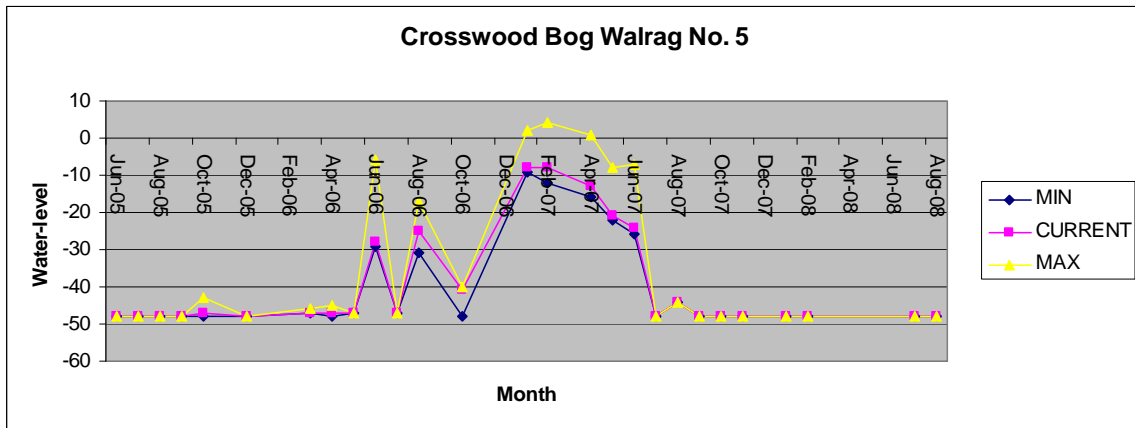
Crosswood Bog Walrag 5: Closed Canopy Conifer Plantation on High Bog. (Water-levels were raised after tree-felling and drain-blocking* but declined again once drains were reopened)

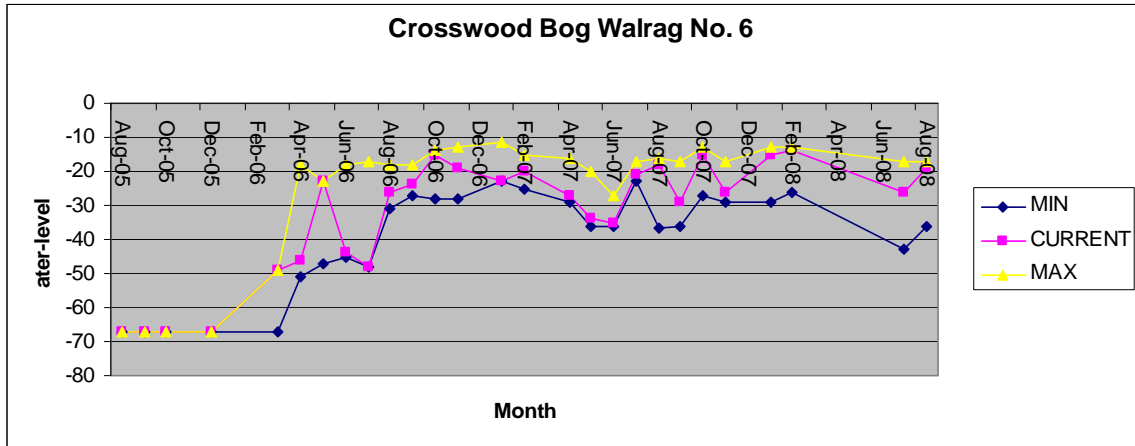
Crosswood Bog Walrag 6: Closed Canopy Conifer Plantation on High Bog. (Water-levels were raised after tree-felling and drain-blocking* and remain high despite reopening of main drains)

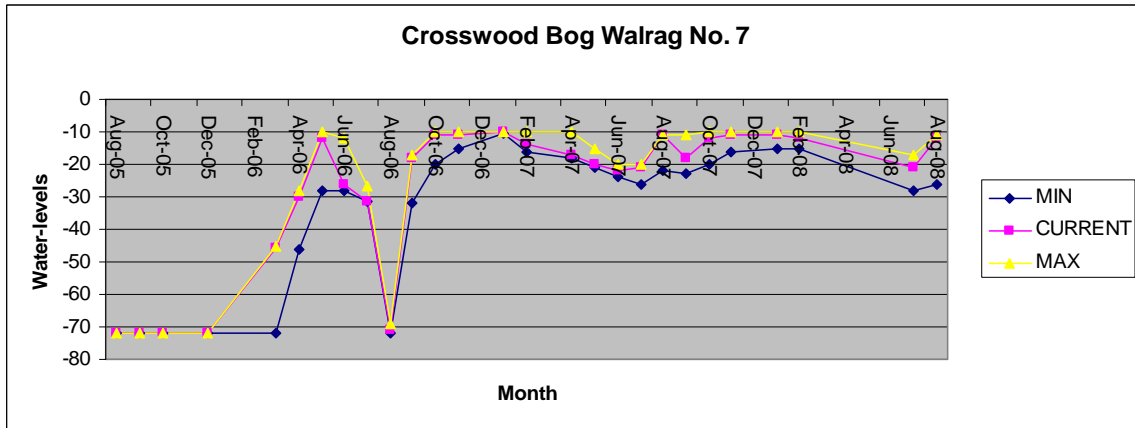
Crosswood Bog Walrag 7: Closed Canopy Conifer Plantation on High Bog. (Water-levels were raised after tree-felling and drain-blocking* and remain high despite reopening of main drains)

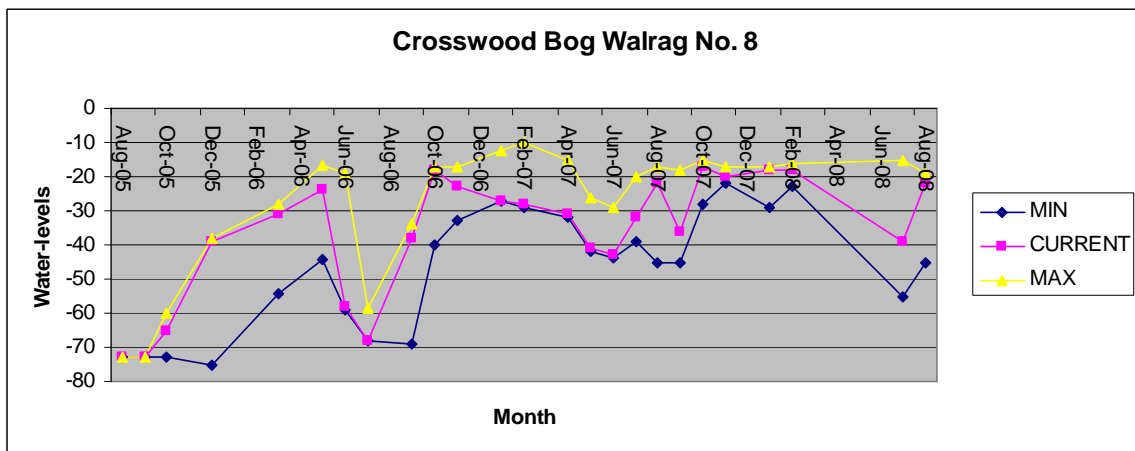
Crosswood Bog Walrag 8: Scrub woodland on Cutover Bog. (Water-levels have been raised post restoration* on adjacent conifer plantations. However water-levels still decline slightly during summer months.)
