RESTORING RAISED BOG IN IRELAND
Project Reference: LIFE04 NAT/IE/000121

A REPORT ON THE RESTORATION OF PROJECT SITE No. 7

DRUMALOUGH BOG, Co. ROSCOMMON

**Compiled by: John Derwin,
Project Ecologist,
September 2008**

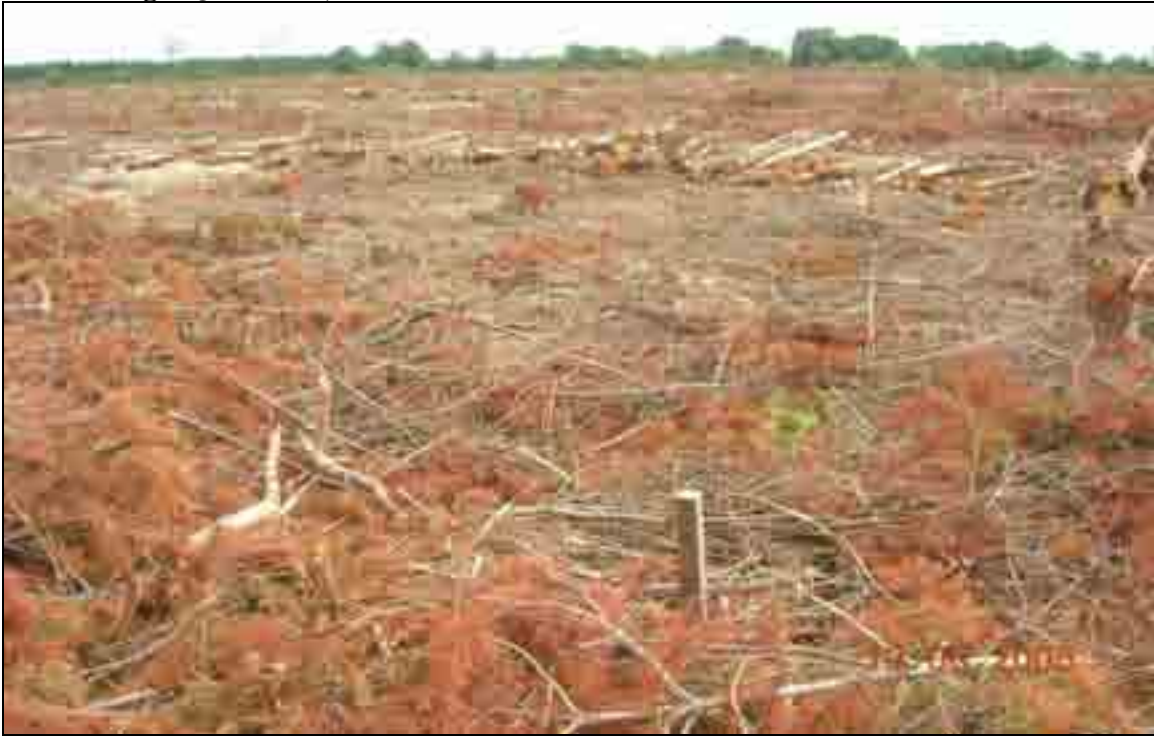
Drumalough Quadrat 1, 2005

Quadrat 1: This quadrat is located towards the centre of the plantation on the south-east margin of Drumalough and occurred under closed canopy conifers with a ground cover containing some *Sphagnum recurvum*, but mainly consisted of pine needles. With the felling of the conifers and blocking of drains, it can be seen that Ling Heather and Hare's-tail Cotton-grass cover increased along with *Sphagnum* cover. Over time, if conditions remain wet, *Sphagnum* cover will increase further and active peat formation will occur.

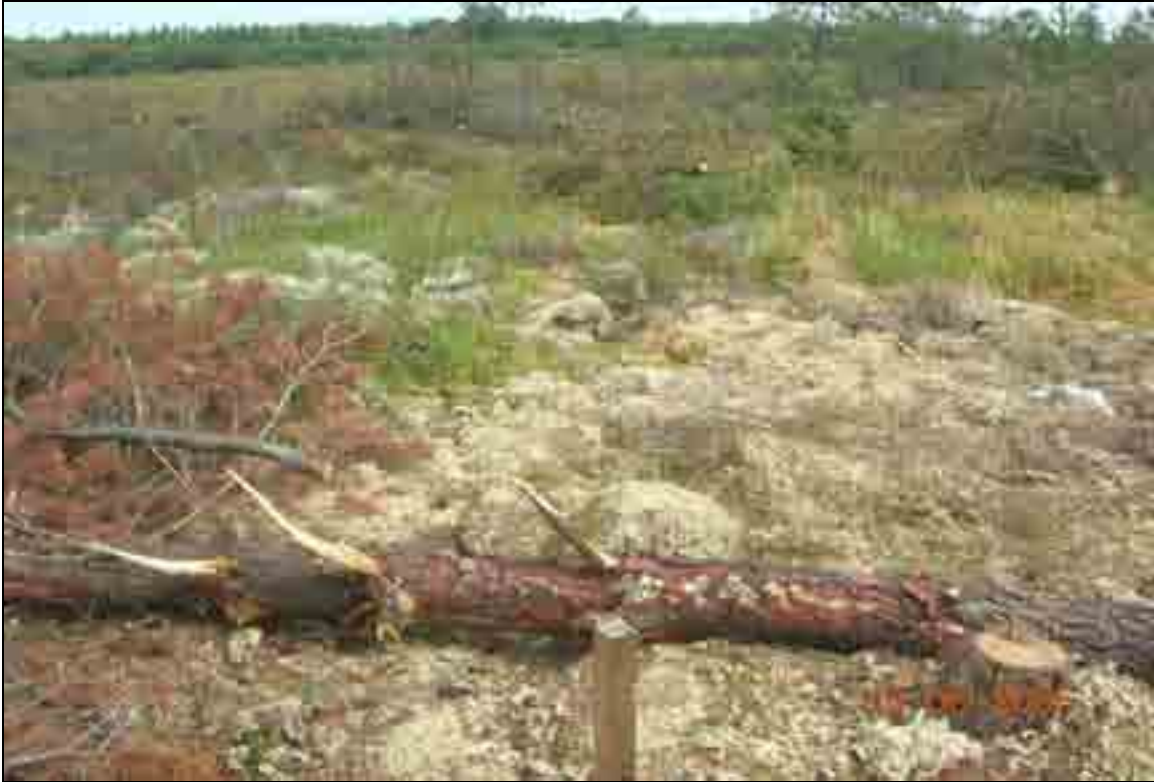
Drumalough Quadrat 2, 2005

Quadrat 2: This quadrat is located at the northern margin of the south-east plantation and occurred with moribund trees and abundant bog vegetation of Ling Heather, Bog Asphodel, Hare's-tail Cotton-grass and numerous *Sphagnum* mosses. With the felling of the sparse conifers and blocking of drains, it can be seen that the *Sphagnum* cover reduced somewhat, but this will recover over time and active bog habitat will be established.

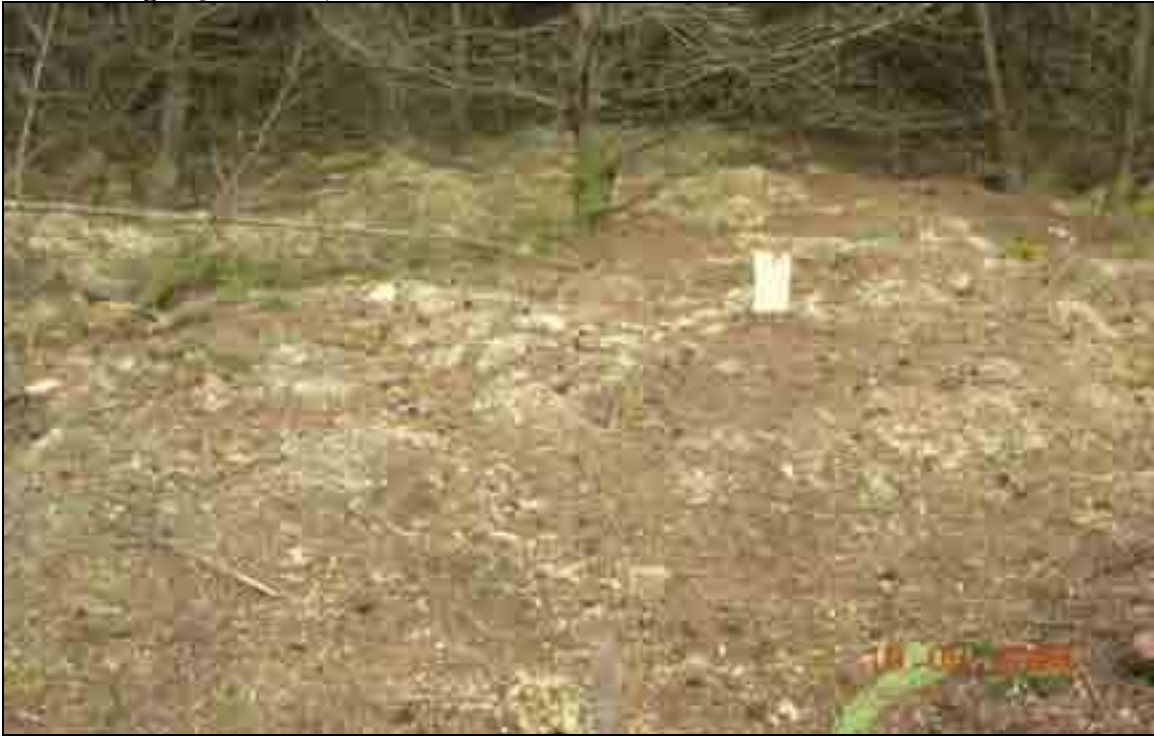
Drumalough Quadrat 3, 2005

Quadrat 3: This quadrat is located in the northern plantation on Drumalough and occurred under open canopy conifers with a ground cover containing *Sphagnum recurvum* and *S. capillifolium* along with pine needles. With the felling of conifers and blocking of drains, it can be seen that Ling Heather, Purple Moor-grass and Hare's-tail cotton-grass cover has increased along with *Sphagnum*. Over time, if conditions remain wet, *Sphagnum* cover will increase further and active raised bog habitat will occur.

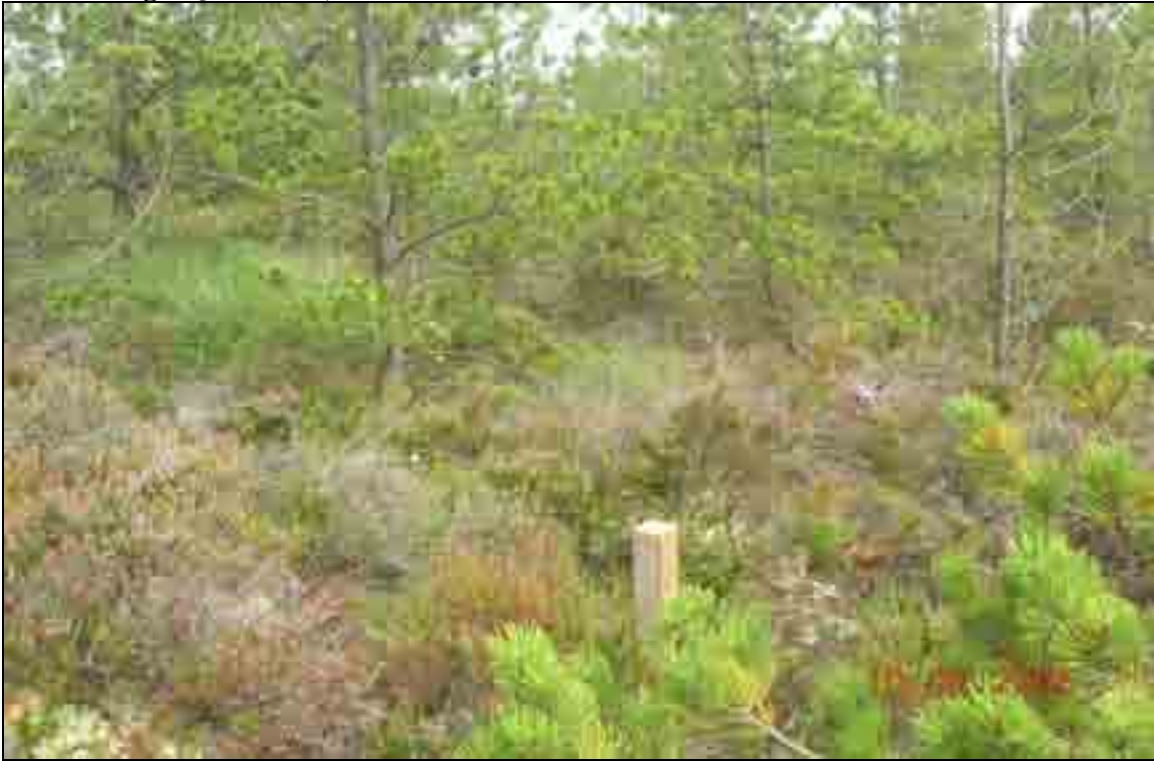
Drumalough Quadrat 4, 2005

Quadrat 4: This quadrat is located towards the margin of the northern plantation at Drumalough and occurred under open canopy of conifers with a ground cover containing Ling Heather, Purple Moor-grass, Cotton-grasses and abundant *Sphagnum*. With the felling of the conifers and blocking of drains, it can be seen that *Sphagnum* cover decreased but this will recover over time. If conditions remain wet, *Sphagnum* cover will increase active bog habitat will be established.

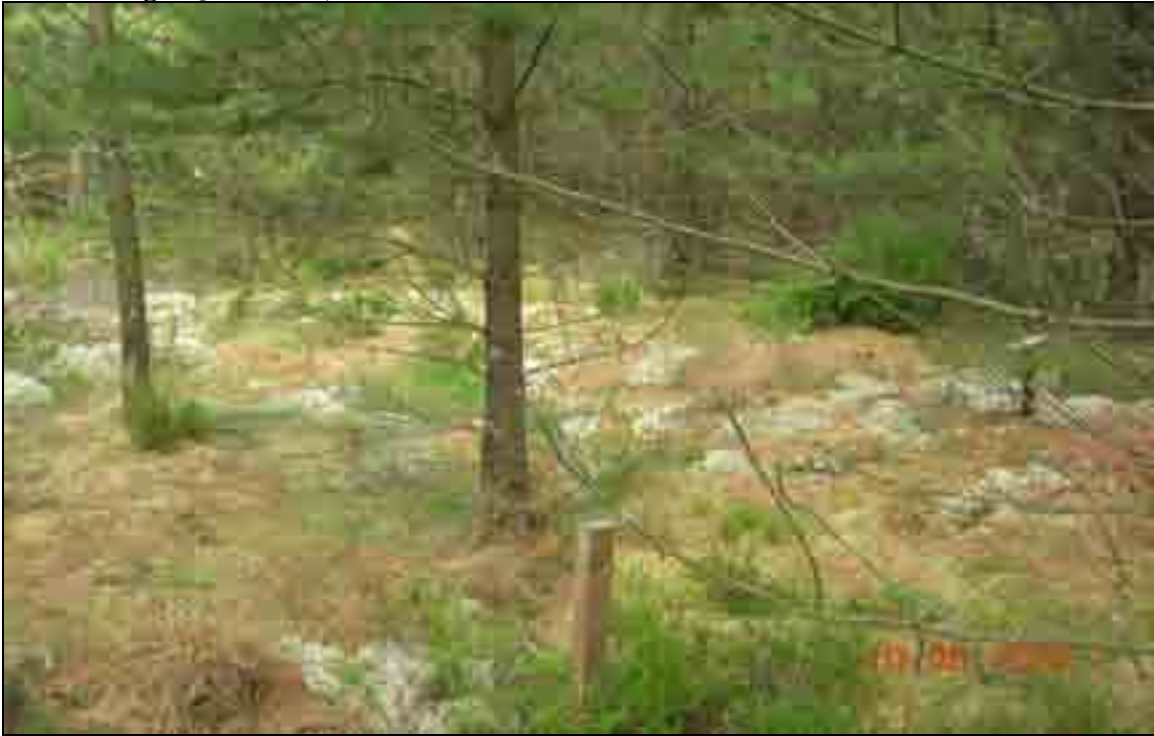
Drumalough Quadrat 5, 2005

Quadrat 5: This quadrat is located towards the margin of the conifer plantation in the western section of raised bog and occurred under closed canopy conifers with a ground cover containing bog vegetation including abundant *Sphagnum*. With the felling of the conifers and blocking of drains, it can be seen that the bog vegetation remains but *Sphagnum* cover decreased. *Sphagnum* cover will recover over time and if conditions remain wet, active raised bog habitat will be established.

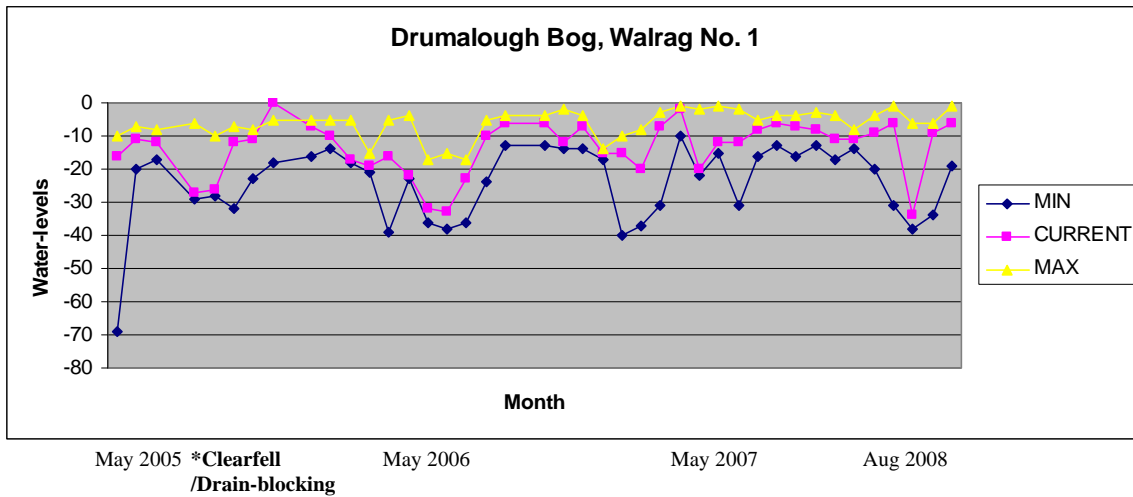
Drumalough Bog Walrag 1: Closed Canopy Conifer Plantation on High Bog. (Water-levels decline in summer months, with little change post restoration*)

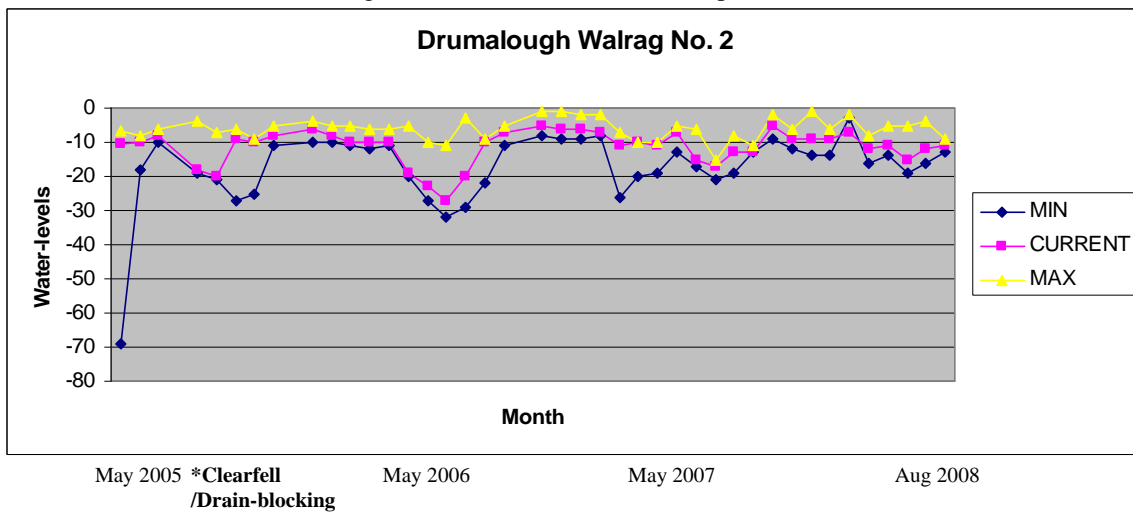
Drumalough Bog Walrag 2: Open Canopy Conifer Plantation on High Bog. (Water-levels decline in summer months, before tree-felling. Water-levels have been raised post restoration*)

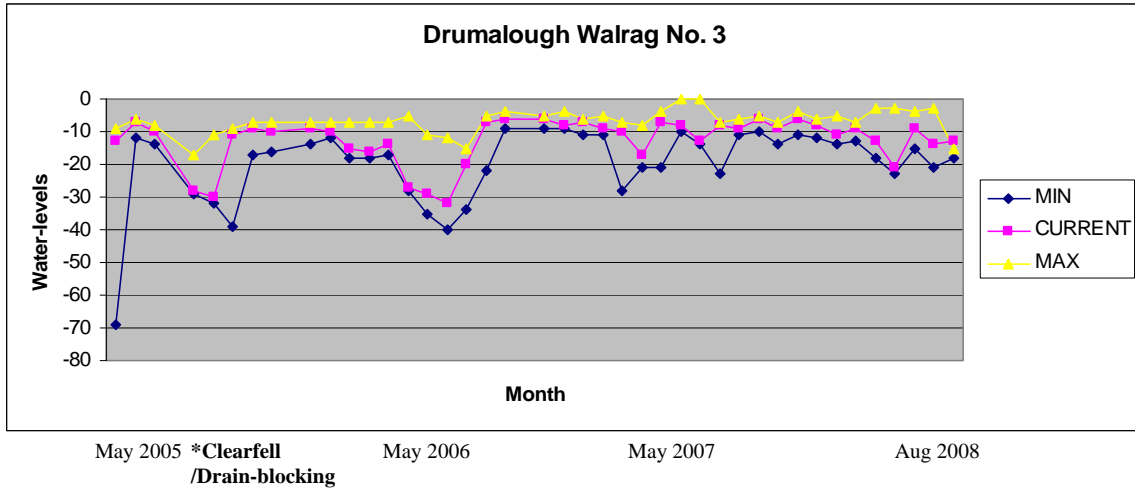
Drumalough Bog Walrag 3: Open Canopy Conifer Plantation on High Bog. (Decline in water-levels in summer months before tree-felling. Water-levels have been raised post restoration*)

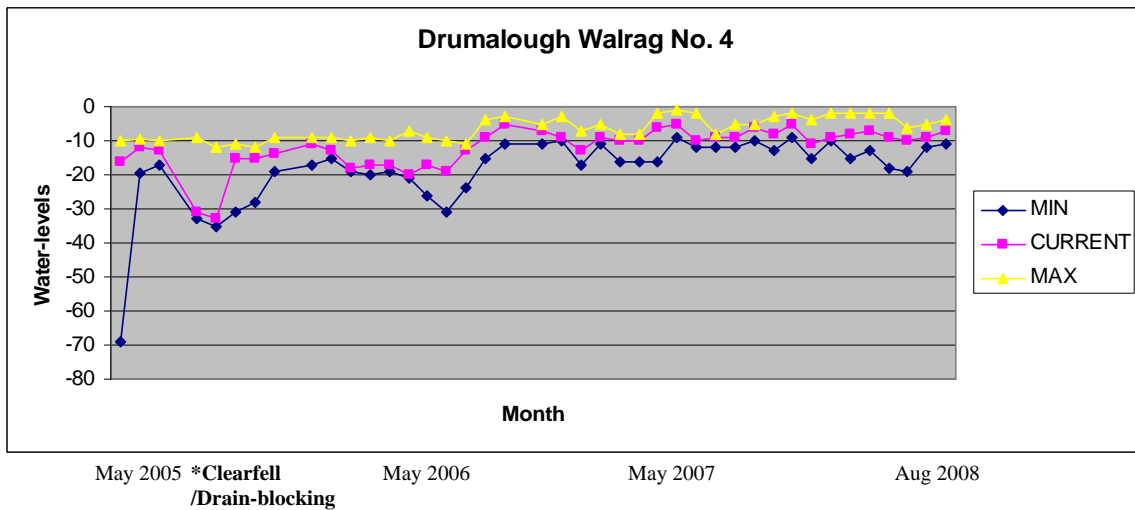
Drumalough Bog Walrag 4: Unplanted Cutover Bog. (Decline in water-levels during summer months. Water-levels have risen post restoration* on adjacent conifer plantations)

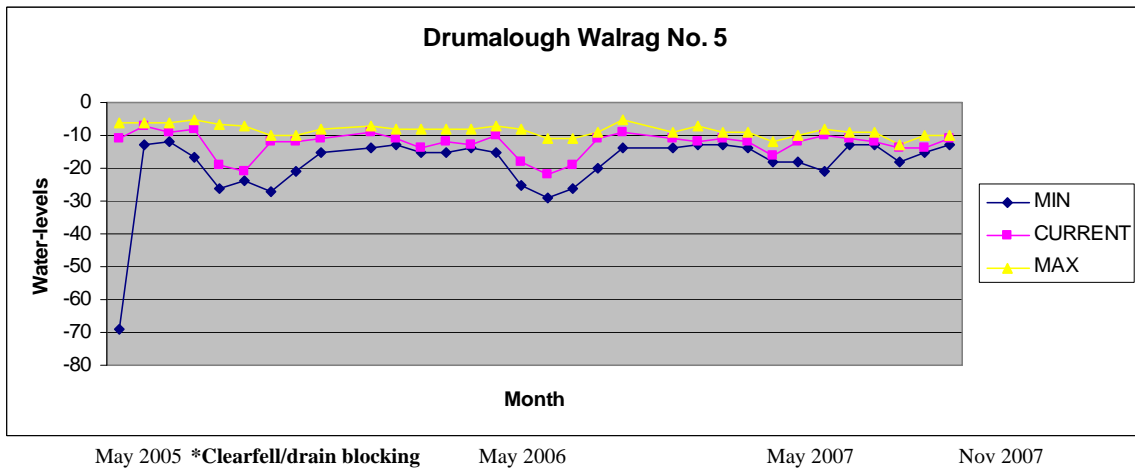
Drumalough Bog Walrag 5: Unplanted Cutover Bog. (Decline in water-levels during summer months, has decreased post restoration* on adjacent conifer plantations, this Walrag was removed in Dec 2007)

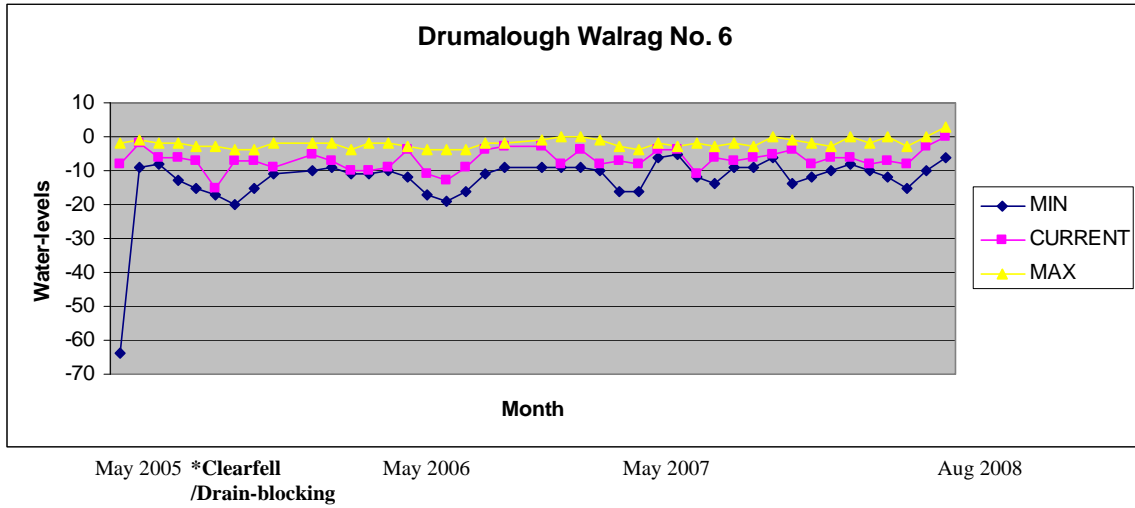
Drumalough Bog Walrag 6: Open Canopy Conifer Plantation on High Bog. (Decline in water-levels in summer months before tree-felling. Water-levels have been raised slightly post restoration*)

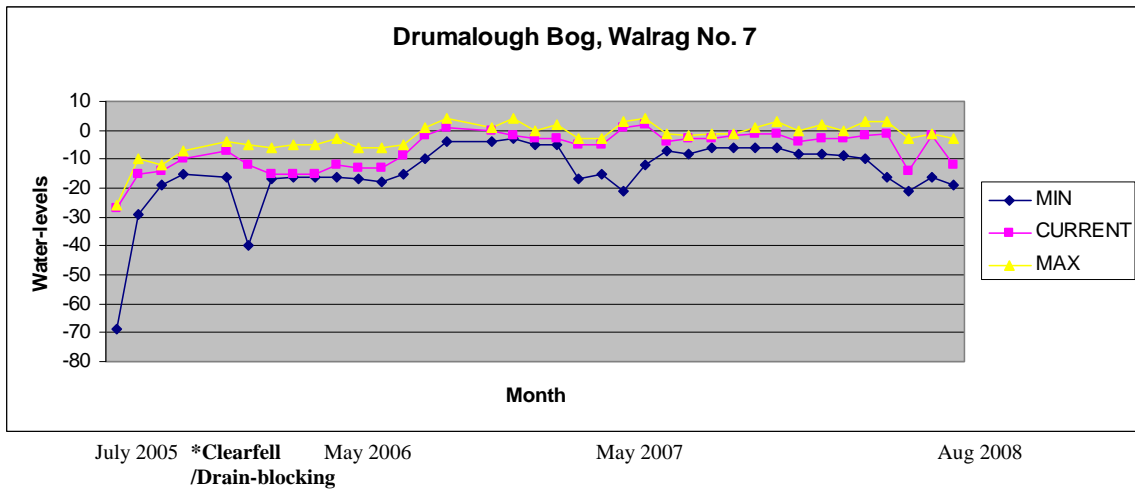
Drumalough Bog Walrag 7: Closed Canopy Conifer Plantation on High Bog. (Water-levels decline in summer months before tree-felling. Water-levels have been raised post restoration*)

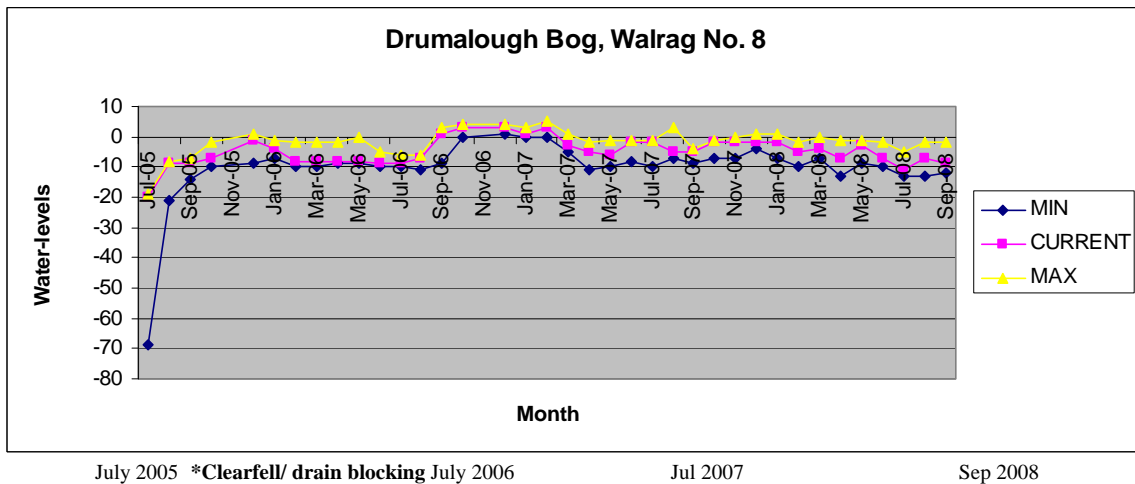
Drumalough Bog Walrag 8: Clearfelled Conifer Plantation on High Bog. (Water-levels remain within 10cm of bog surface post restoration*)

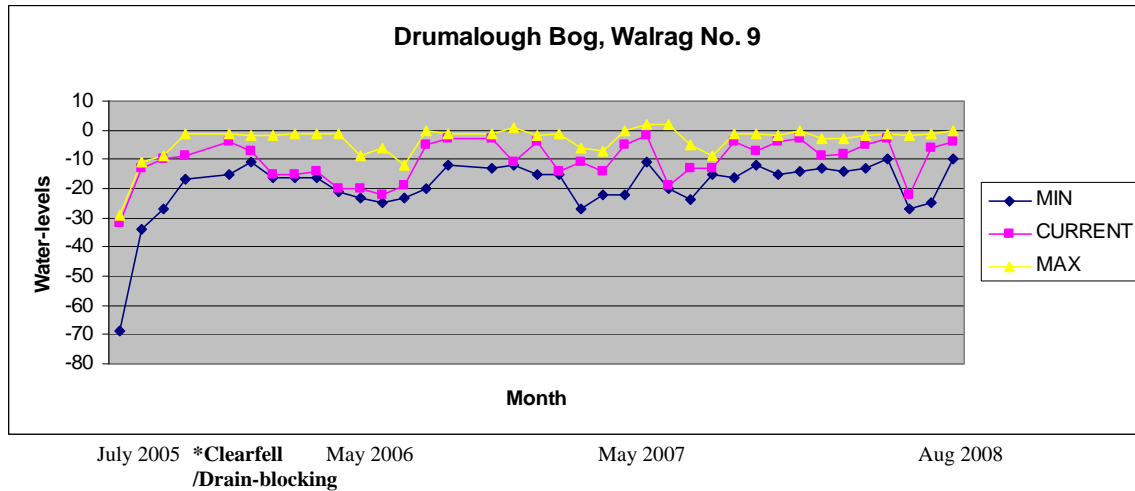
Drumalough Bog Walrag 9: Open Canopy Conifer Plantation on High Bog. (Decline in water-levels in summer months before tree-felling. Water-levels have been raised slightly post restoration*).

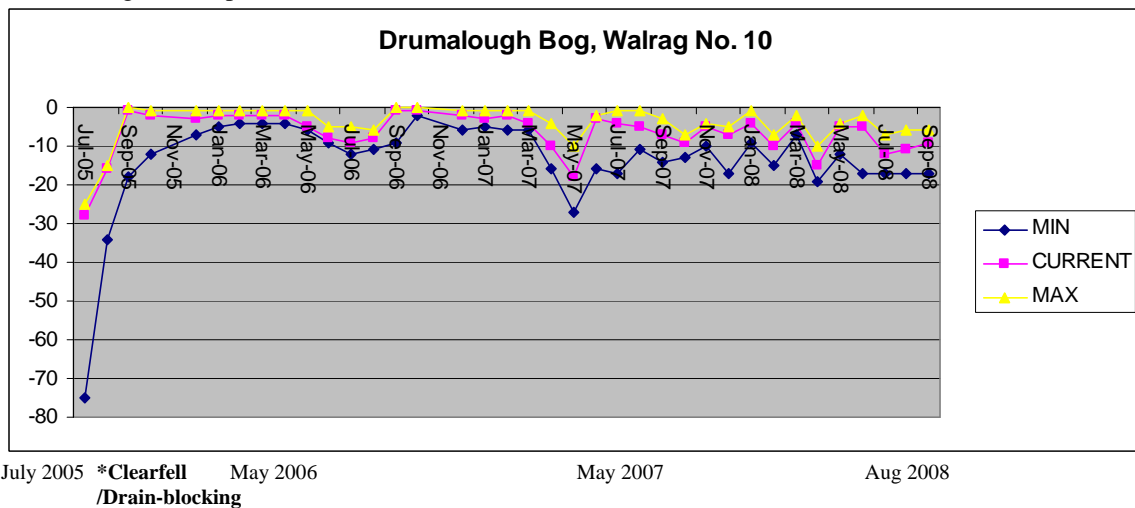
Drumalough Bog Walrag 10: Clearfelled Conifer Plantation on High Bog. (Water-levels remain within 20cm of bog surface post restoration*).
