RESTORING RAISED BOG IN IRELAND
Project Reference: LIFE04 NAT/IE/000121

A REPORT ON THE RESTORATION OF PROJECT SITE No. 9

KILLYCONNY BOG, Co. CAVAN

**Compiled by: John Derwin,
Project Ecologist,
September 2008**

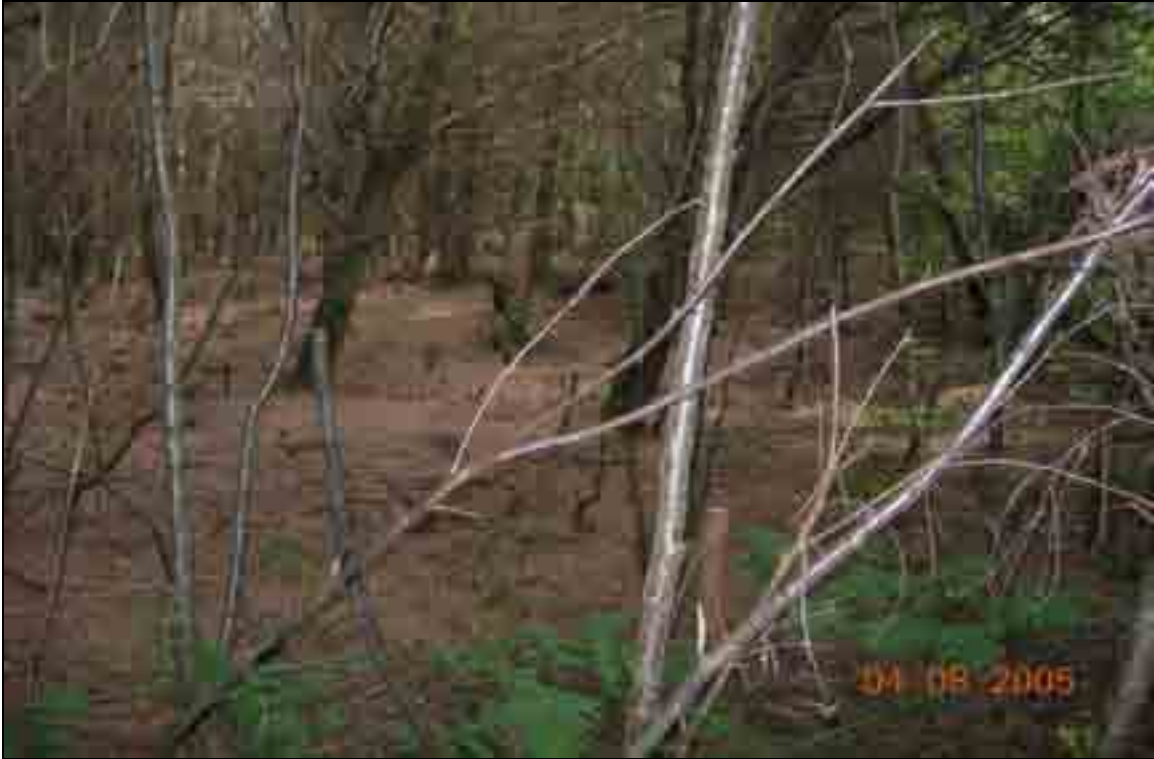
Quadrat 1, Aug 2005

Quadrat 1: This quadrat is located towards the western margin of the plantation and occurred under closed canopy conifers with a ground cover containing some *Sphagnum recurvum*, but mainly consisted of pine needles. With the felling of the conifers and blocking of drains, it can be seen that Ling Heather cover and *Sphagnum* cover increased along with Purple Moor-grass and Bramble. Over time, if conditions remain wet, *Sphagnum* cover will increase further and the invasive Bramble will die out.

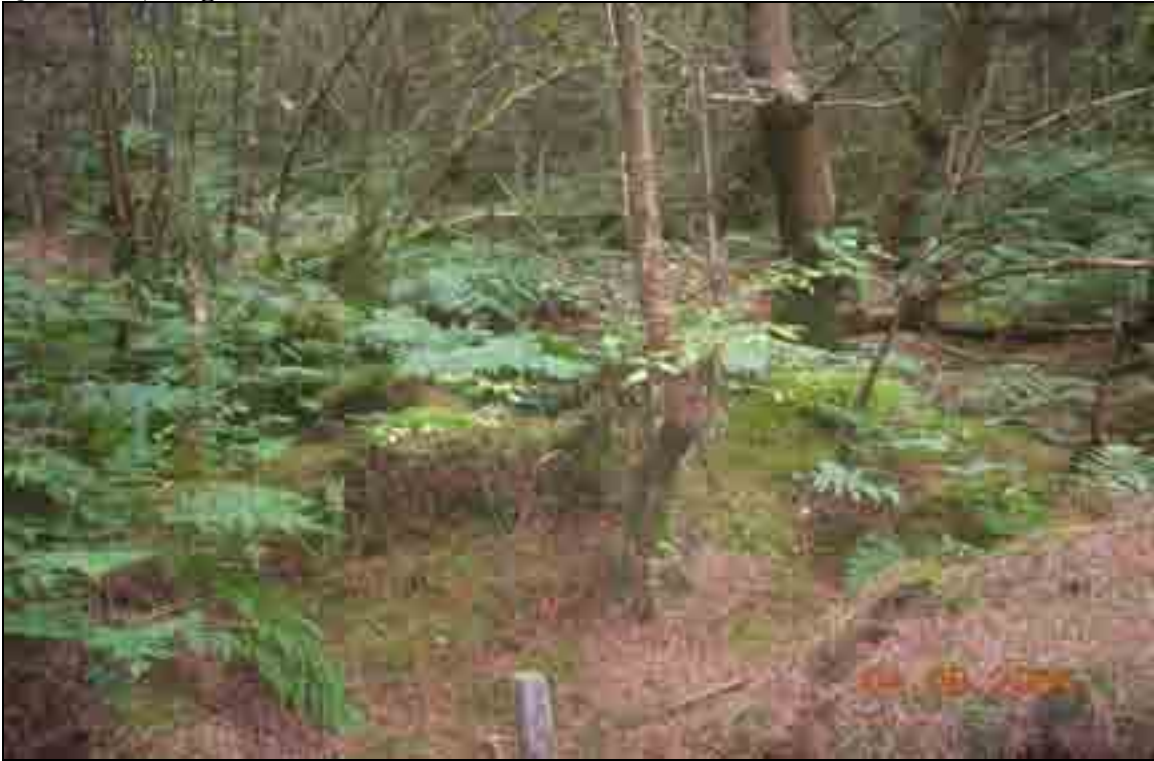
Quadrat 2, Aug 2005

Quadrat 2: This quadrat is located towards the northern margin of the plantation and occurred under mixed woodland of conifers and birch with a sparse groundflora containing some *Sphagnum recurvum*, but mainly dominated by Buckler Fern. With the felling of the conifers and blocking of drains, it can be seen that Ling Heather cover increased along with Bracken and Bramble. This area has remained dry, despite drain-blocking and Birch woodland will establish here at the bog margin.

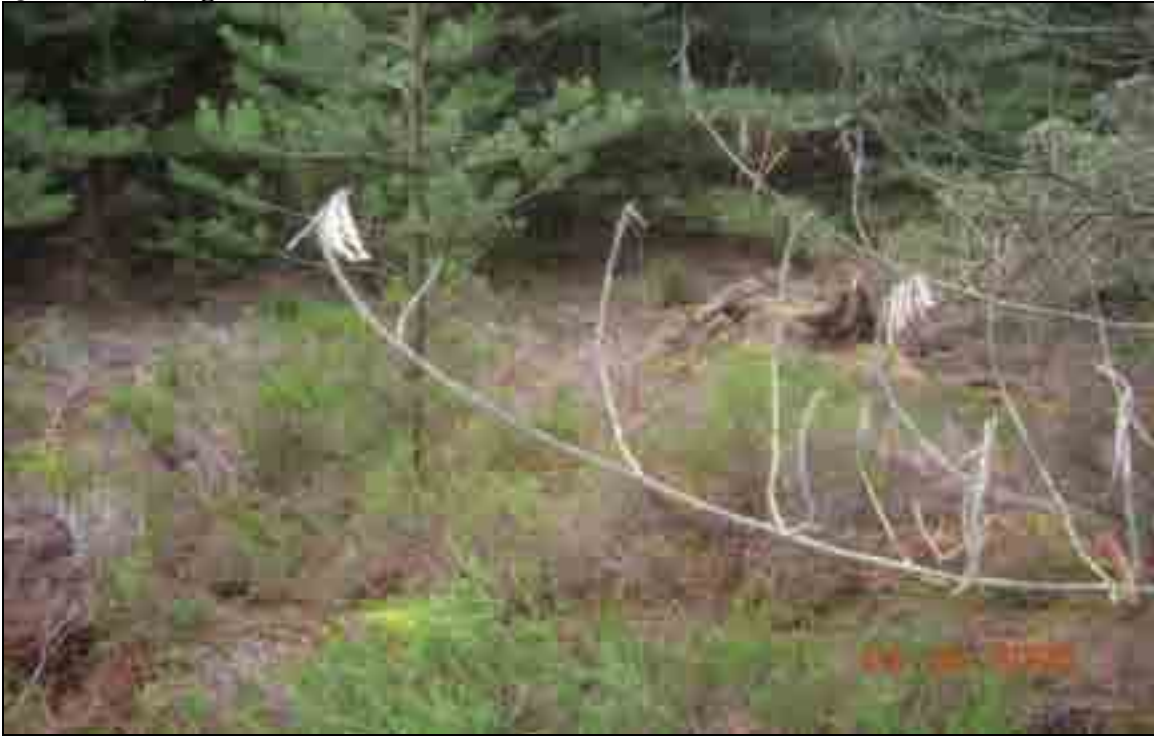
Quadrat 3, Aug 2005

Quadrat 3: This quadrat is located towards the centre of the plantation and occurred under an open canopy of conifers along a firebreak with groundflora containing *Sphagnum* mosses but mainly dominated by Ling Heather. With the felling of the conifers and blocking of drains, it can be seen that Ling Heather cover decreased and *Sphagnum* cover increased along with Purple Moor-grass and Hare's-tail Cottongrass.

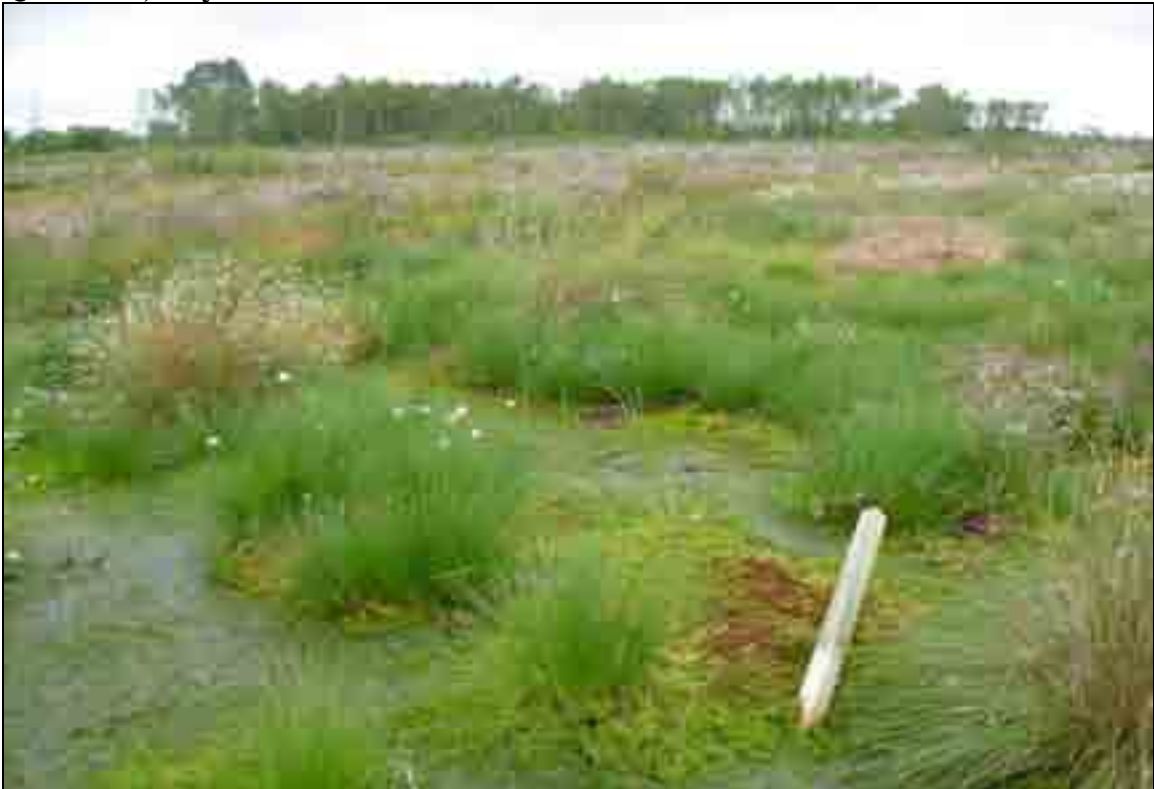
Quadrat 3, July 2008

Over time, if conditions remain wet, *Sphagnum* cover will increase further and active peat formation may be established. It should be noted that an algal blooms occur due to a flush of nutrients after clear-felling, but this should reduce over time as ombrotrophic conditions return.

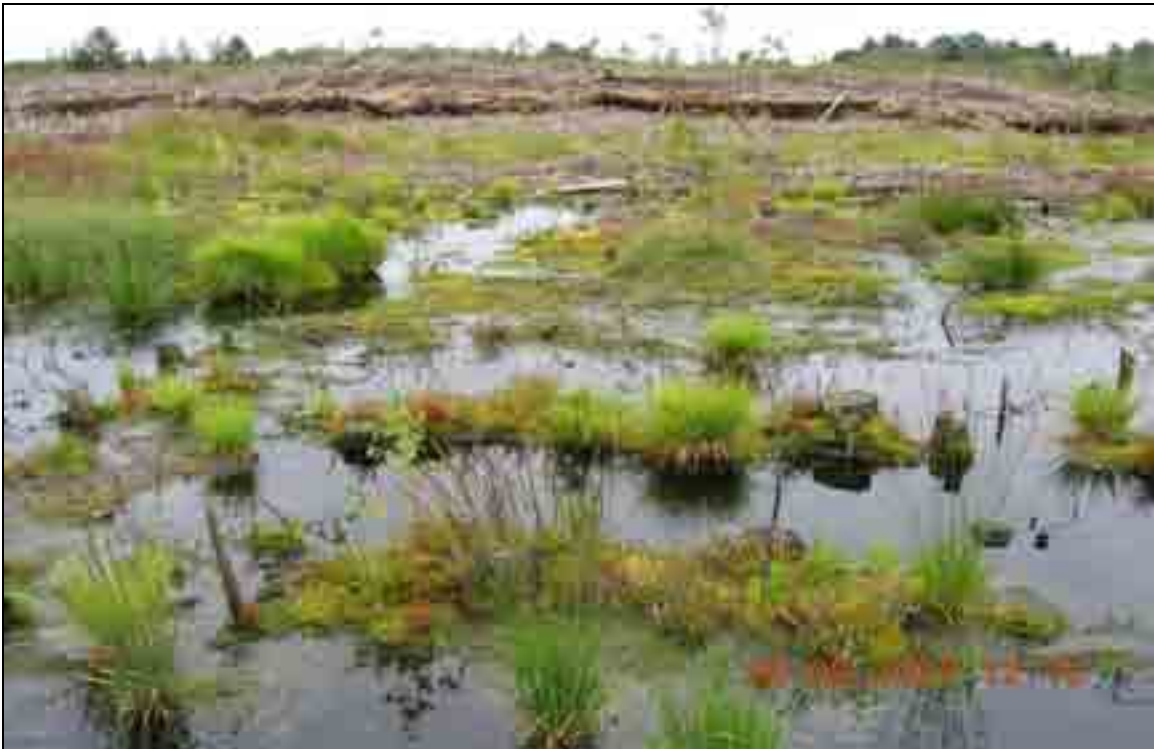
Prior to restoration, Walrags were installed in the conifer plantation to record any changes in water-levels, due to tree removal and drain blocking. Water-levels were found to be up to **60cm** below the surface. With the removal of conifers and drain-blocking, there was a significant rise in the water-table within the project site. Extensive areas of open water were created and the water-table remains close to the bog surface throughout most of the year.

Water-levels rise on Killyconny after clear-felling

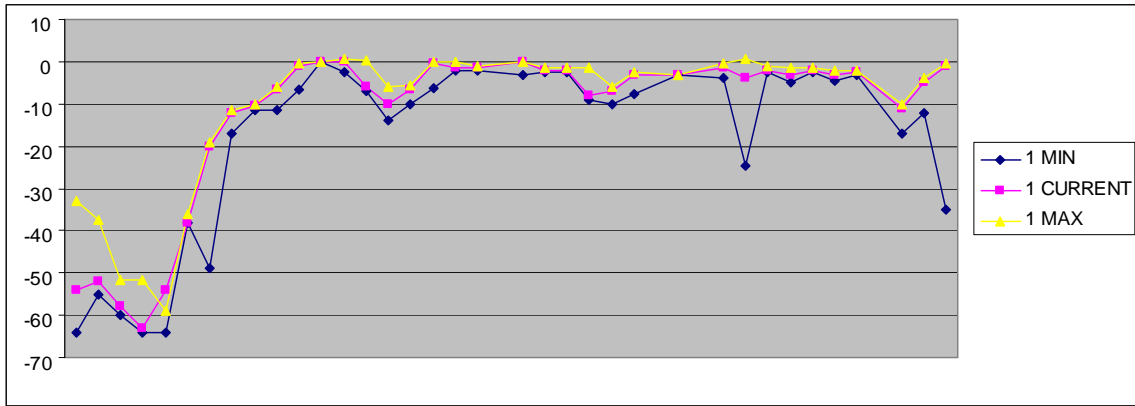
Killyconny Bog Walrag 1 (Cutover Bog, distinct rise in water-levels post restoration*)

May 2005 (Installed) * May 2006 *Clearfell & Drain-blocking May 2007 Aug 2008

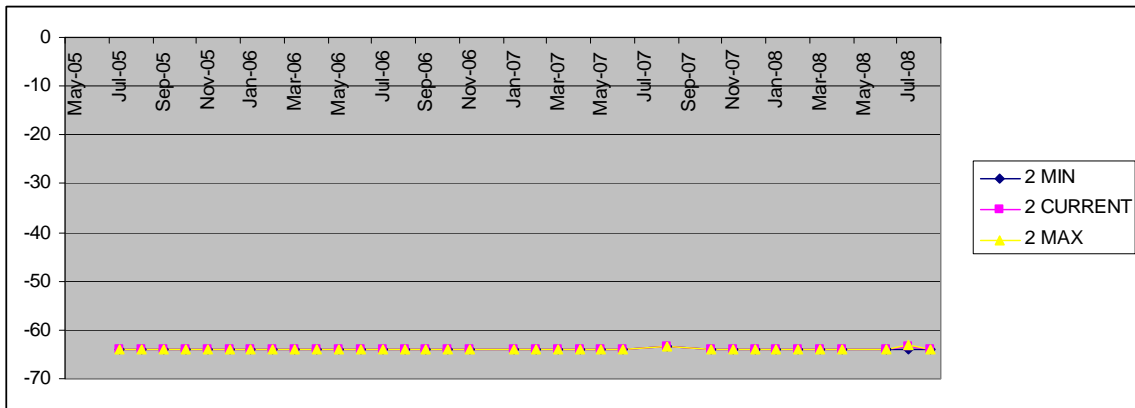
Killyconny Bog Walrag 2 (Dry Woodland Margin, no rise in water-levels)

May 2005 (Installed) * May 2006 *Clearfell & Drain-blocking May 2007 Aug 2008

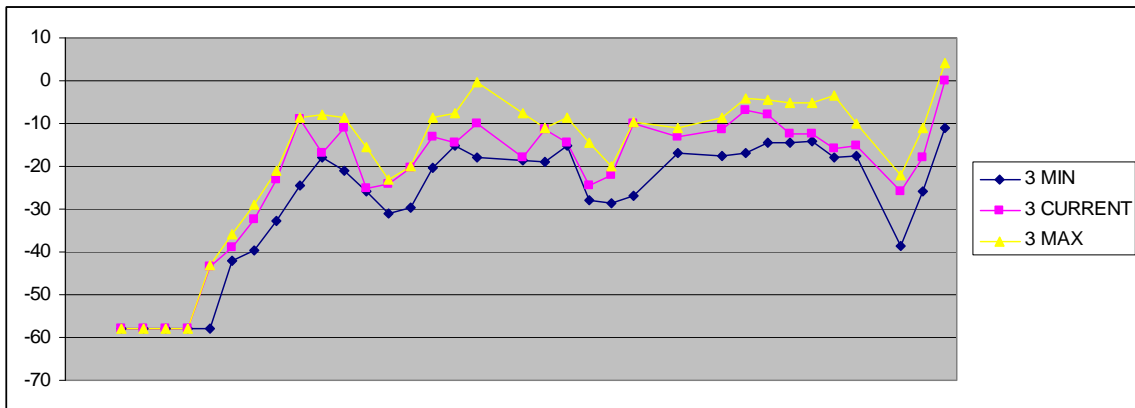
Killyconny Bog Walrag 3 (Cutover Bog, distinct rise in water-levels post restoration*)

May 2005 (Installed) * May 2006 *Clearfell & Drain-blocking May 2007 Aug 2008

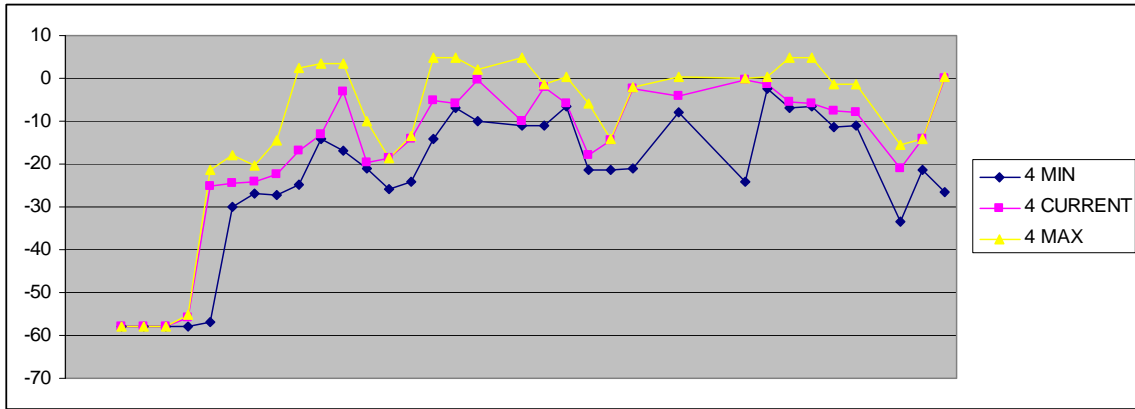
Killyconny Bog Walrag 4 (Cutover Bog, distinct rise in water-levels post restoration*)

May 2005 (Installed) * May 2006 May 2007 Aug 2008
 *Clearfell & Drain-blocking

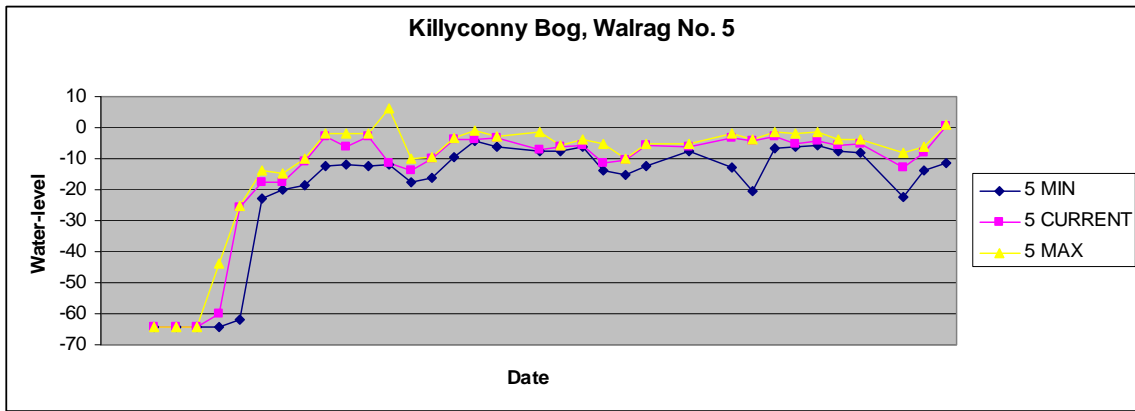
Killyconny Bog Walrag 5 (Cutover Bog, distinct rise in water-levels post restoration*)

May 2005 (Installed) * May 2006 May 2007 Aug 2008
 *Clearfell & Drain-blocking

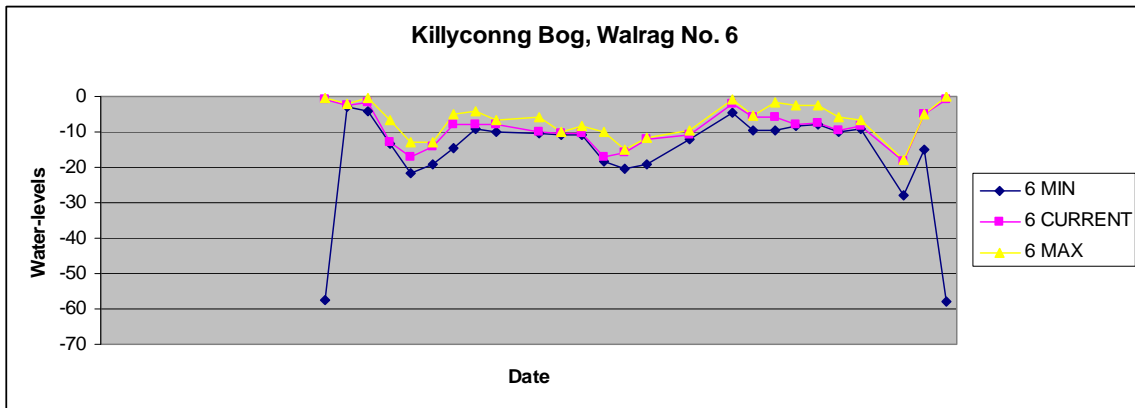
Killyconny Bog Walrag 6 (Cutover Bog, high water-levels post restoration*)

May 2005 * May 2006 (Installed) May 2007 Aug 2008
 *Clearfell & Drain-blocking
