**RESTORING RAISED BOG IN IRELAND**  
**Project Reference: LIFE04 NAT/IE/000121**

**A REPORT ON THE RESTORATION OF PROJECT SITE No. 4**

**KILLSALLAGH BOG, Co. GALWAY**

**Compiled by: John Derwin,  
Project Ecologist,  
September 2008**

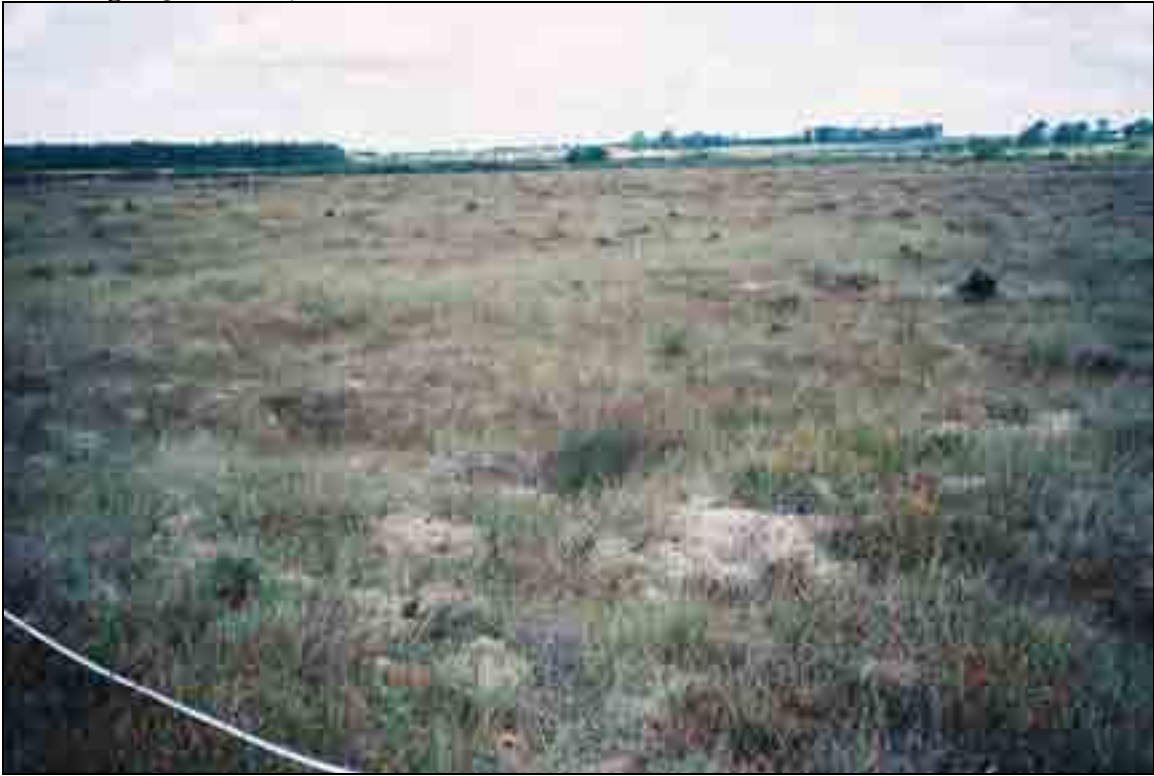
**Kilsallagh Quadrat 1, 2005**

**Quadrat 1:** This quadrat is located on the northern margin of Kilsallagh Bog and occurred on open high bog with vegetation containing Ling Heather, Cross-leaved Heath, Bog Asphodel, Carnation Sedge and bog Bean. There are a number of pools present with *Sphagnum* moss. With the blocking of drains, *Sphagnum* cover will increase and over time, this wet bog margin will develop into active raised bog.

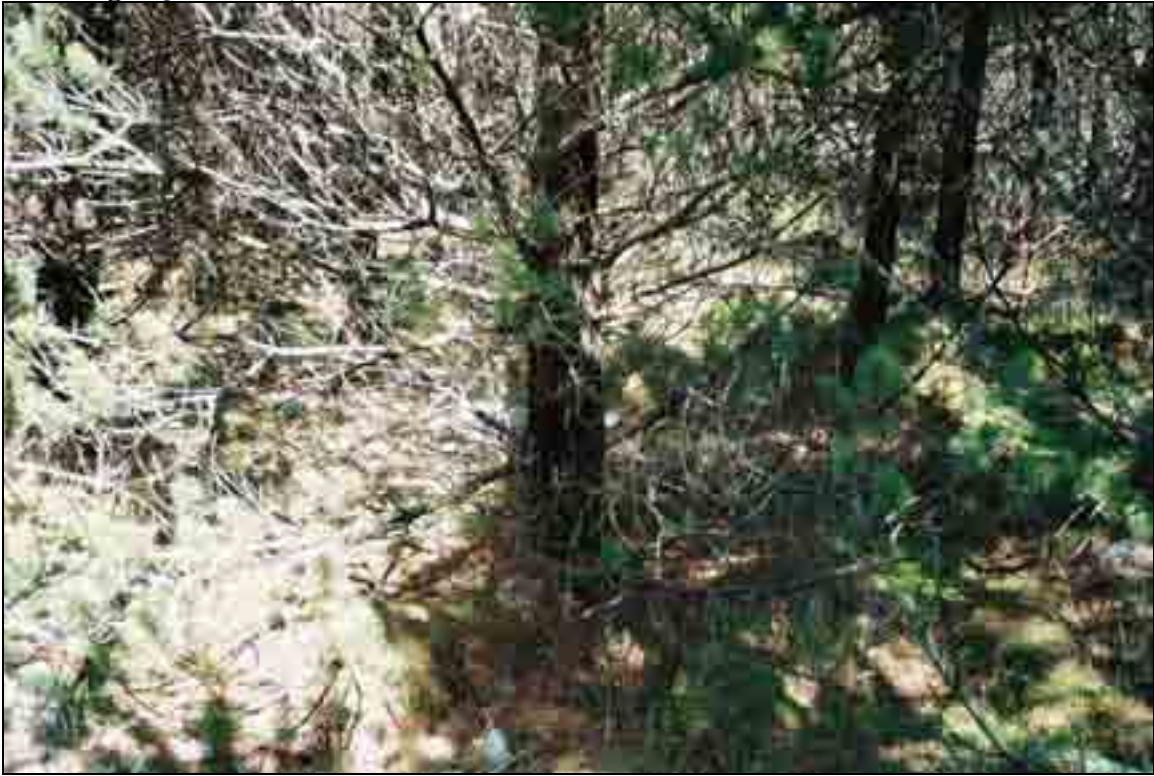
**Kilsallagh Quadrat 2, 2005**

**Quadrat 2:** This quadrat is located in the centre of the plantation on Kilsallagh Bog and occurred within a moribund conifer plantation with a ground cover containing Hare's-tail Cotton-grass, Bog-rosemary and abundant Cranberry. There is also an abundant cover of *Sphagnum* moss. Only three year were monitored as felling occurred in August 2006. With the felling to waste of the conifers, it can be seen that bog vegetation still dominates and over time, this wet bog habitat will develop into **active raised bog.**

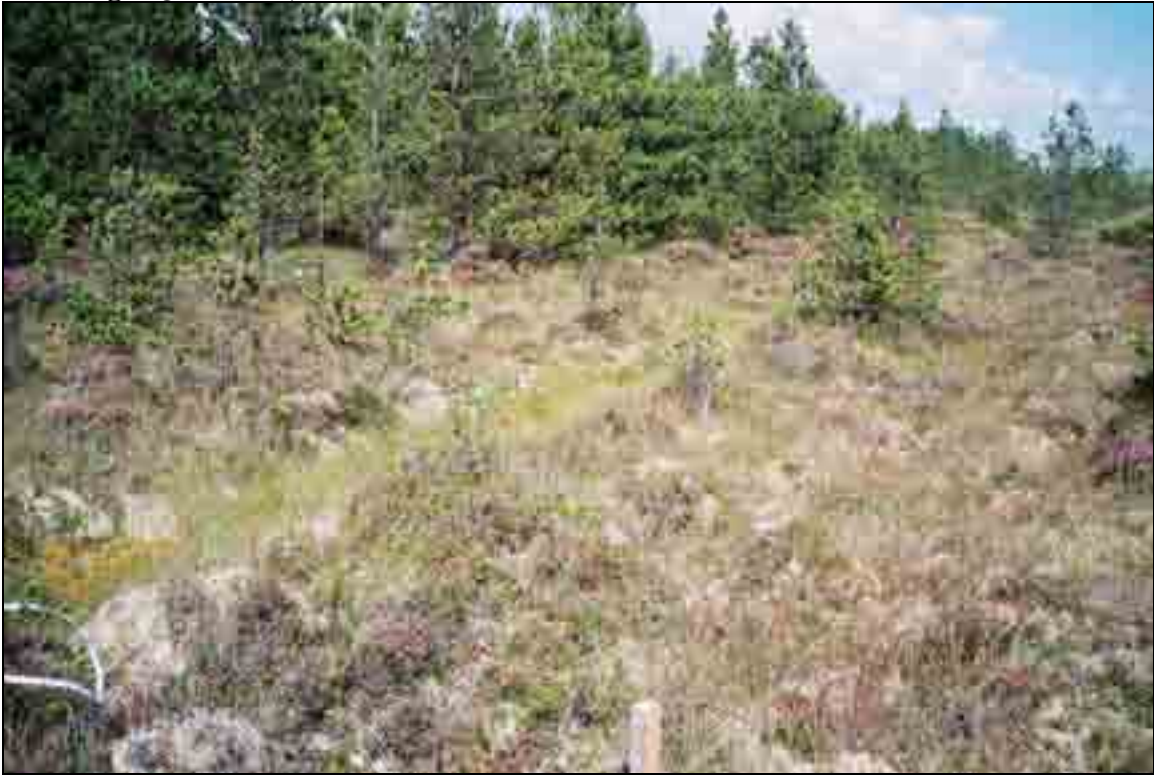
**Kilsallagh Quadrat 3, 2005**

**Quadrat 3:** This quadrat is located on the southern margin of the plantation on Kilsallagh Bog and occurred within a moribund conifer plantation with a ground cover containing Ling Heather, Cross-leaved Heath, Hare's-tail Cottongrass and White-beaked Sedge. There is also abundant *Sphagnum* moss cover. With the felling to waste of the conifers, it can be seen that bog vegetation still dominates and over time, this wet bog habitat will develop into **active raised bog**.

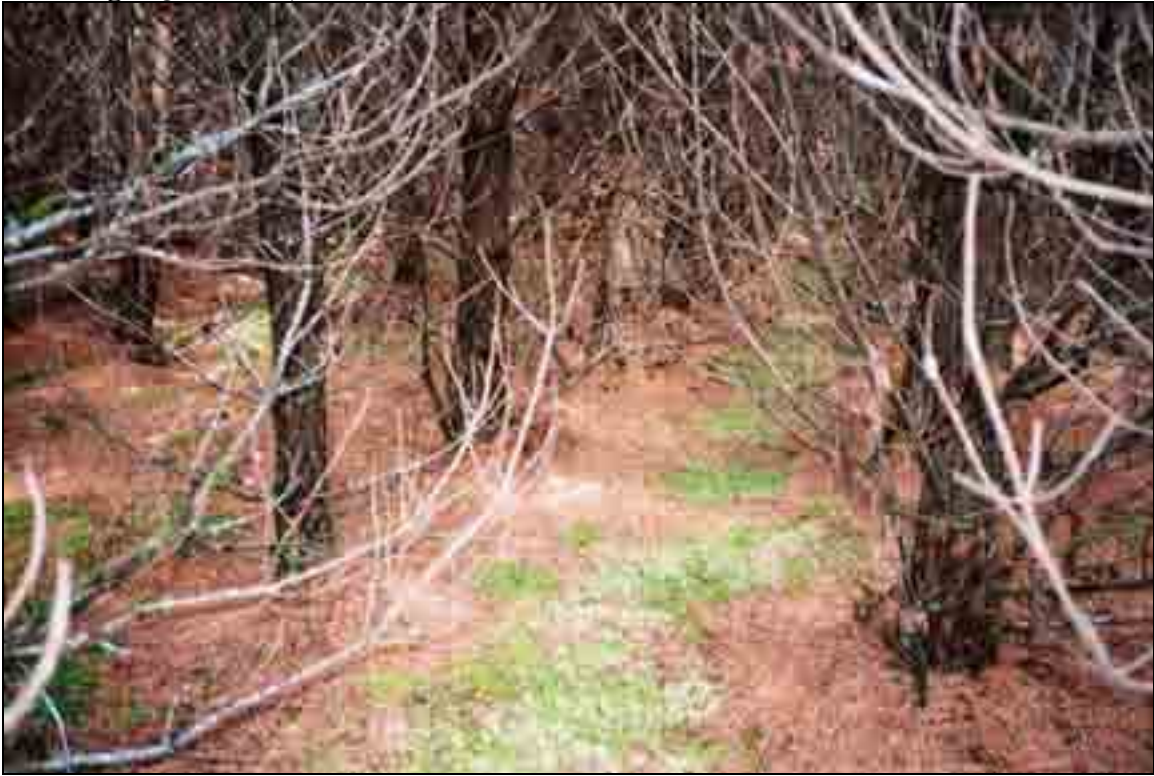
**Kilsallagh Quadrat 4, 2005**

**Quadrat 4:** This quadrat is located on the north-east margin of the plantation on Kilsallagh Bog and occurred within closed canopy conifer plantation *Sphagnum recurvum* moss, but is mainly dominated by pine needles. Only three year were monitored as felling occurred in August 2006. With the felling to waste of the conifers, it can be seen that Hare's-tail Cotton-grass and *Sphagnum* moss cover increased. Over time, this wet bog habitat will develop into **active raised bog**.

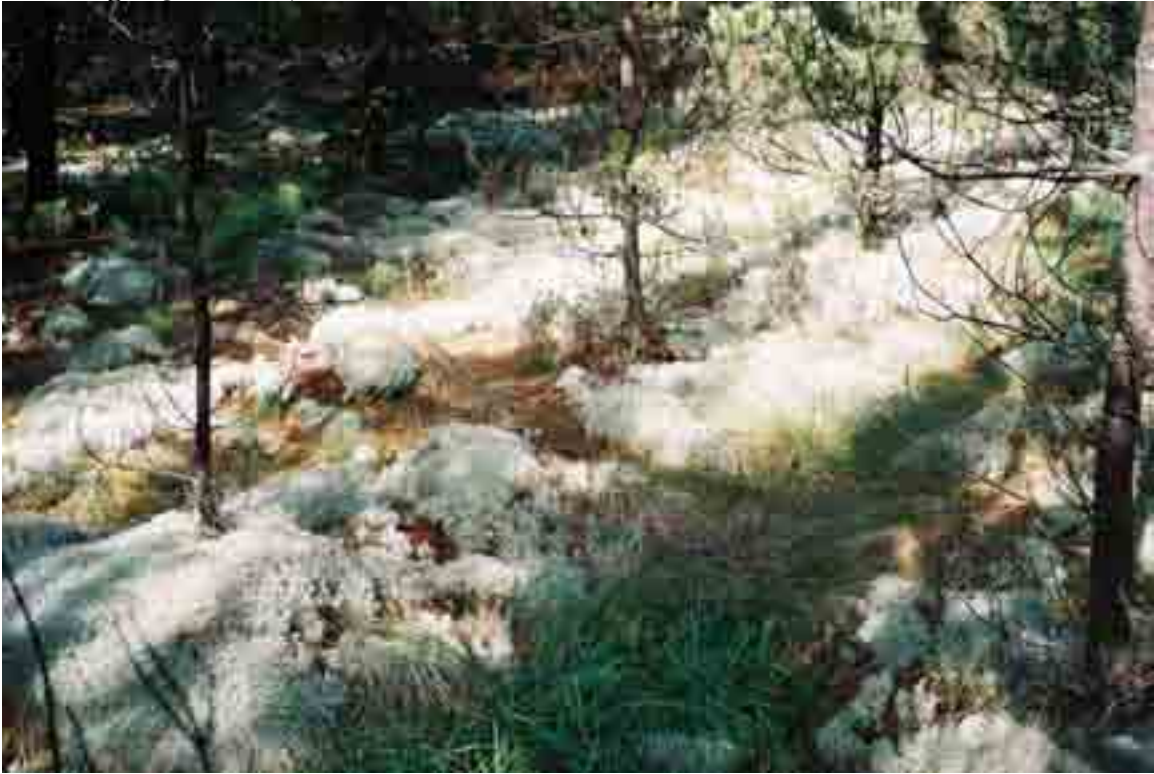
**Kilsallagh Quadrat 5, 2005**

**Quadrat 5:** This quadrat is located on the south-western margin of the plantation on Kilsallagh Bog and occurred within closed canopy conifer plantation with a ground cover containing Hare's-tail Cottongrass, Bog Asphodel and abundant *Cladonia* lichen and *Sphagnum* moss. Only three years were monitored as tree-felling occurred in August 2006. With the felling to waste of the conifers, it can be seen that raised bog vegetation dominates. Over time, this wet bog habitat will develop into **active raised bog**.

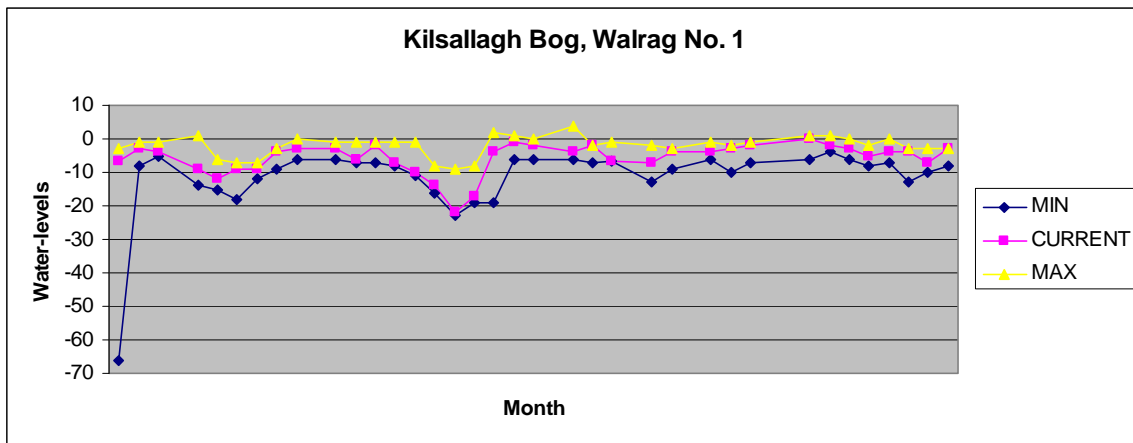
**Kilsallagh Bog Walrag 1: Young Conifer Plantation on High Bog.** (Water-levels high throughout year, slight decline in summer before tree-felling. Water-levels remain within 10cm of surface post restoration\*)

(Installed) May 2005    **Clearfell \***    May 2006    May 2007    **Drain-blocking \***    Aug 2008

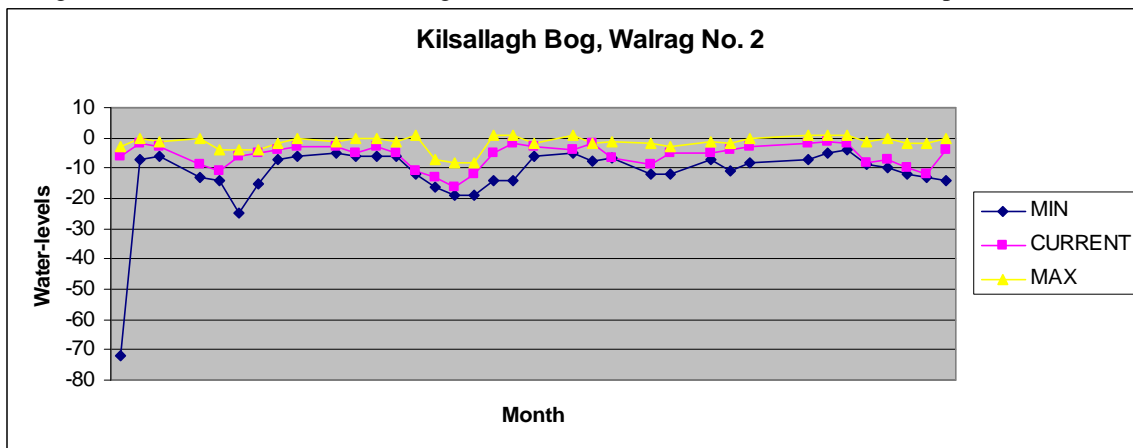
**Kilsallagh Bog Walrag 2: Conifer Plantation Margin on High Bog.** (Slight decline in water-levels during summer months, before tree-felling. Water-levels remain within 10cm of surface post restoration \*)

(Installed) May 2005    **Clearfell \***    May 2006    May 2007    **Drain-blocking \***    Aug 2008

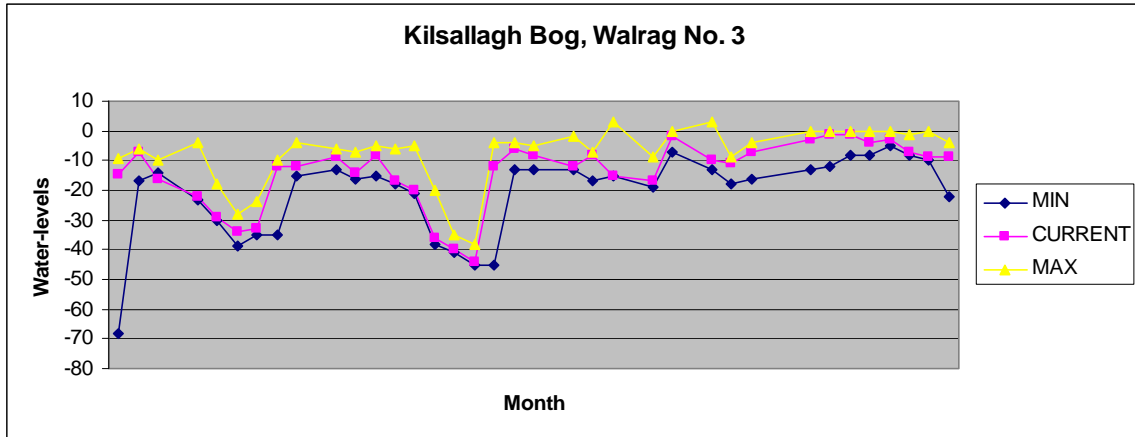
**Kilsallagh Bog Walrag 3: Closed Canopy Conifer Plantation on High Bog.** (Decline in water-levels in summer months before tree-felling. Distinct rise in water-levels post restoration\*)

(Installed) May 2005    **Clearfell \***    May 2006    May 2007    **Drain-blocking \***    Aug 2008

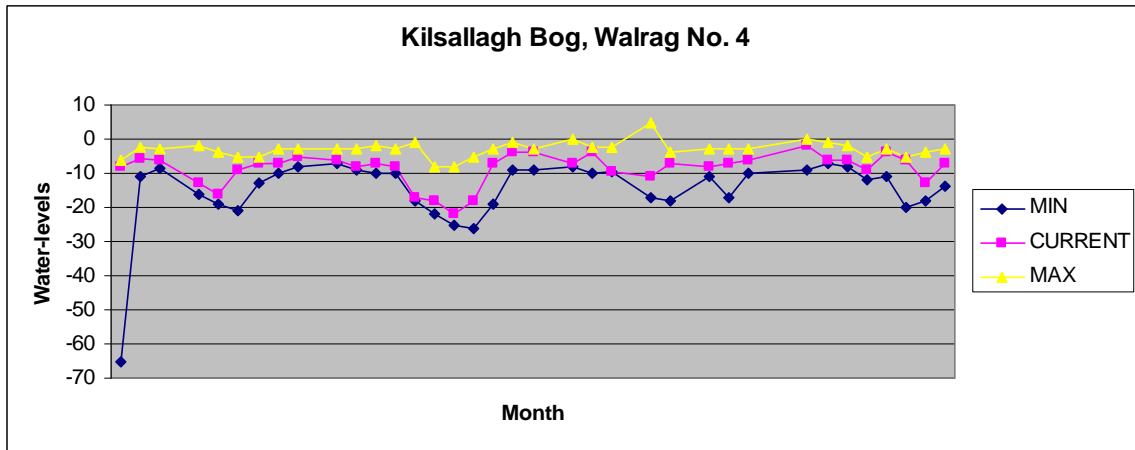
**Kilsallagh Bog Walrag 4: Open High Bog at Plantation Margin.** (Decline in water-levels during summer months less distinct post restoration\*)

(Installed) May 2005    **Clearfell \***    May 2006    May 2007    **Drain-blocking \***    Aug 2008

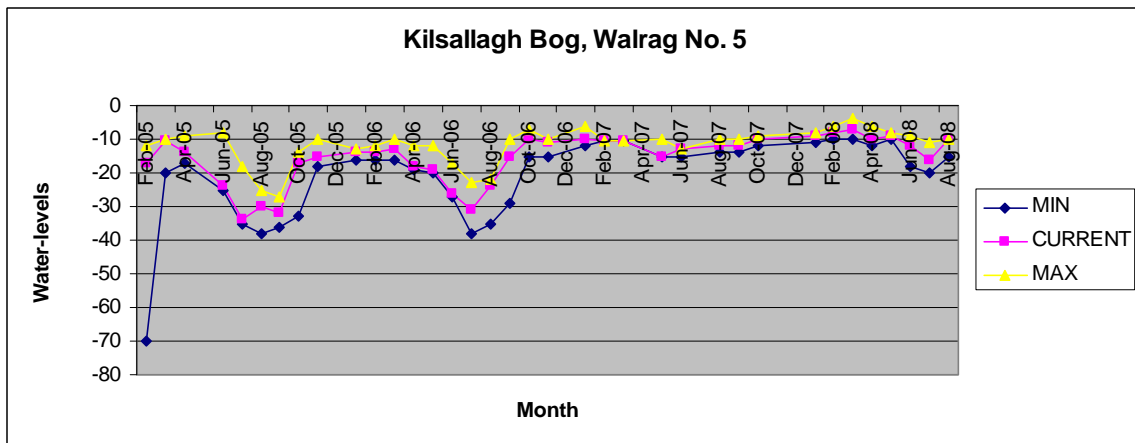
**Kilsallagh Bog Walrag 5: Closed Canopy Conifer Plantation on High Bog.** (Distinct decline in water-levels in summer months before tree-felling. Water-levels remain high in summer post restoration\*)

(Installed) May 2005    **Clearfell \***    May 2006    May 2007    **Drain-blocking \***    Aug 2008
