RESTORING RAISED BOG IN IRELAND
Project Reference: LIFE04 NAT/IE/000121

A REPORT ON THE RESTORATION OF PROJECT SITE No. 5

LOUGH REE cSAC - (KILTEEVAN BOG), Co. ROSCOMMON

**Compiled by: John Derwin,
Project Ecologist,
September 2008**

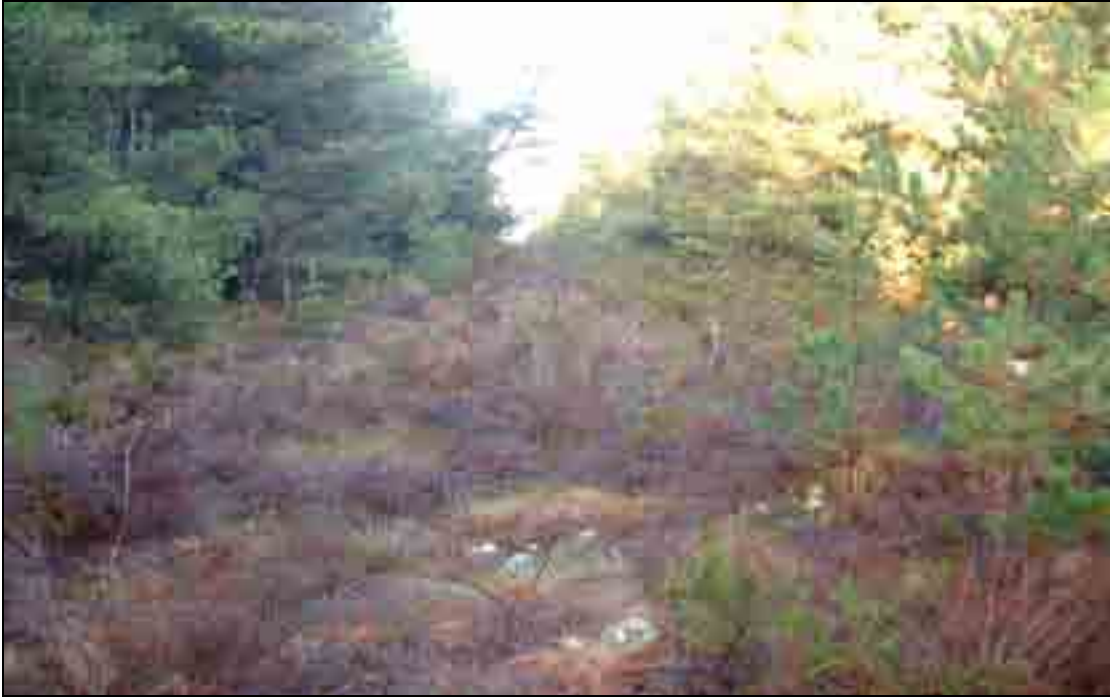
Bog vegetation persists along fire-lines in conifer plantation

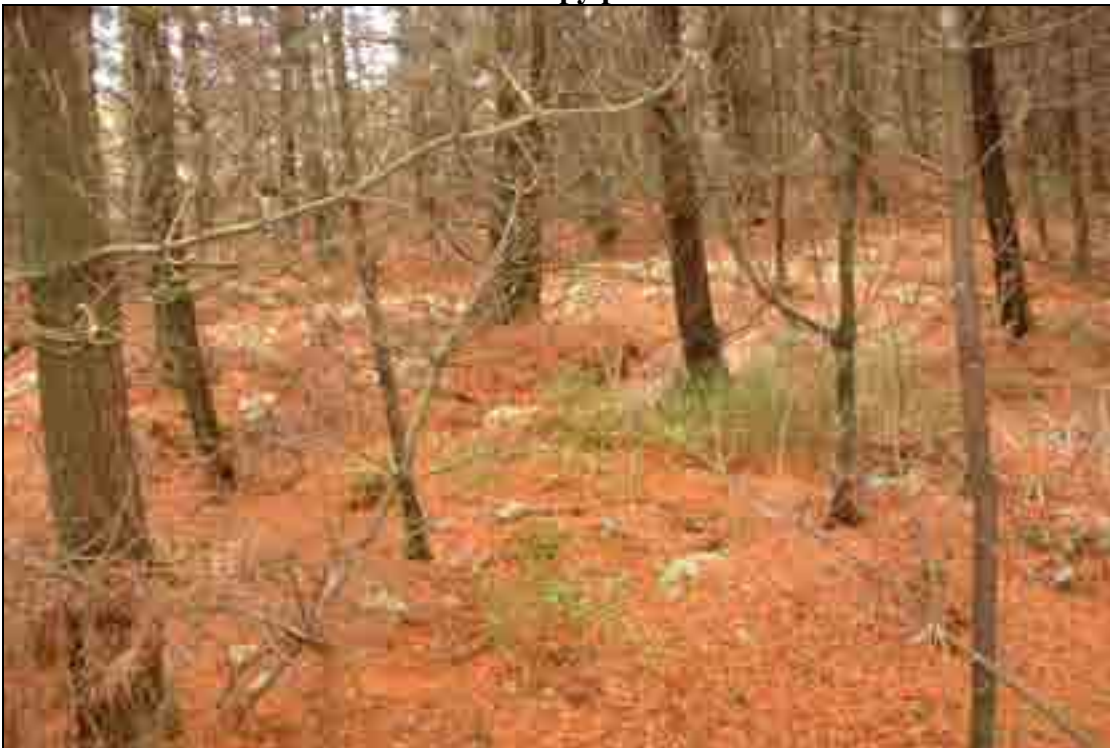
Pine needles dominate under closed canopy plantation

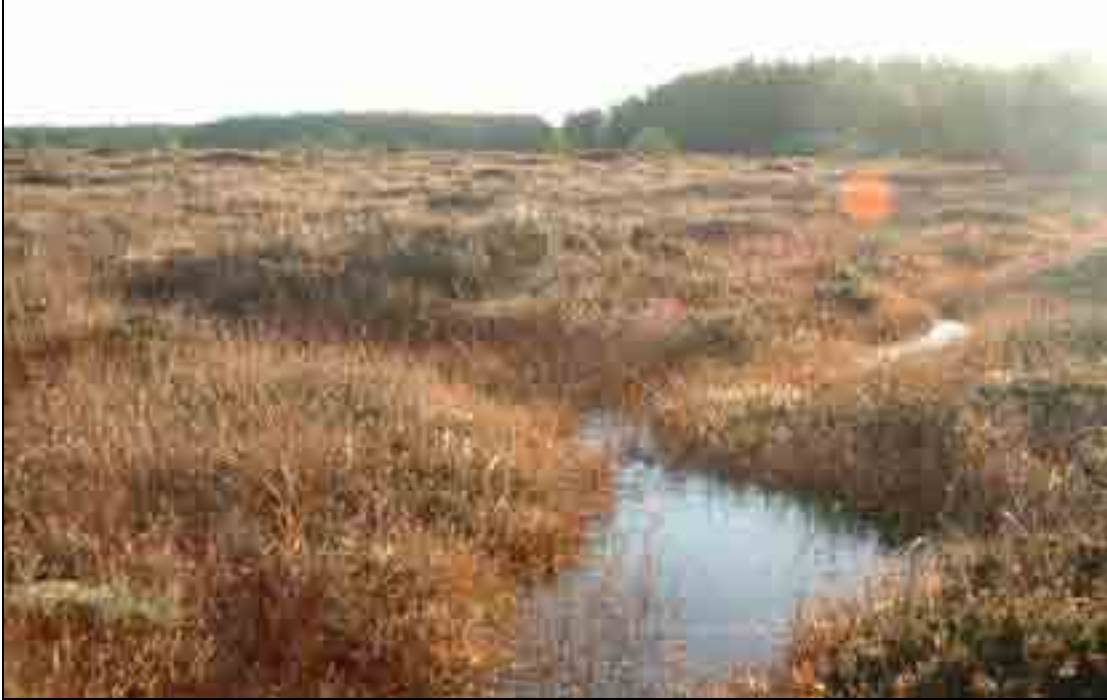
Pool system on open bog adjacent to conifer plantation

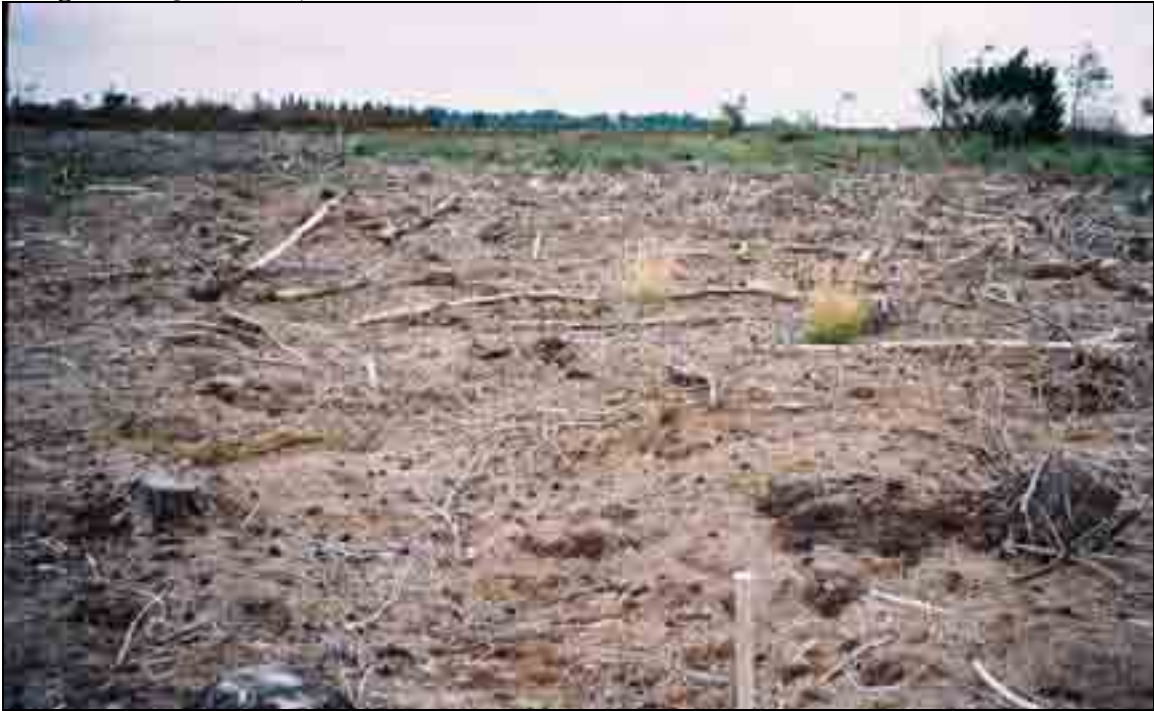
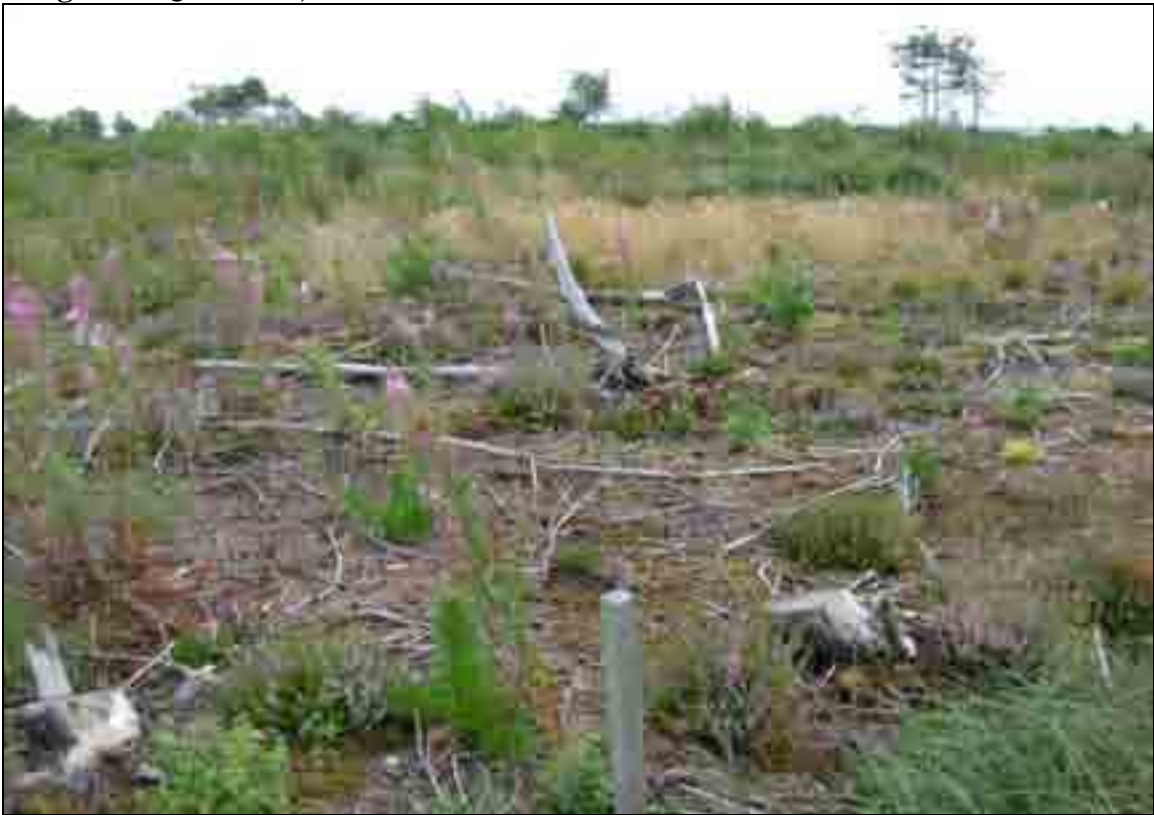
Lough Ree (Kiltreevan Bog) Quadrat 1

Quadrat 1: This quadrat is located on the south-western margin of Kiltreevan Bog and occurred under closed canopy conifer plantation on cutover bog. The sparse ground cover consists of Bramble, Purple Moor-grass and Yorkshire Fog, but is mainly dominated by pine needles and brash. With the felling of conifers, Ling Heather and mosses are recolonising and over time, raised bog habitat will establish.

Lough Ree Quadrat 1, 2005

Lough Ree Quadrat 1, 2008

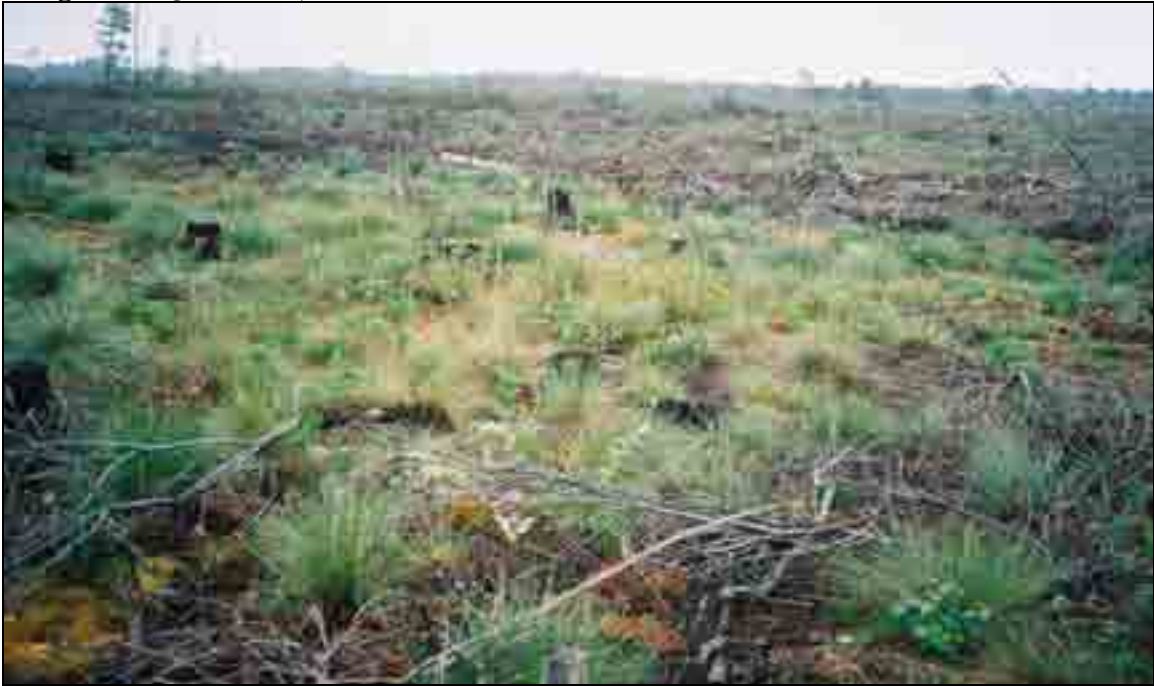
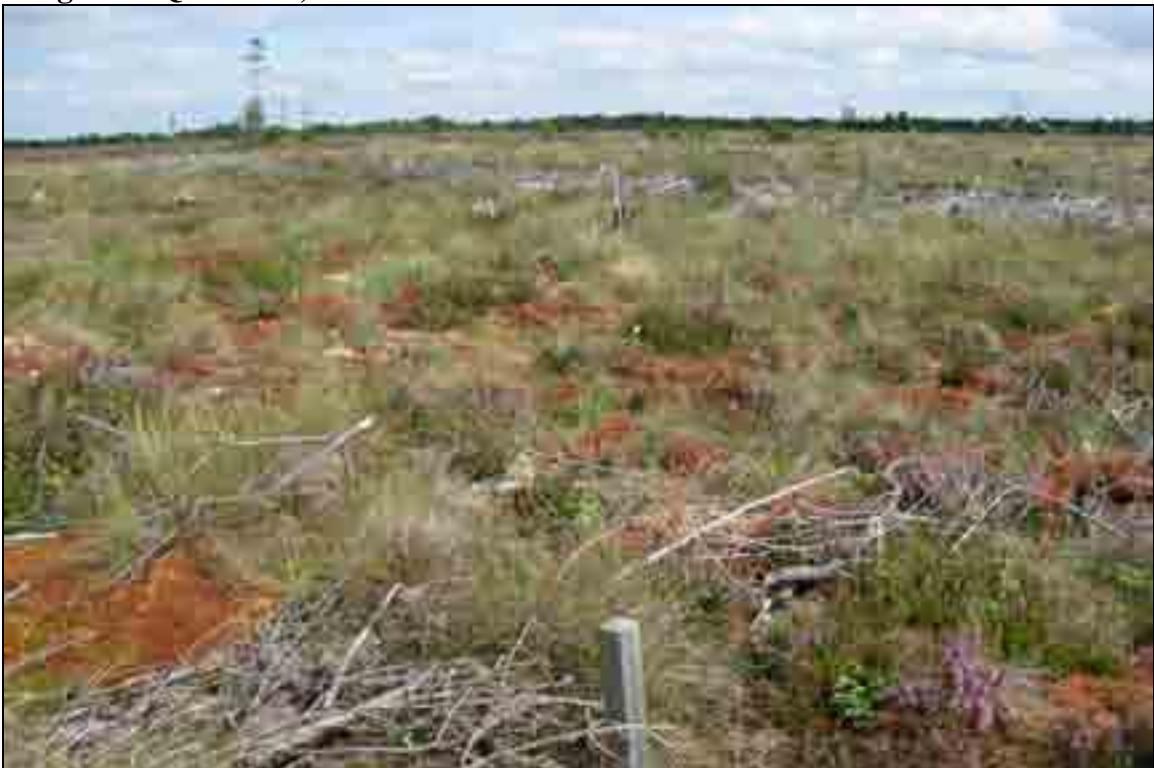
Lough Ree (Kiltreevan Bog) Quadrat 2

Quadrat 2: This quadrat is located on the southern margin of Kiltreevan Bog and occurred under closed canopy conifer plantation on high bog. The ground cover consisted of Hare's-tail Cotton-grass and *Sphagnum* moss. Over time, as the plantation becomes wetter, conditions of this raised bog habitat will improve and *Sphagnum* cover may increase further and active raised bog habitat may become established.

Lough Ree Quadrat 2, 2005

Lough Ree Quadrat 2, 2008

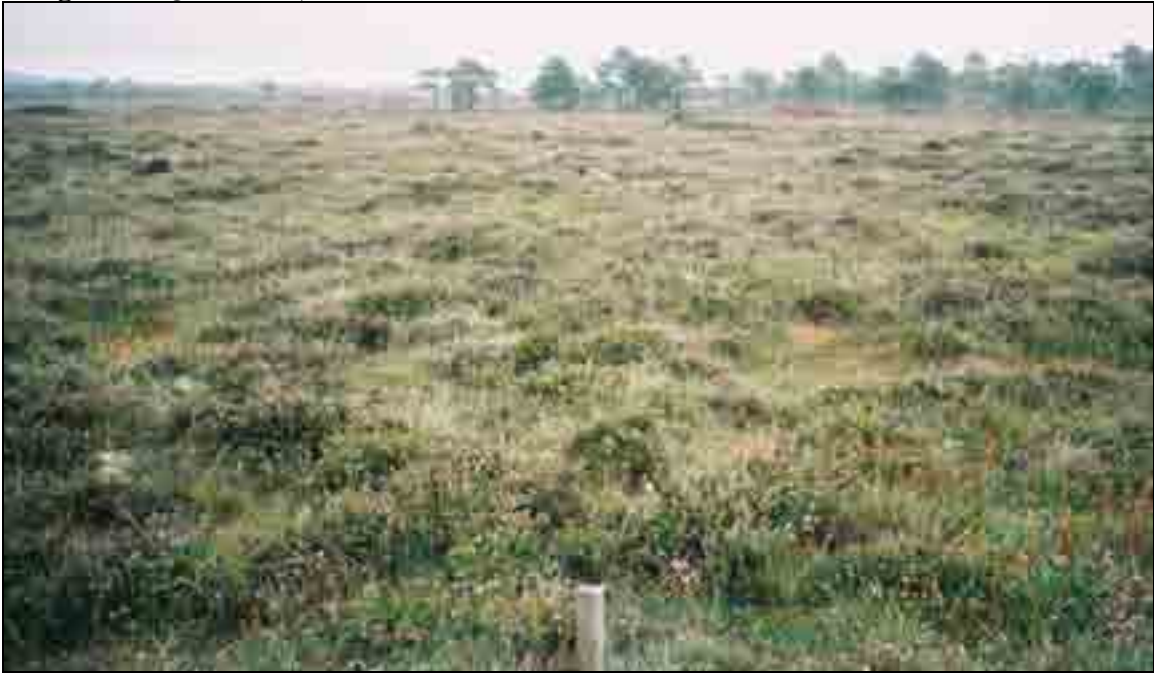
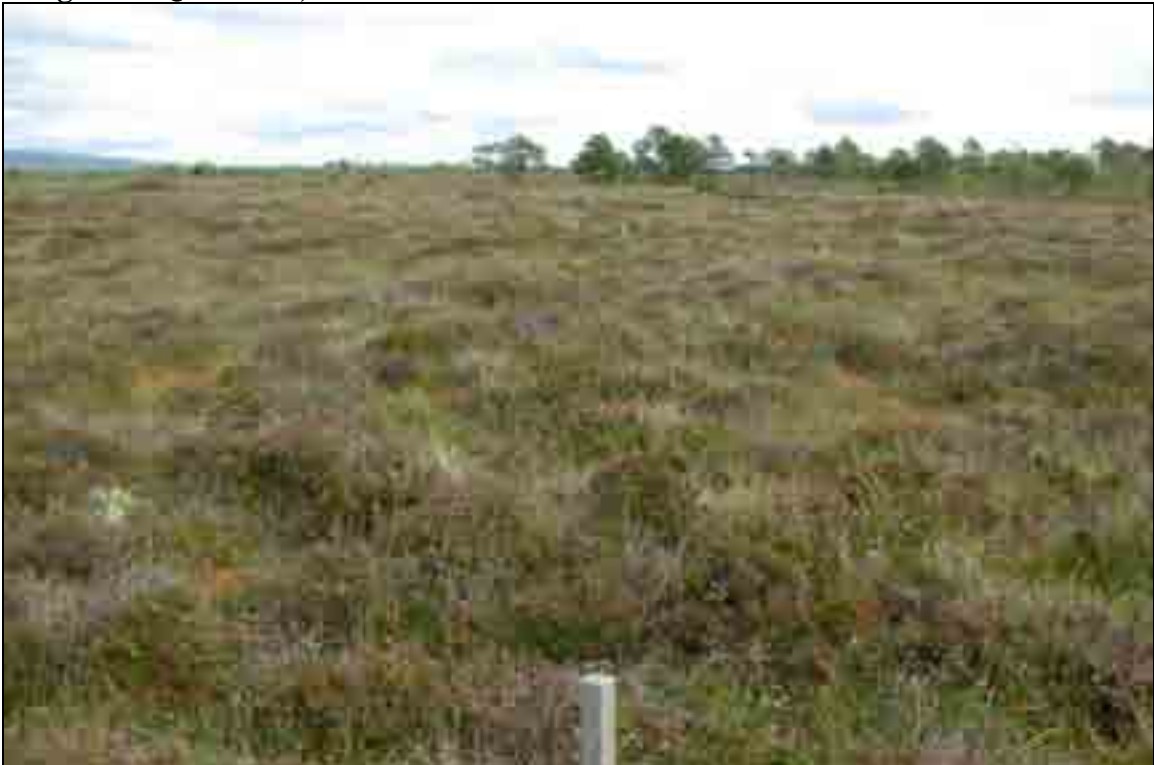
Lough Ree (Kilteevan Bog) Quadrat 3

Quadrat 3: This quadrat occurred on open bog to the south of the bog woodland and is dominated by Ling Heather, Cross-leaved Heath, Bog Asphodel, Hare's-tail Cotton-grass and *Sphagnum* moss. Over time, as the adjoining plantation becomes wetter, conditions of this active raised bog habitat will improve and *Sphagnum* cover may increase further.

Lough Ree Quadrat 3, 2005

Lough Ree Quadrat 3, 2008

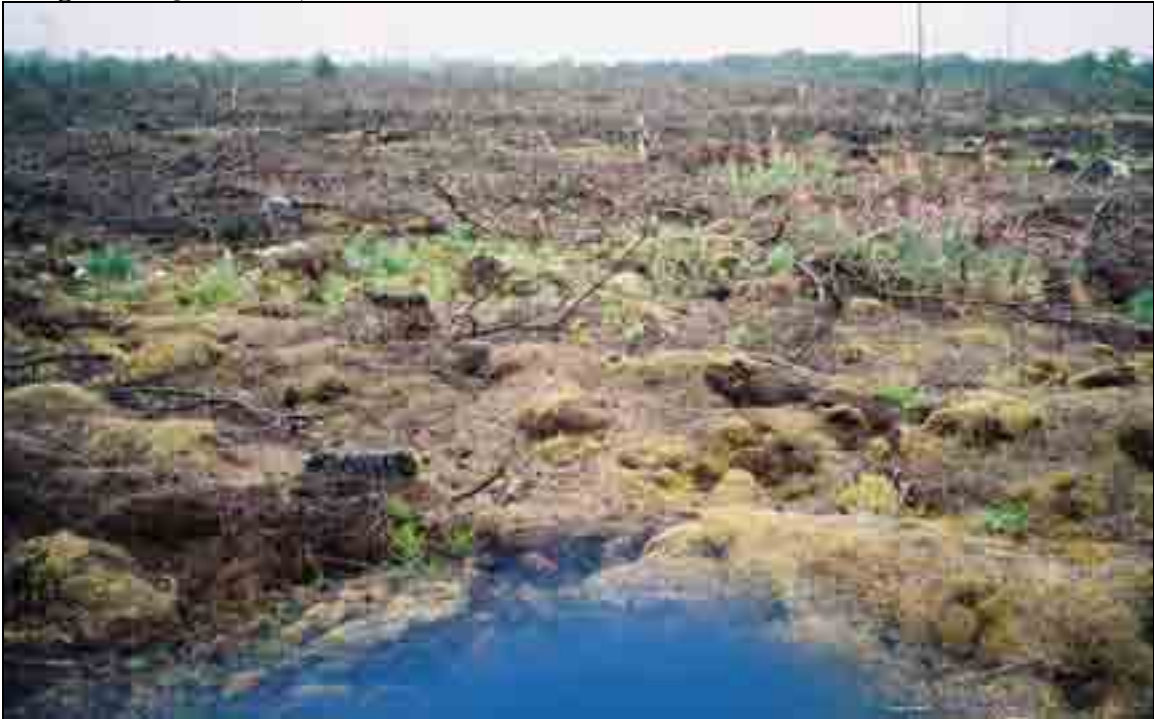
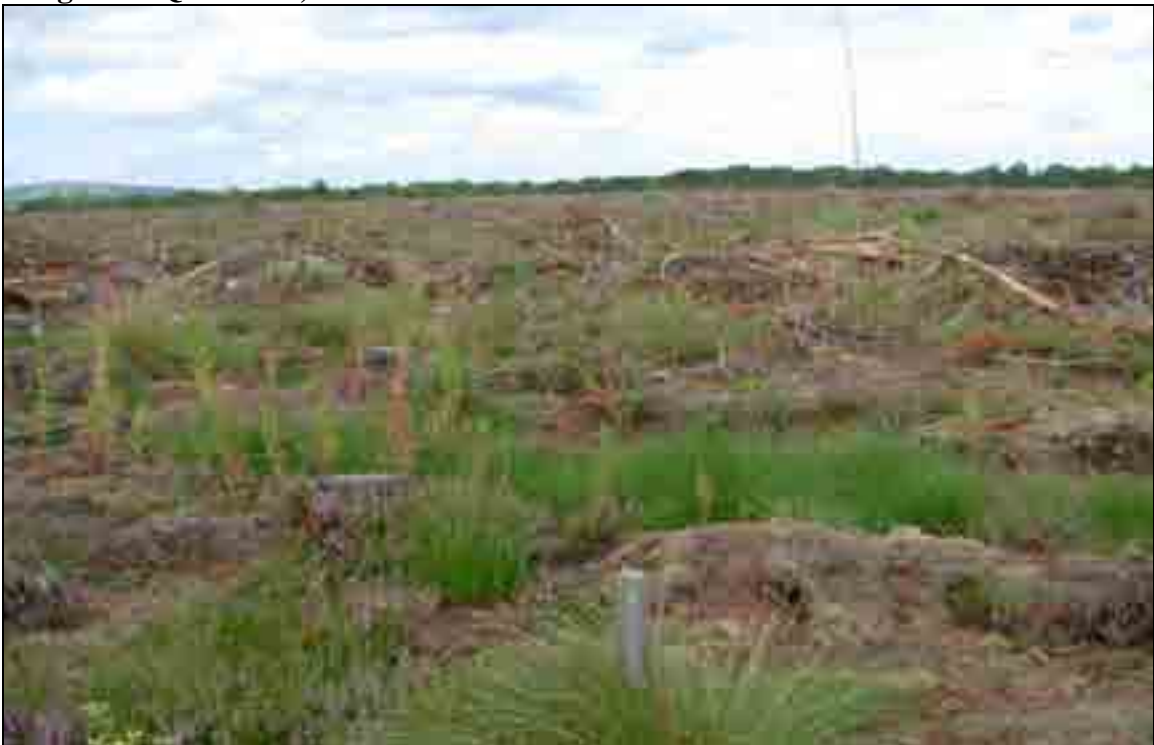
Lough Ree (Kiltreevan Bog) Quadrat 4

Quadrat 4: This quadrat is located in the centre of Kiltreevan Bog and occurred under closed canopy conifer plantation on high bog. The sparse ground cover consisted of Cladonia lichen and *Sphagnum* moss, but is mainly dominated by pine needles and brash. With the felling of conifers and blocking of drains raised bog habitat dominated by Ling Heather and Hare's-tail Cotton-grass has improved and *Sphagnum* cover may increase further.

Lough Ree Quadrat 4, 2005

Lough Ree Quadrat 4, 2008

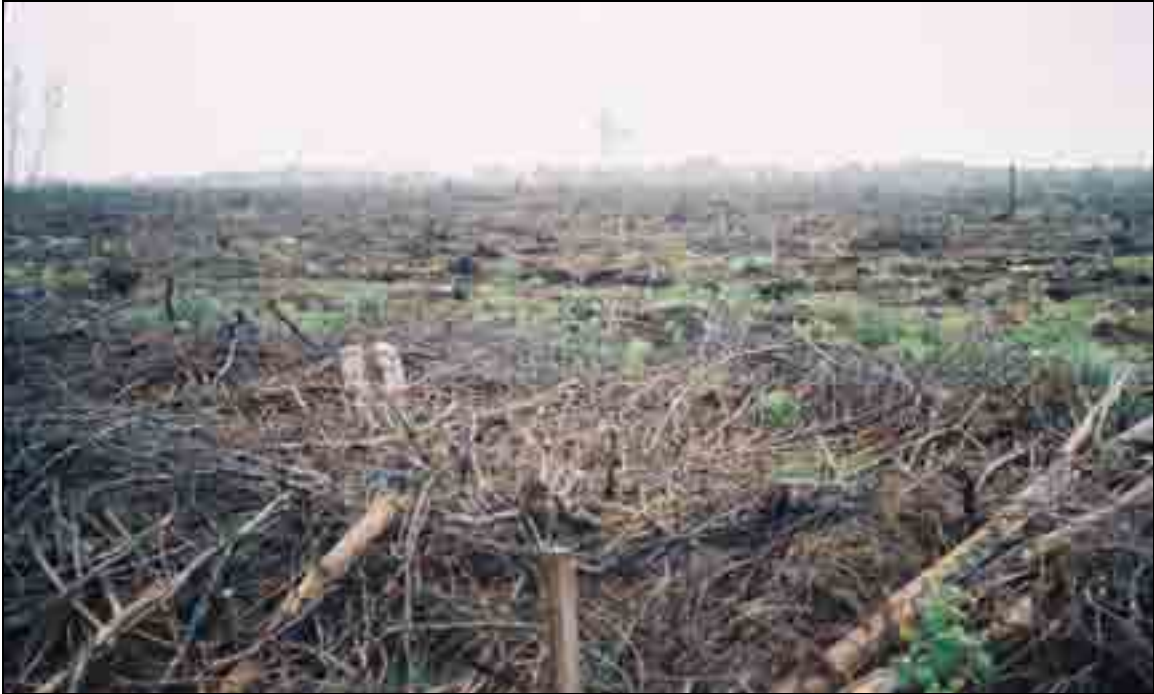
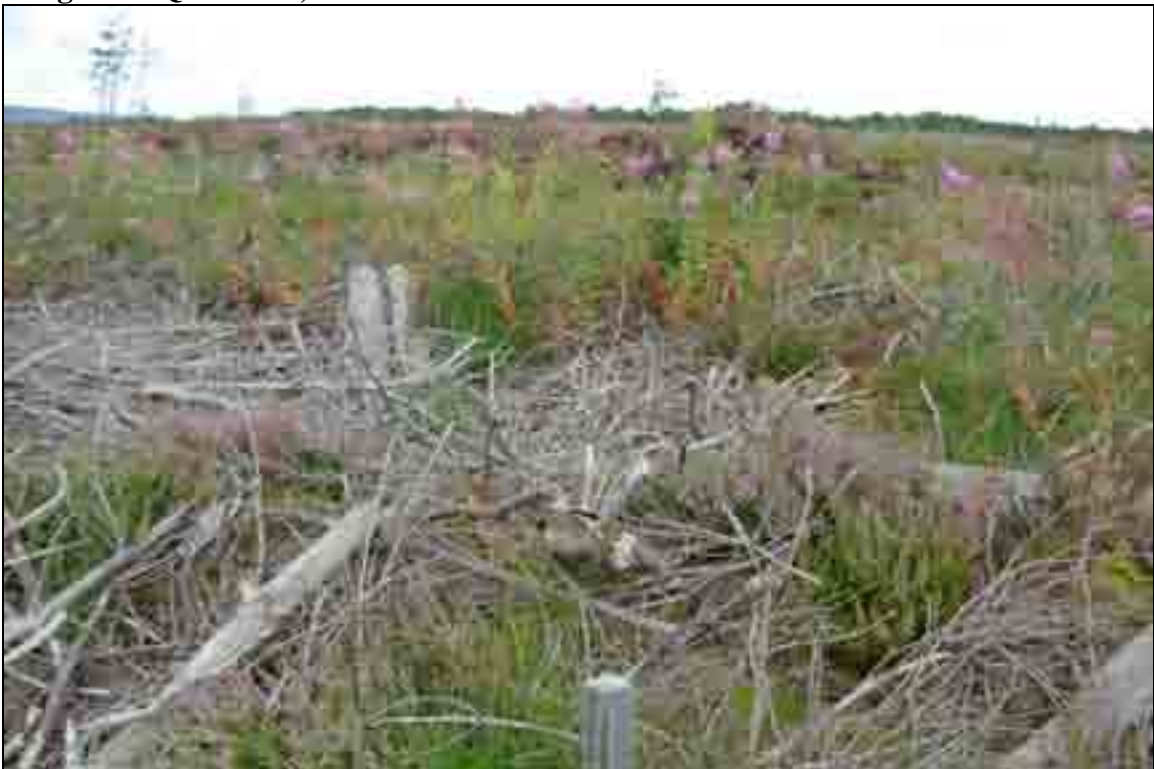
Lough Ree (Kiltreevan Bog) Quadrat 5

Quadrat 5: This quadrat is located in the centre of Kiltreevan Bog and occurred under closed canopy conifer plantation on high bog. The sparse ground cover is dominated by Cladonia lichen and *Sphagnum* moss, with pine needles and brash. With the felling of conifers and blocking of drains, Ling Heather, Hare's-tail Cotton-grass dominated raised bog habitat has established and *Sphagnum* cover may increase further.

Lough Ree Quadrat 5, 2005

Lough Ree Quadrat 5, 2008

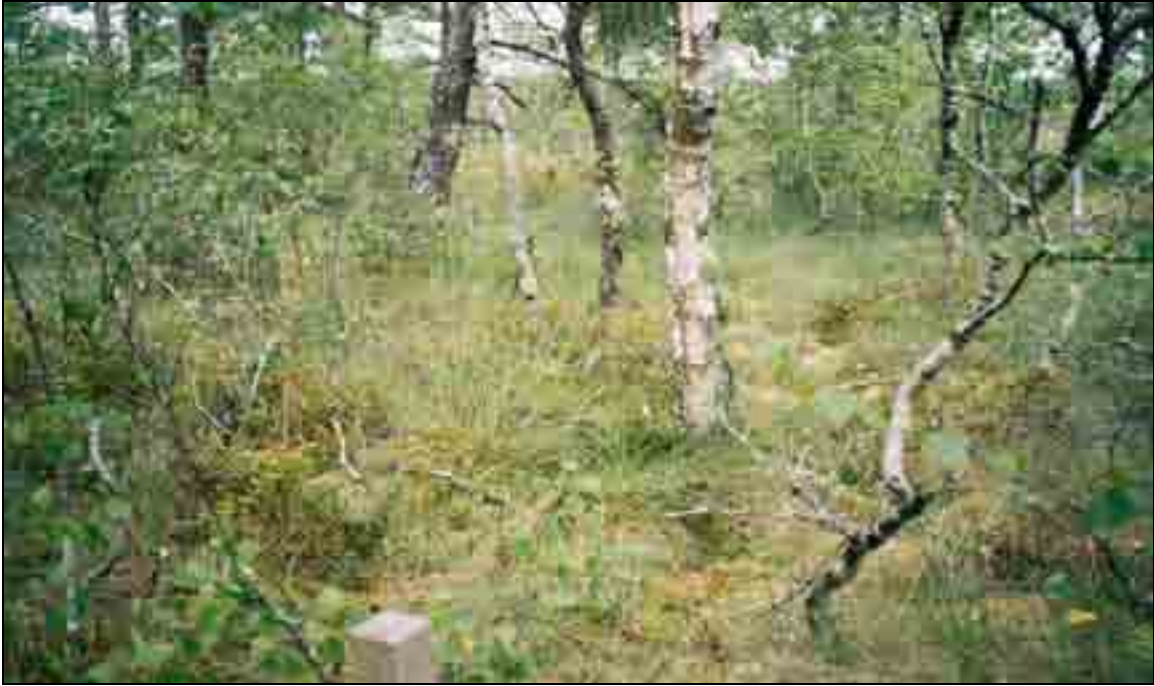
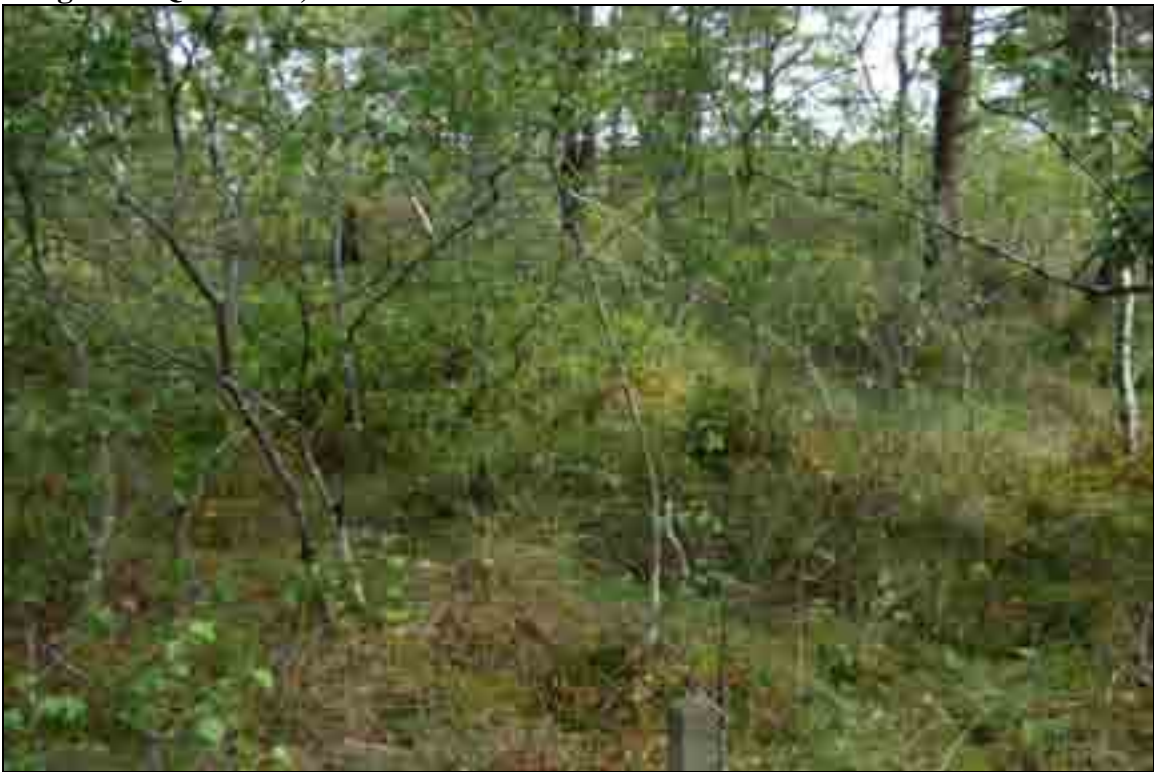
Lough Ree (Kiltveevan Bog) Quadrat 6

Quadrat 6: This quadrat is located within the bog woodland in the centre of Kiltveevan Bog , that is dominated by Scot's Pine and Birch with a ground cover of Hare's-tail Cotton-grass, Bog Myrtle and *Sphagnum* moss. Over time, as the adjoining plantation becomes wetter, conditions of this priority Annex I raised bog habitat will improve and *Sphagnum* cover may increase further.

Lough Ree Quadrat 6, 2005

Lough Ree Quadrat 6, 2008

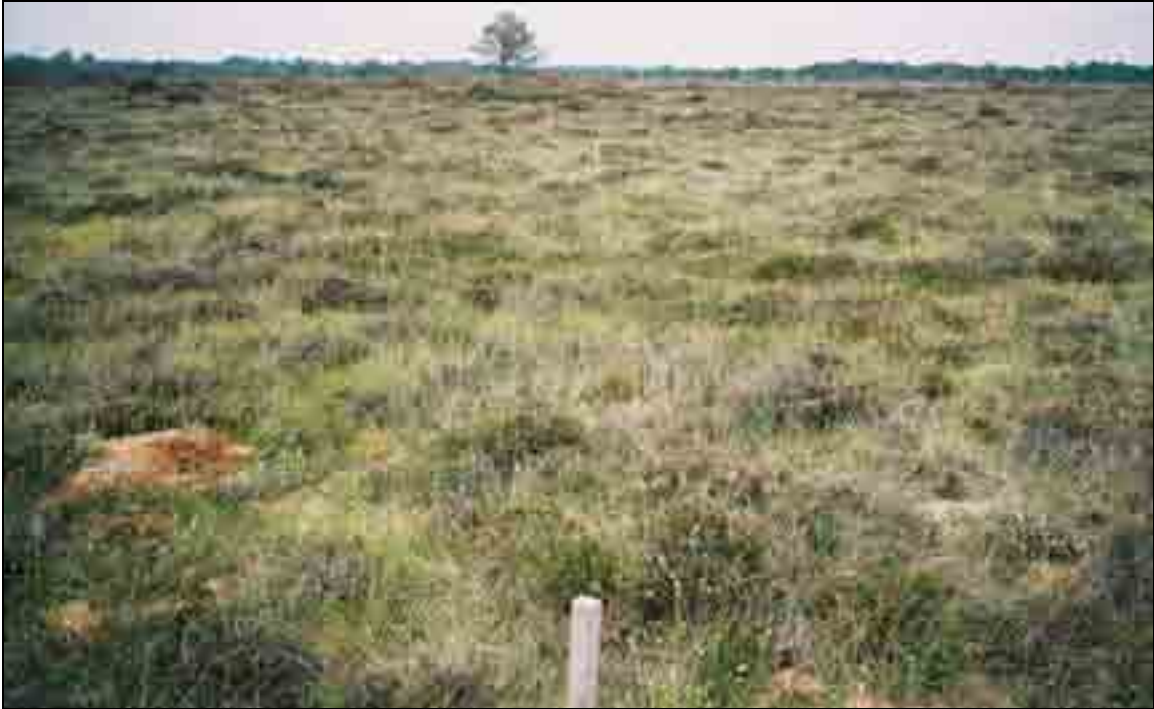
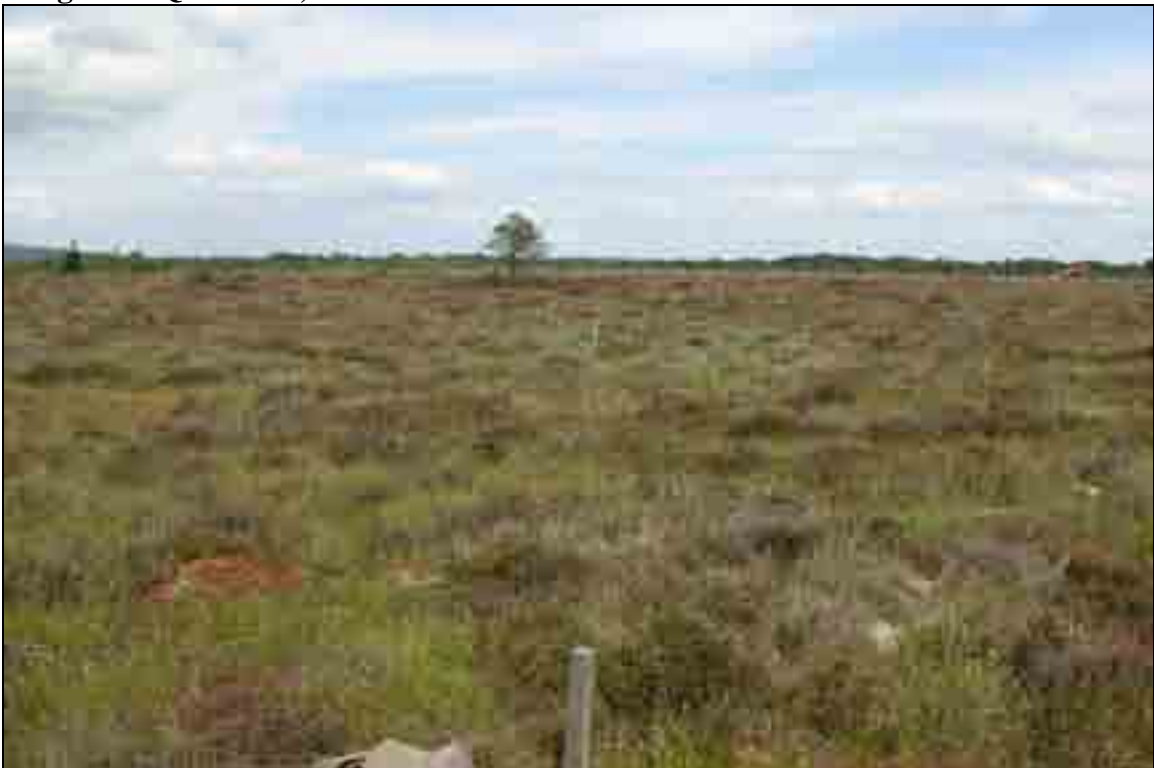
Lough Ree (Kiltveevan Bog) Quadrat 7

Quadrat 7: This quadrat is located open bog to the north of the bog woodland on Kiltveevan Bog. The vegetation is dominated by Ling Heather, Cross-leaved Heath, Hare's-tail Cotton-grass, White-beaked Sedge and *Sphagnum* moss. Over time, as the adjoining plantation becomes wetter, conditions of this active raised bog habitat will improve and *Sphagnum* cover may increase further.

Lough Ree Quadrat 7, 2005

Lough Ree Quadrat 7, 2008

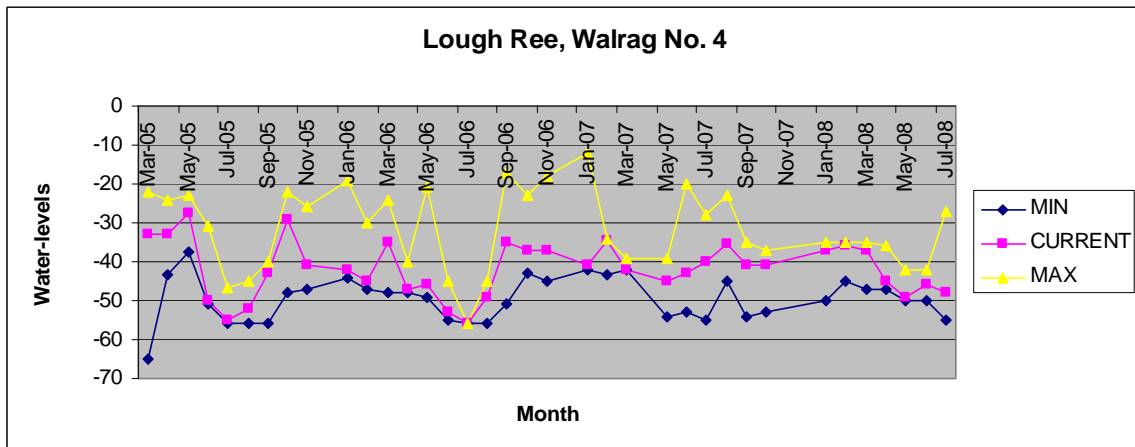
Lough Ree Walrag 4: Clearfell Conifer Plantation on High Bog Margin (Water-levels remain below 30cm of bog surface post restoration*, due to the shallow peat depth)

* ClearFell Jul 2005 Jul 2006 Jul 2007 *Drain-blocking Jul 2008

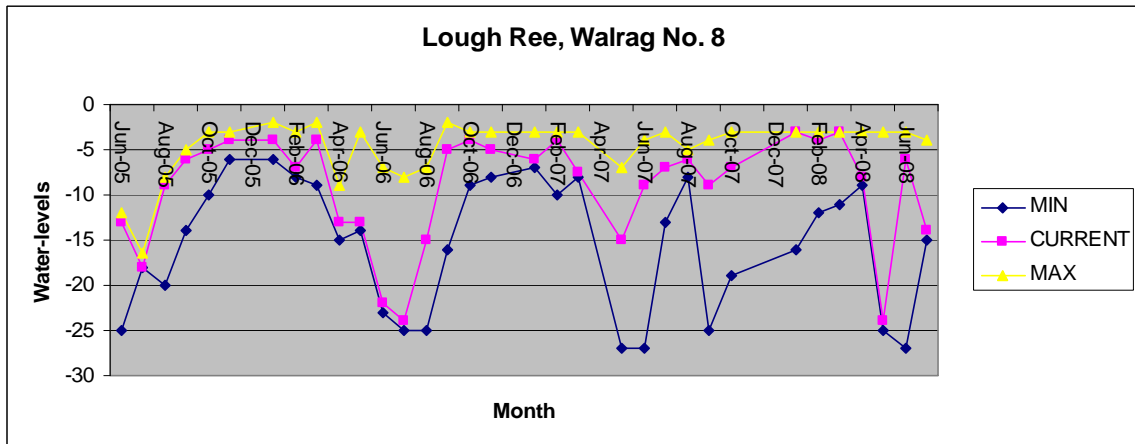
Lough Ree Walrag 8: Clearfell on High Bog (Water-levels variable, but mainly remain within 10cm of bog surface post restoration*. Decline during summer months remains)

* ClearFell Jul 2005 Jul 2006 Jul 2007 *Drain-blocking Jul 2008
