RESTORING RAISED BOG IN IRELAND
Project Reference: LIFE04 NAT/IE/000121

A REPORT ON THE RESTORATION OF PROJECT SITE No. 13

MOUNT HEVEY BOG, Co. MEATH/ WESTMEATH

**Compiled by: John Derwin,
Project Ecologist,
September 2008**

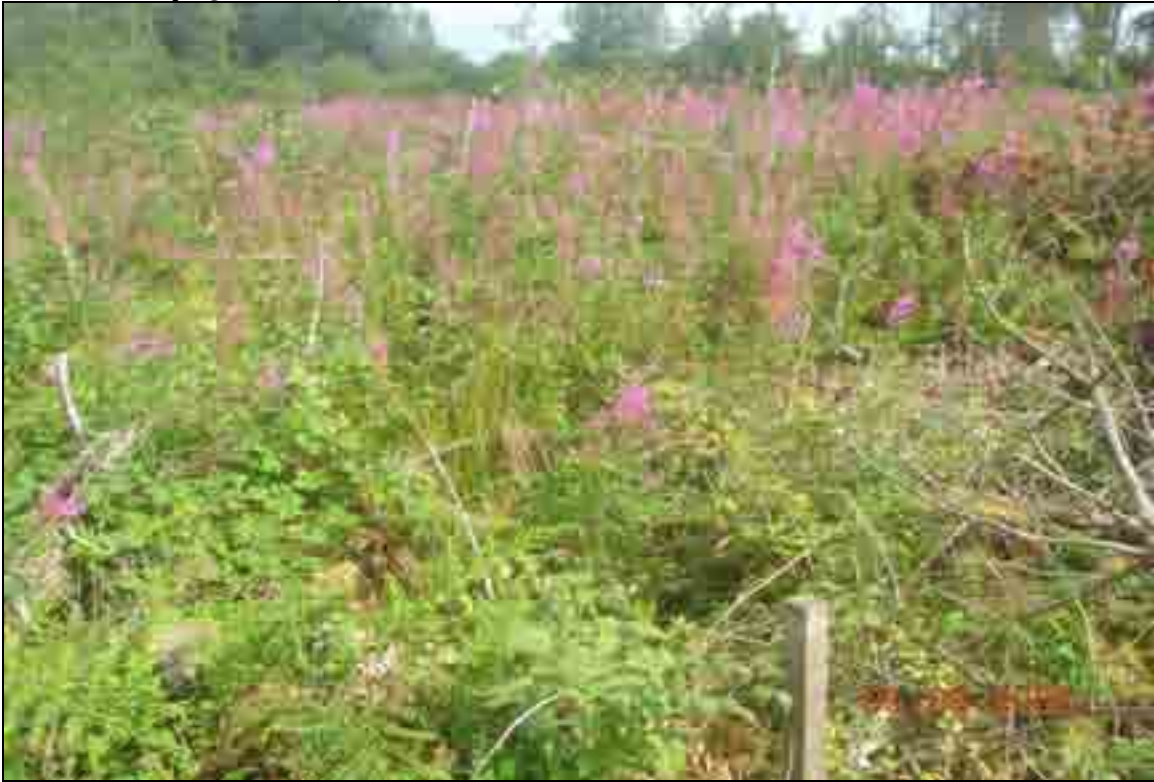
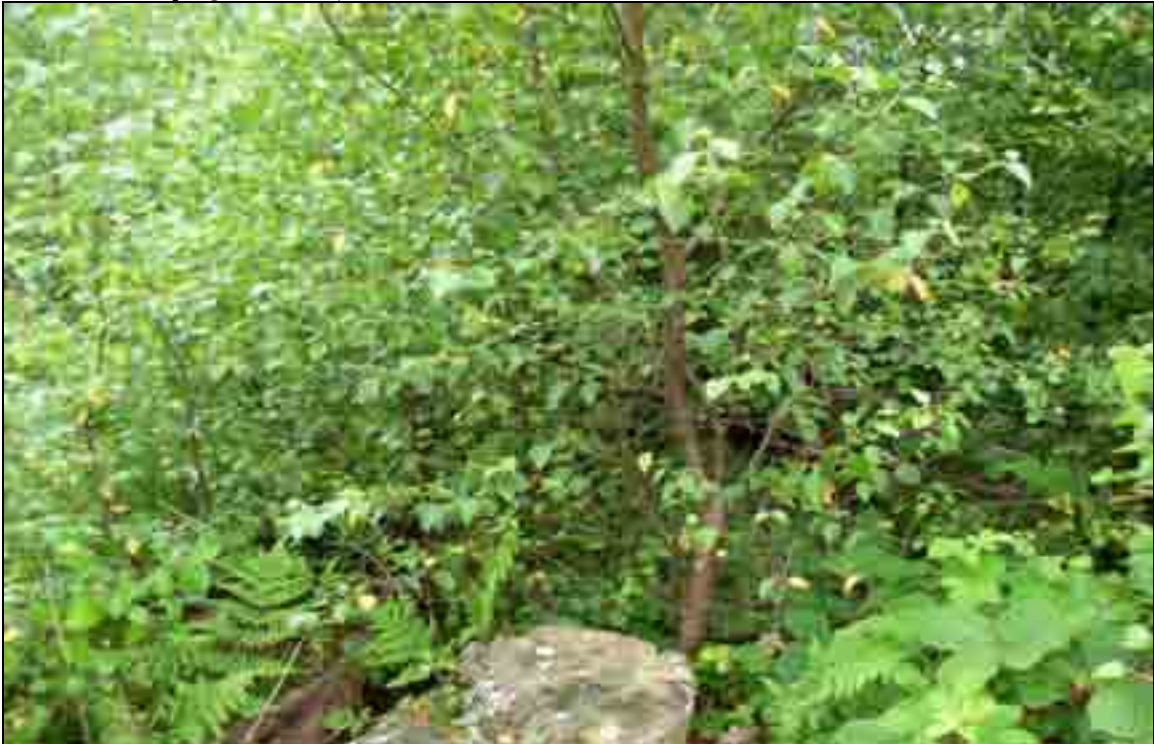
Mount Hevey Quadrat 1

Quadrat 1: This quadrat is located on the eastern margin of Mount Hevey and occurred within a young conifer plantation on cutover bog with a ground cover containing Bramble, Willow-herb and *Hypnum* moss. With the felling to waste of the conifers, it can be seen that Birch and Ling Heather cover increased, but due to the dry nature of this area, *Sphagnum* moss is absent. Over time, this dry bog margin will develop into birch woodland.

Mount Hevey Quadrat 1, 2005

Mount Hevey Quadrat 1, 2008

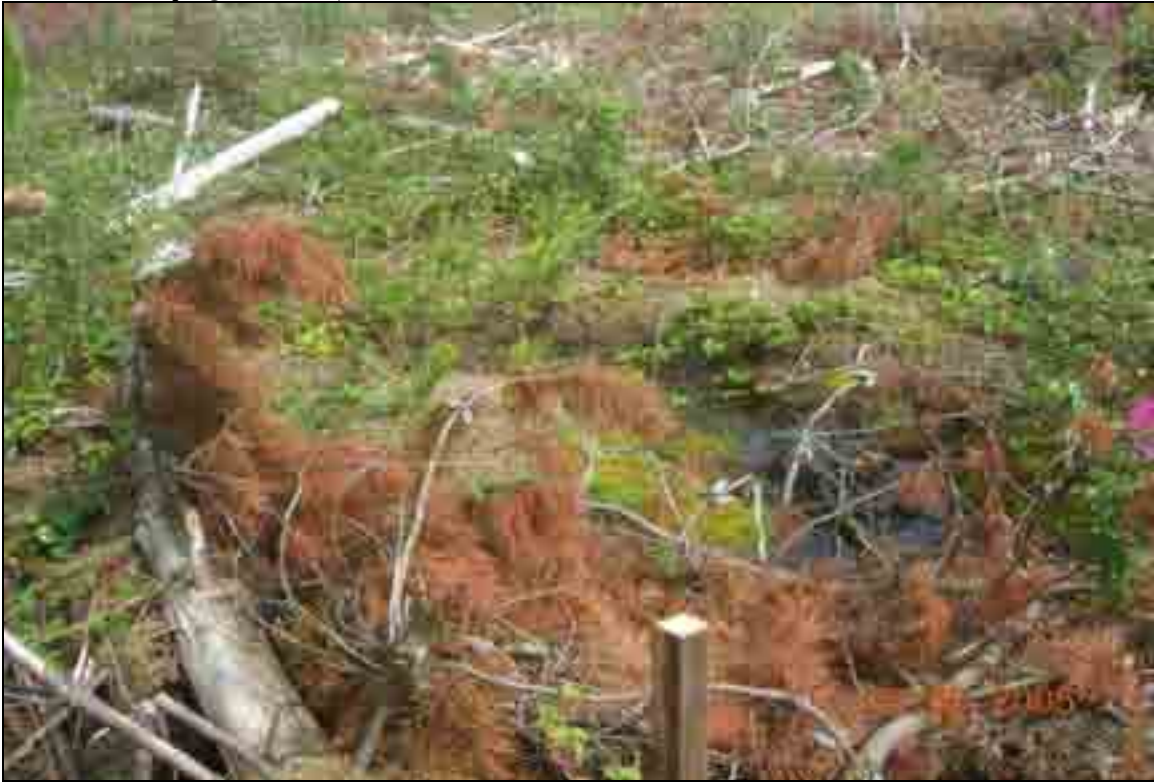
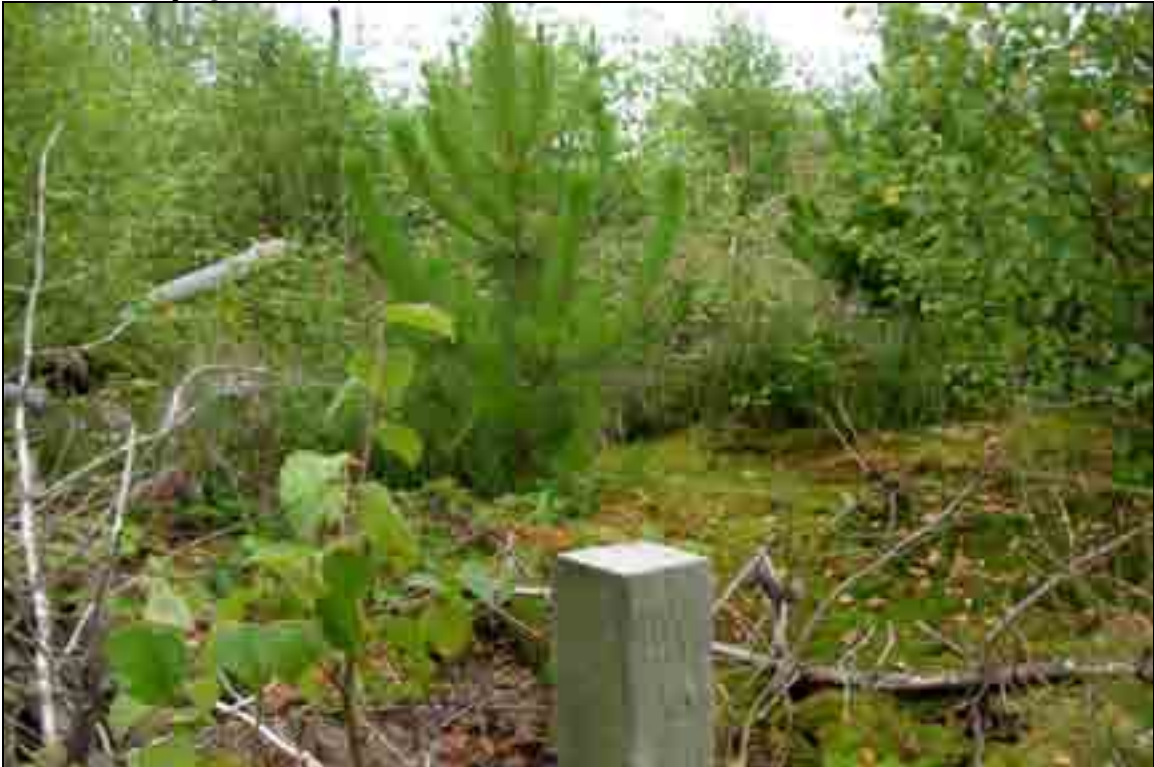
Mount Hevey Quadrat 2

Quadrat 2: This quadrat is located on the south-east margin of Mount Hevey and occurred within a mature conifer plantation with a ground cover containing Ling Heather, Willow-herb and *Hypnum* moss. With the clear-felling of the conifers and blocking of drains, it can be seen that Birch, Bramble, Ling Heather and Cotton-grass cover increased along with an increase in *Sphagnum* moss cover. Over time, this wet bog margin will develop into wet birch woodland with some areas dominated by bog vegetation.

Mount Hevey Quadrat 2, 2005

Mount Hevey Quadrat 2, 2008

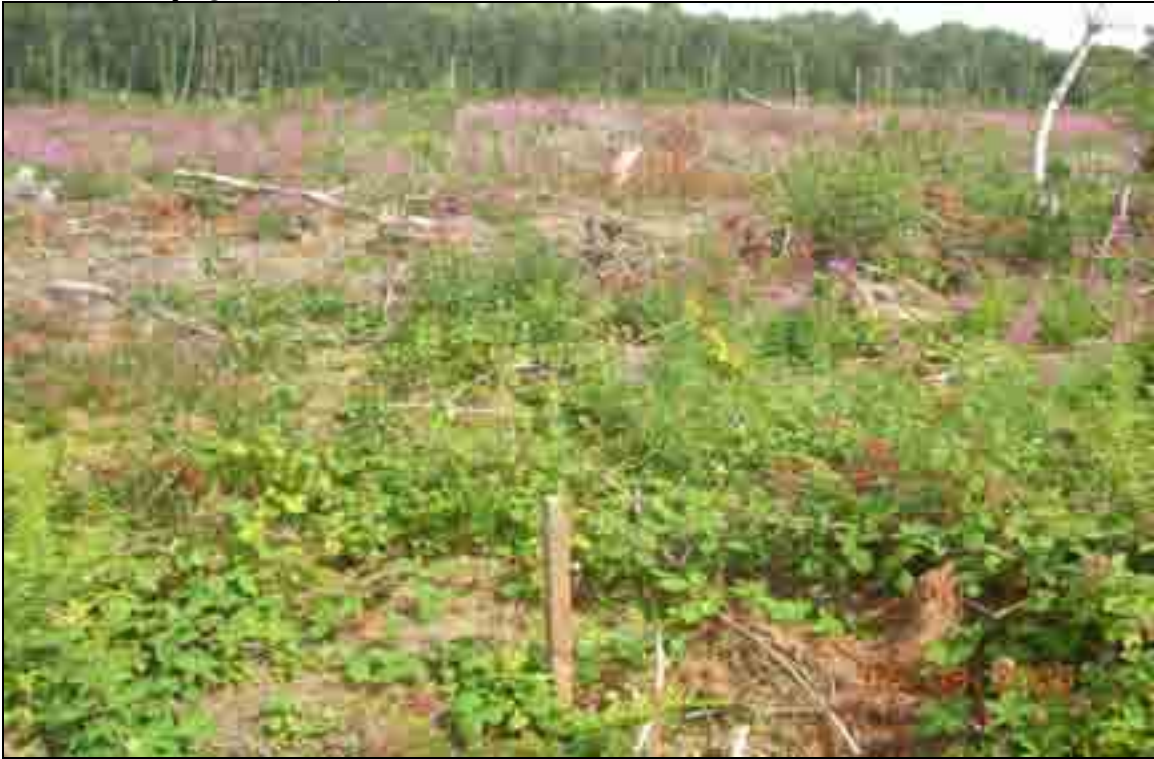
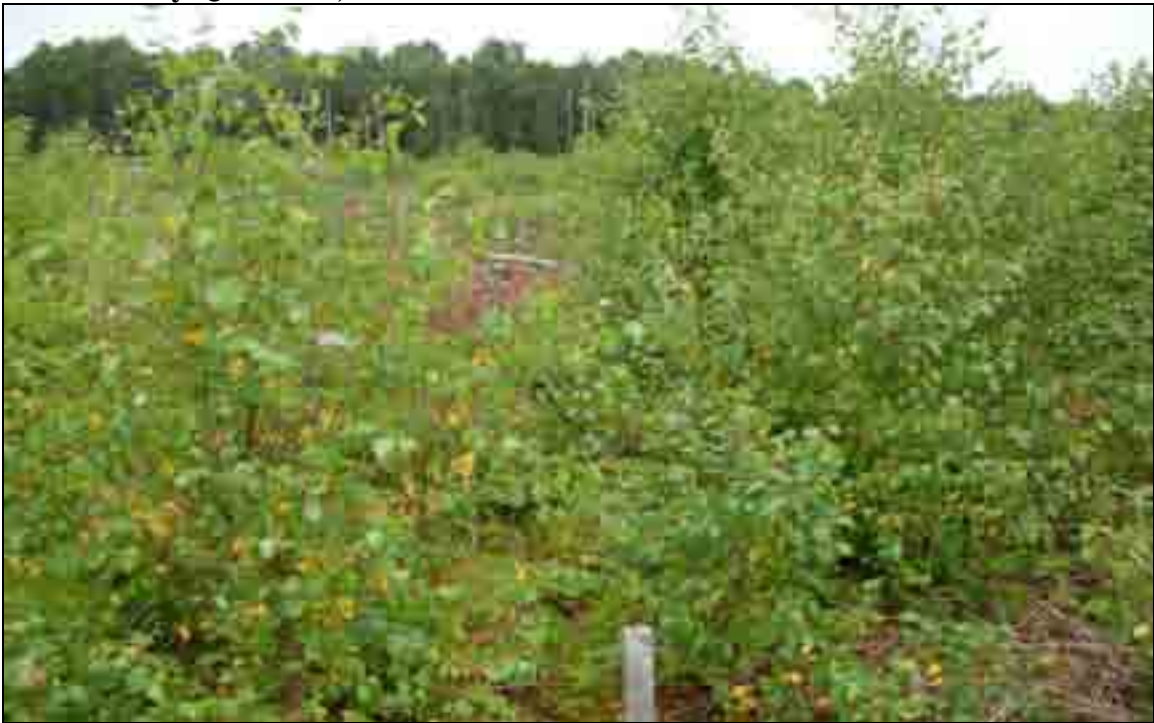
Mount Hevey Quadrat 3

Quadrat 3: This quadrat was located in a mature conifer plantation on the eastern high bog of Mount Hevey and occurred within closed canopy plantation with a ground cover containing Ling Heather, Bramble, Willow-herb and *Hypnum* moss. With the felling to waste of the conifers, it can be seen that Birch and Ling Heather cover increased along with *Sphagnum* moss cover. Over time, with the removal of the regenerating birch this high bog area may develop raised bog habitat.

Mount Hevey Quadrat 3, 2005

Mount Hevey Quadrat 3, 2008

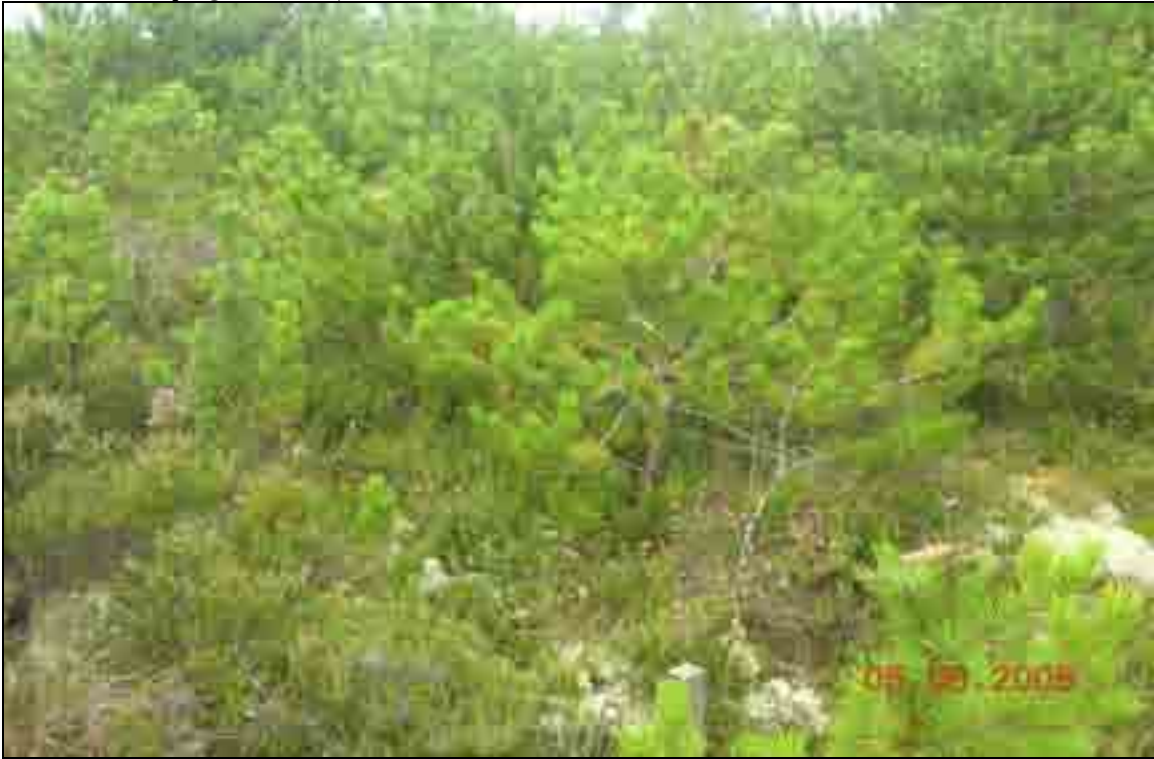
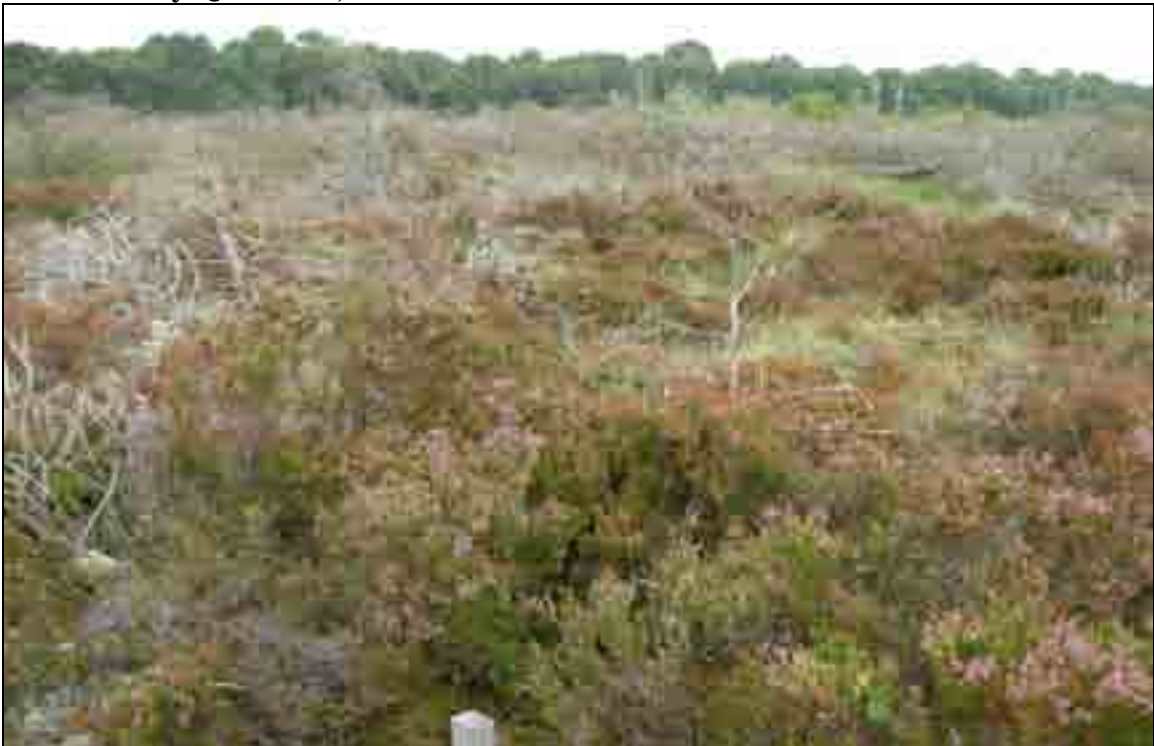
Mount Hevey Quadrat 4

Quadrat 4: This quadrat was located within a young conifer plantation on high bog to the west of the project area. The ground cover is dominated by bog vegetation of Ling Heather, Cross-leaved Heath and Hare's-tail Cotton-grass with the midland indicator species Bog-rosemary and Cranberry. There is also a high cover of *Sphagnum* mosses. With the felling to waste of the conifers, the bog vegetation will recover and over time, this high bog area will develop active raised bog habitat.

Mount Hevey Quadrat 4, 2005

Mount Hevey Quadrat 4, 2008

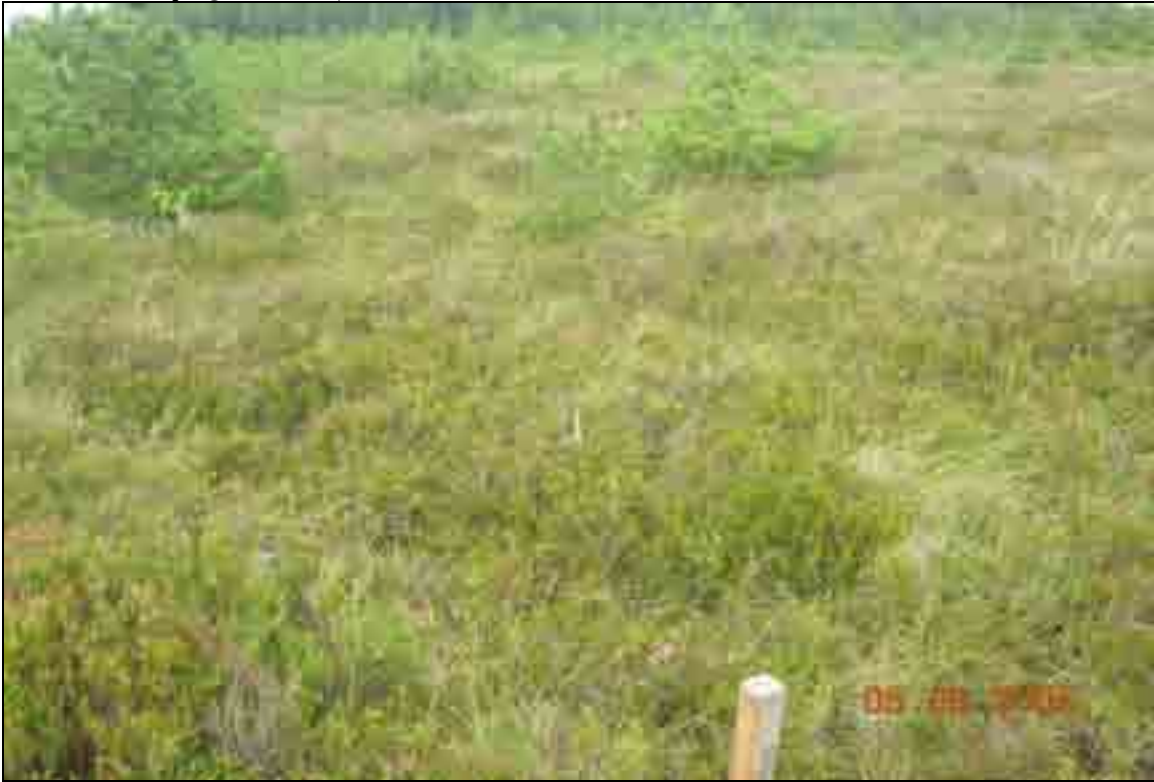
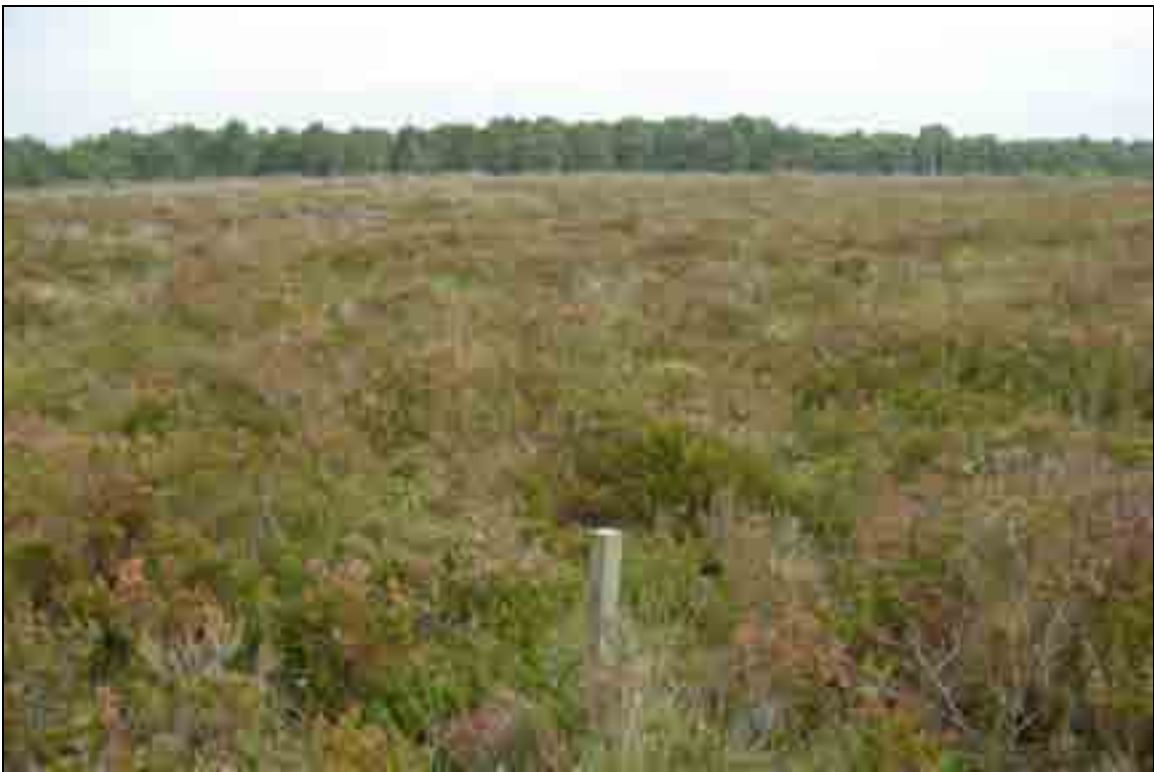
Mount Hevey Quadrat 5

Quadrat 5: This quadrat was located on the western margin of the young conifer plantation on high bog. The ground cover was dominated by Ling Heather and Hare's-tail cotton-grass with abundant *Sphagnum* moss. With the felling to waste of the conifers, the bog vegetation will recover and over time, this high bog area will develop active raised bog habitat.

Mount Hevey Quadrat 5, 2005

Mount Hevey Quadrat 5, 2008

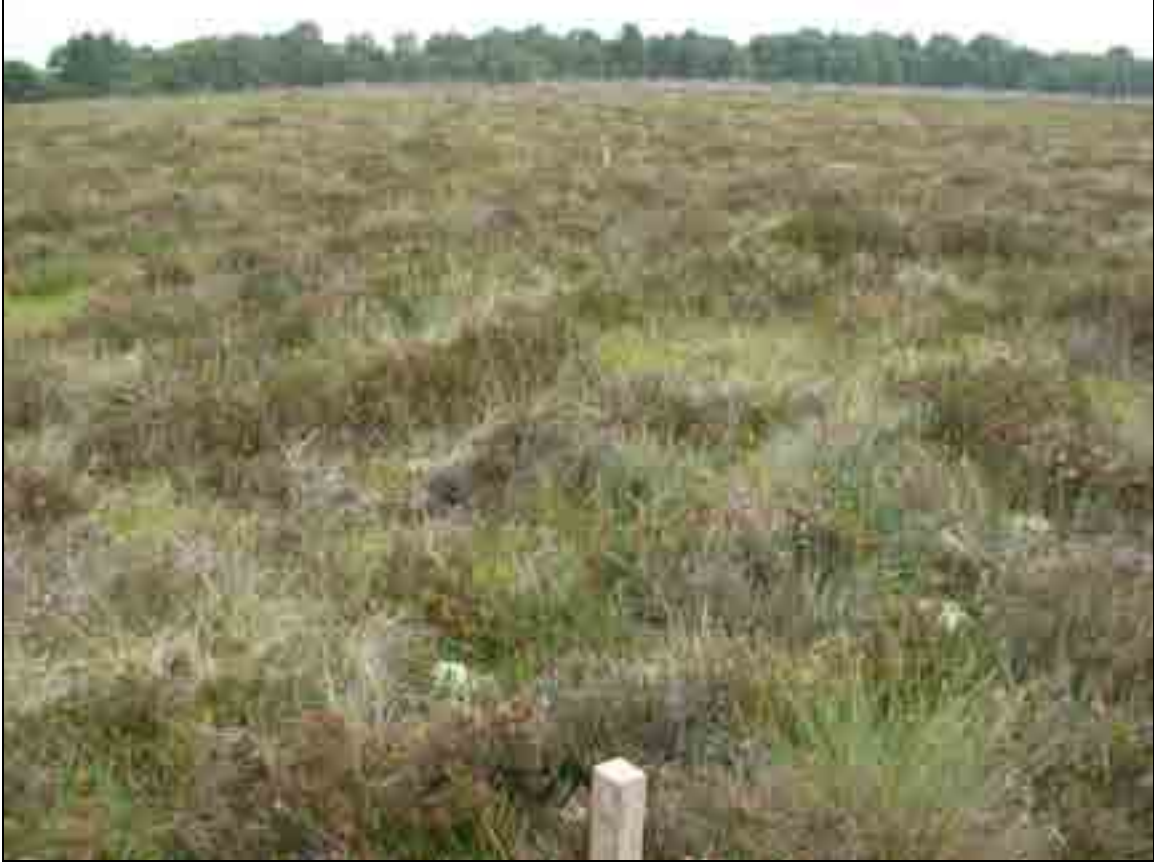
Mount Hevey Quadrat 6

Quadrat 6: This quadrat is located on the open bog to the west of the project area at Mount Hevey Bog. It occurs on active raised bog habitat dominated by Ling Heather, Cross-leaved Heath, Bog Asphodel, Hare's-tail Cotton-grass and White-beaked sedge. The midland indicator species Bog-rosemary and Cranberry also occur along with abundant *Sphagnum* moss. This quadrat details the bog vegetation present on active raised bog habitat and describes the ideal vegetation for the restoration sites.

Mount Hevey Quadrat 6, 2008

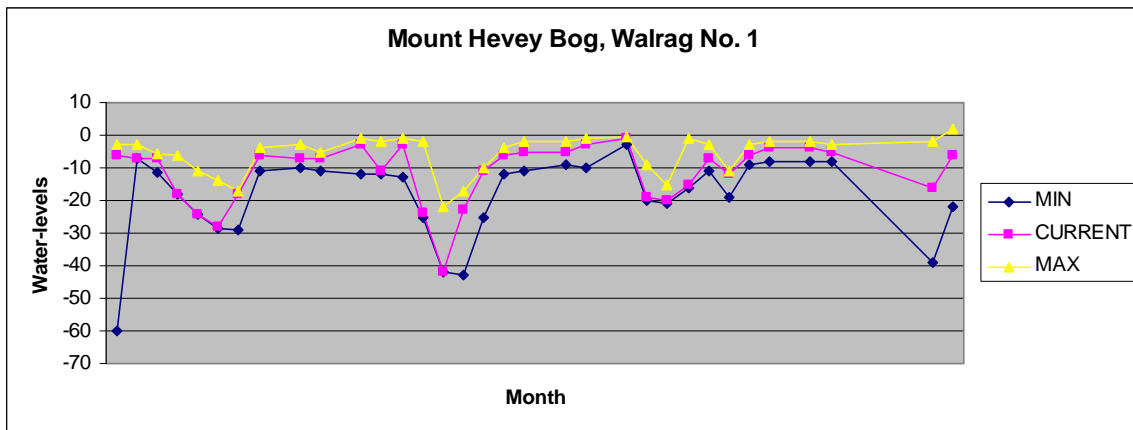
Mount Hevey Bog Walrag 1: Clear-felled Conifer Plantation on High Bog. (Water-levels decline in summer months. Water-levels have been raised post restoration*)

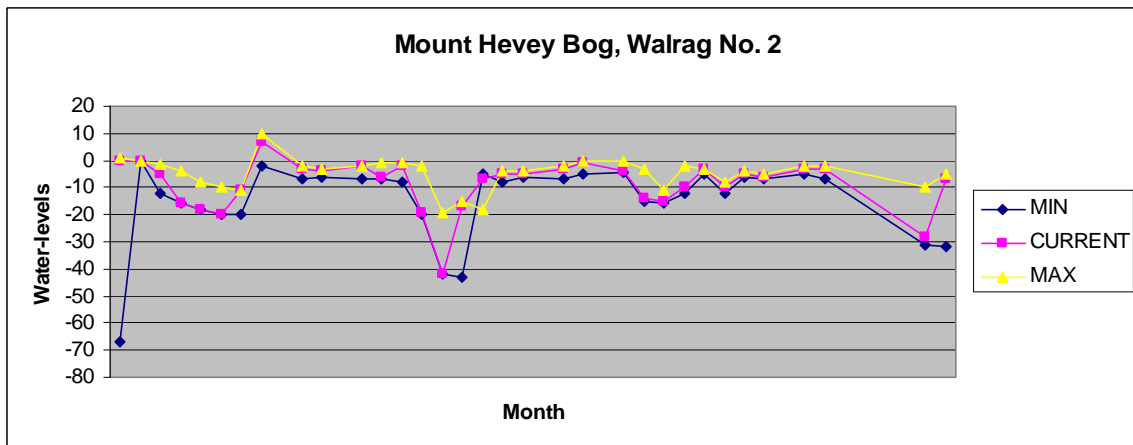
Mount Hevey Bog Walrag 2: Clear-felled Conifer Plantation on High Bog. (Water-levels decline in summer months. Water-levels have been raised post restoration*)

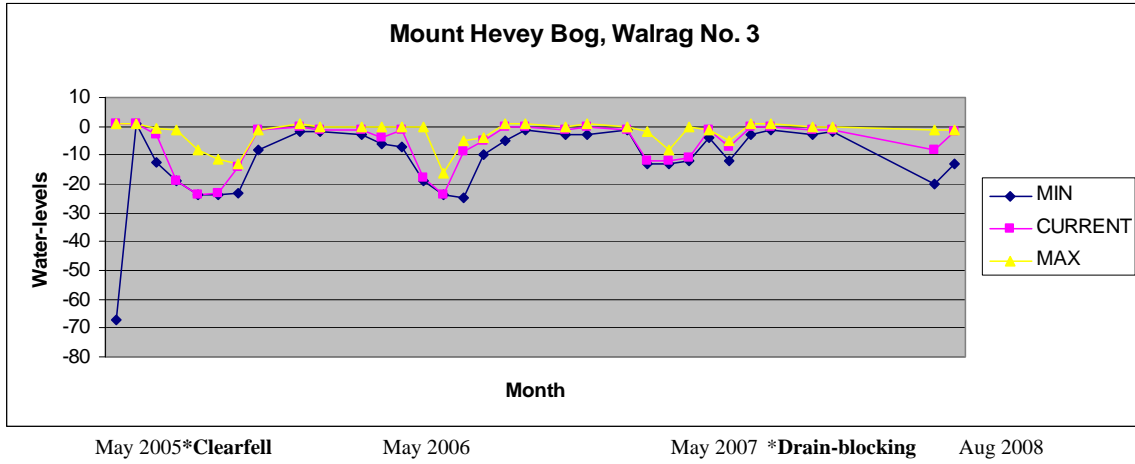
Mount Hevey Bog Walrag 3: Open Canopy Conifer Plantation on High Bog. (Decline in water-levels in summer months before tree-felling. Water-levels have been raised post restoration*)

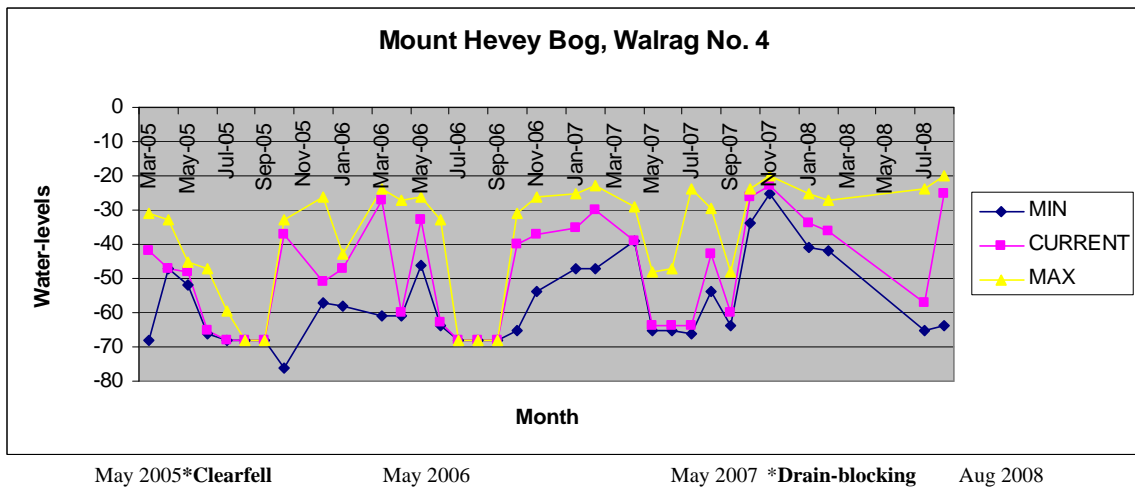
Mount Hevey Bog Walrag 4: Clearfelled Conifer Plantation on Cutover Bog. (Large decline in water-levels during summer months. Water-levels remain variable post restoration* due shallow peat substrate)

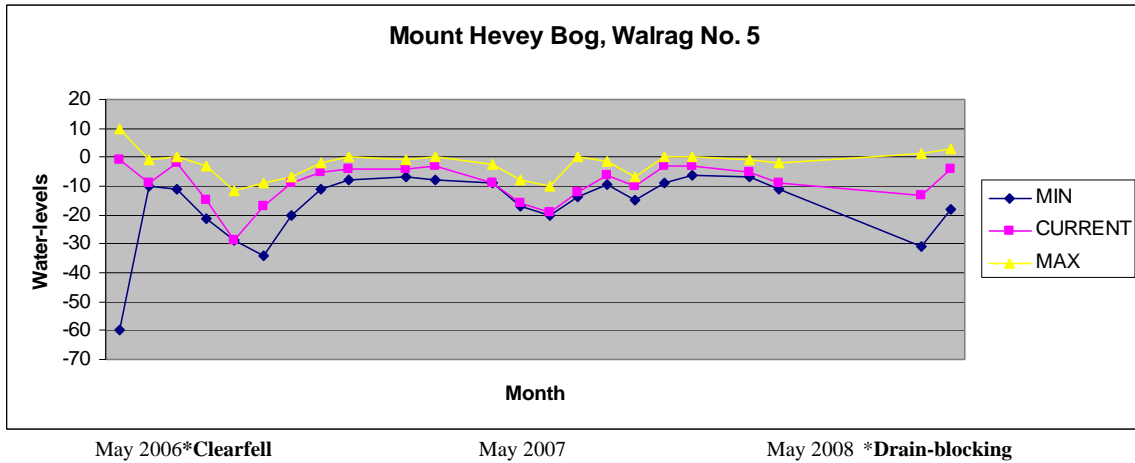
Mount Hevey Bog Walrag 5: Clear-felled Conifer Plantation on High Bog. (Water-levels decline in summer months. Water-levels have been raised post restoration*)

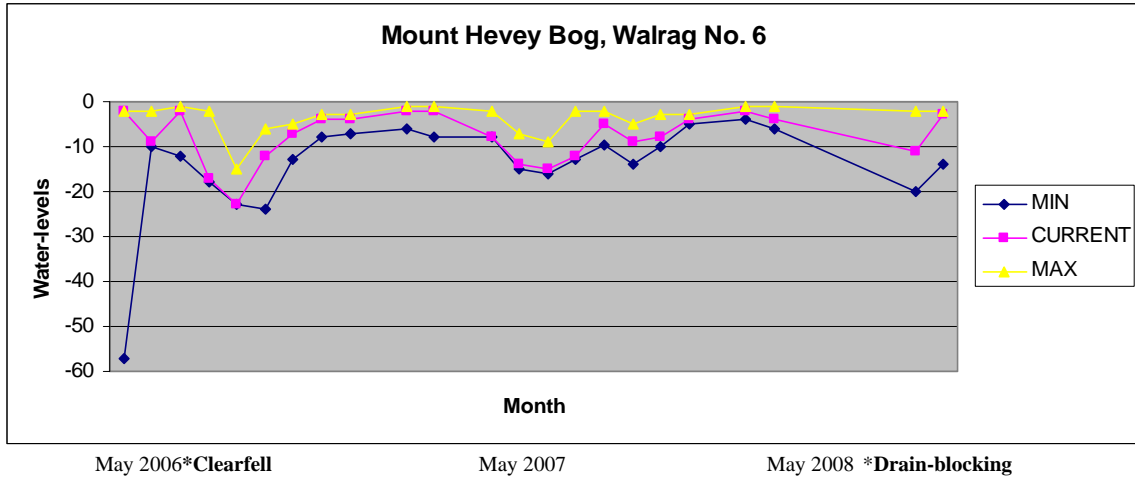
Mount Hevey Bog Walrag 6: Open Canopy Conifer Plantation on High Bog. (Decline in water-levels in summer months before tree-felling. Water-levels have been raised post restoration*)

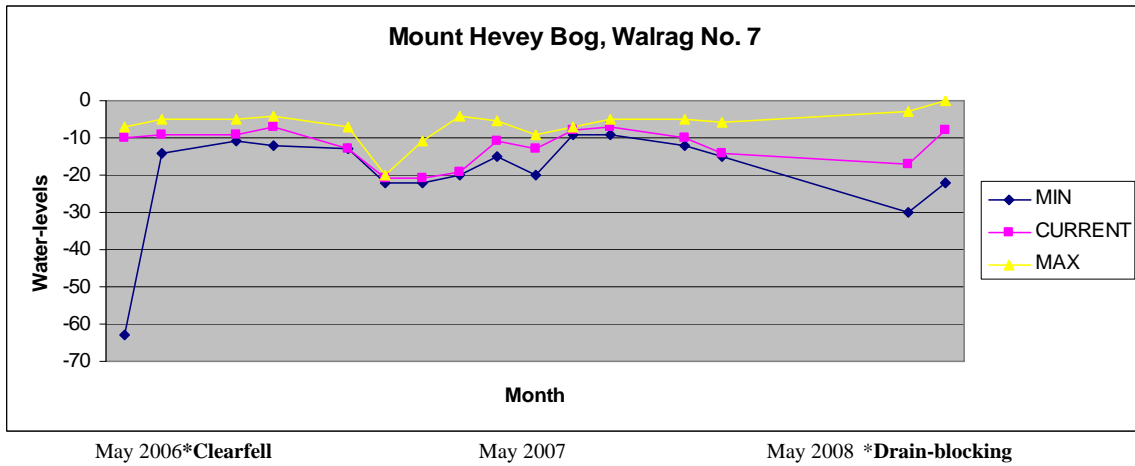
Mount Hevey Bog Walrag 7: Open High Bog - Active. (Slight decline in water-levels during summer months, but within 10 cm of surface for most of the year).

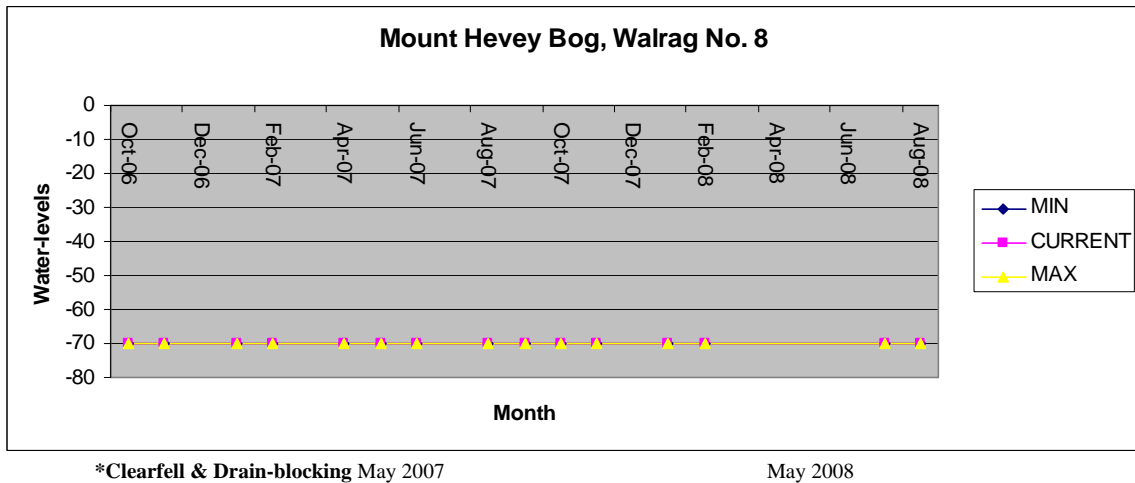
Mount Hevey Bog Walrag 8: Clearfelled Conifer Plantation on Cutover Bog. Water-levels remain far below the surface post restoration* due to shallow peat substrate)
